HD2740 – Purangi Road RP 11.1 – Inspection of underslip

PROJECT: Purangi Road RP 10.8

Coastal Processes, Engineering and Ecological Assessment for Purangi Road Coastal Protection

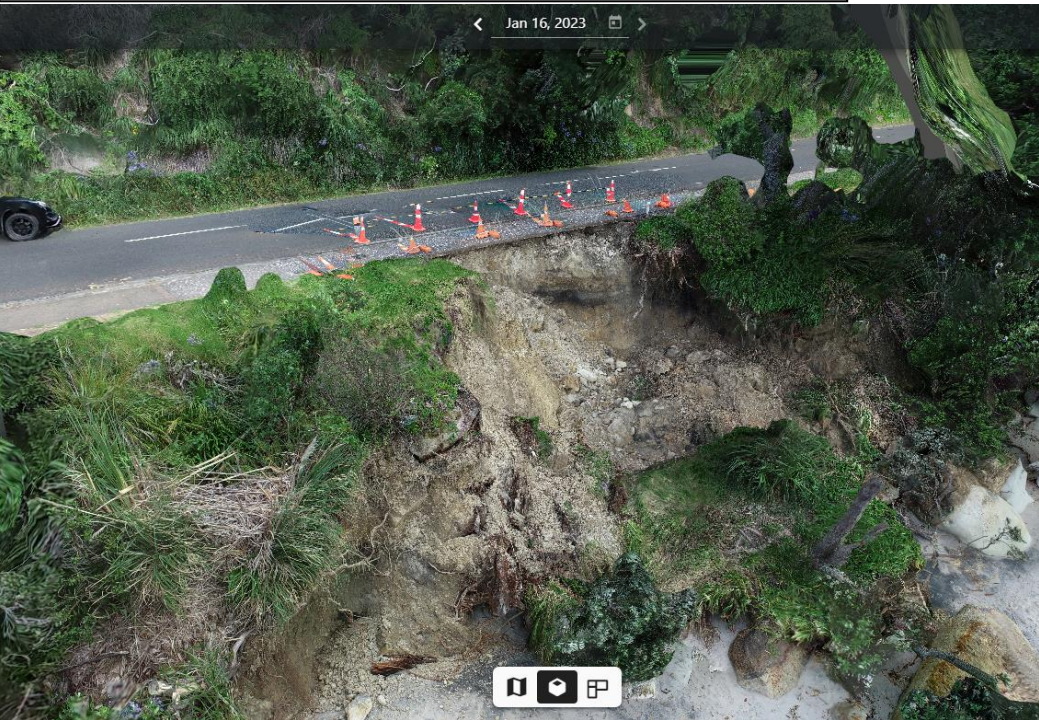
Figure 1: Drone image 16.01.2023.

A 10 m long under slip has occurred on the True Right-Hand Side (TRHS) of the Purangi Road at RP 10.870. The shoulder has completely failed creating a 3 m high vertical scarp slope directly adjacent to the concrete foot path. The debris including a large Pohutukawa Trees is located on the foreshore and will slowly be removed during high tides. The path and road have not been damaged however it is expected to crack as the outside edge settles. This could result in the foot path suddenly dropping away. The shoulder either side of the slip are expected to fail in a similar way in the near future.

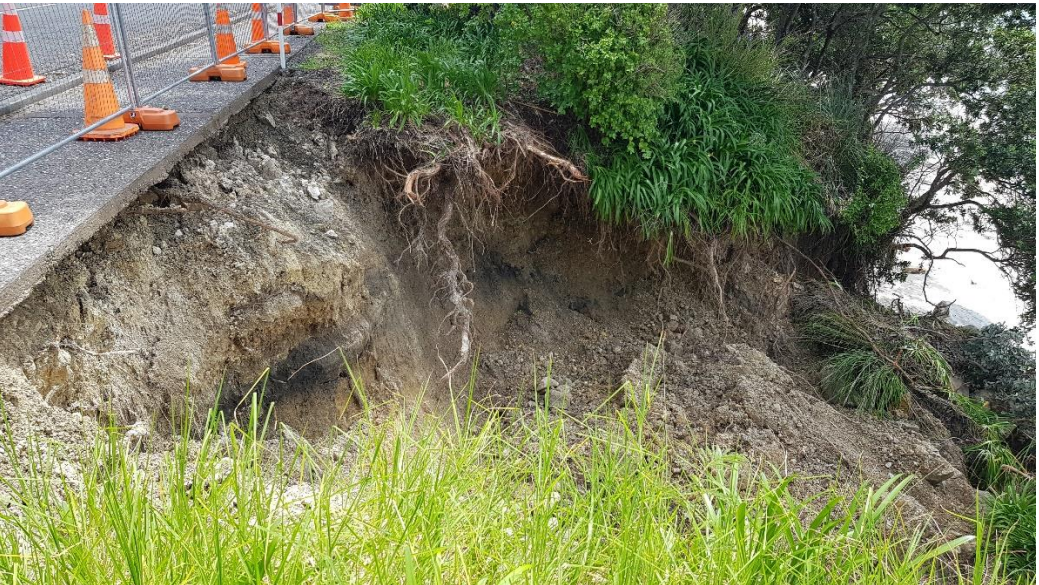
The walkover revealed that the true right-hand side (TRHS) shoulder has been undercut by coastal erosion during high sea levels and storm surges. This has caused the large Pohutukawa trees to lose support and fail downslope with their root ball pulling the soil from below the concrete footpath.

Figure 2: Looking up chainage at the scarp. Not the very outside edge of the concrete is undermined.

We recommend that the concrete foot path is closed until the slip is repaired. We recommend that the practitioner's rock buttress and gabion wall is constructed to re-form the road shoulder and to mitigate further costal erosion.

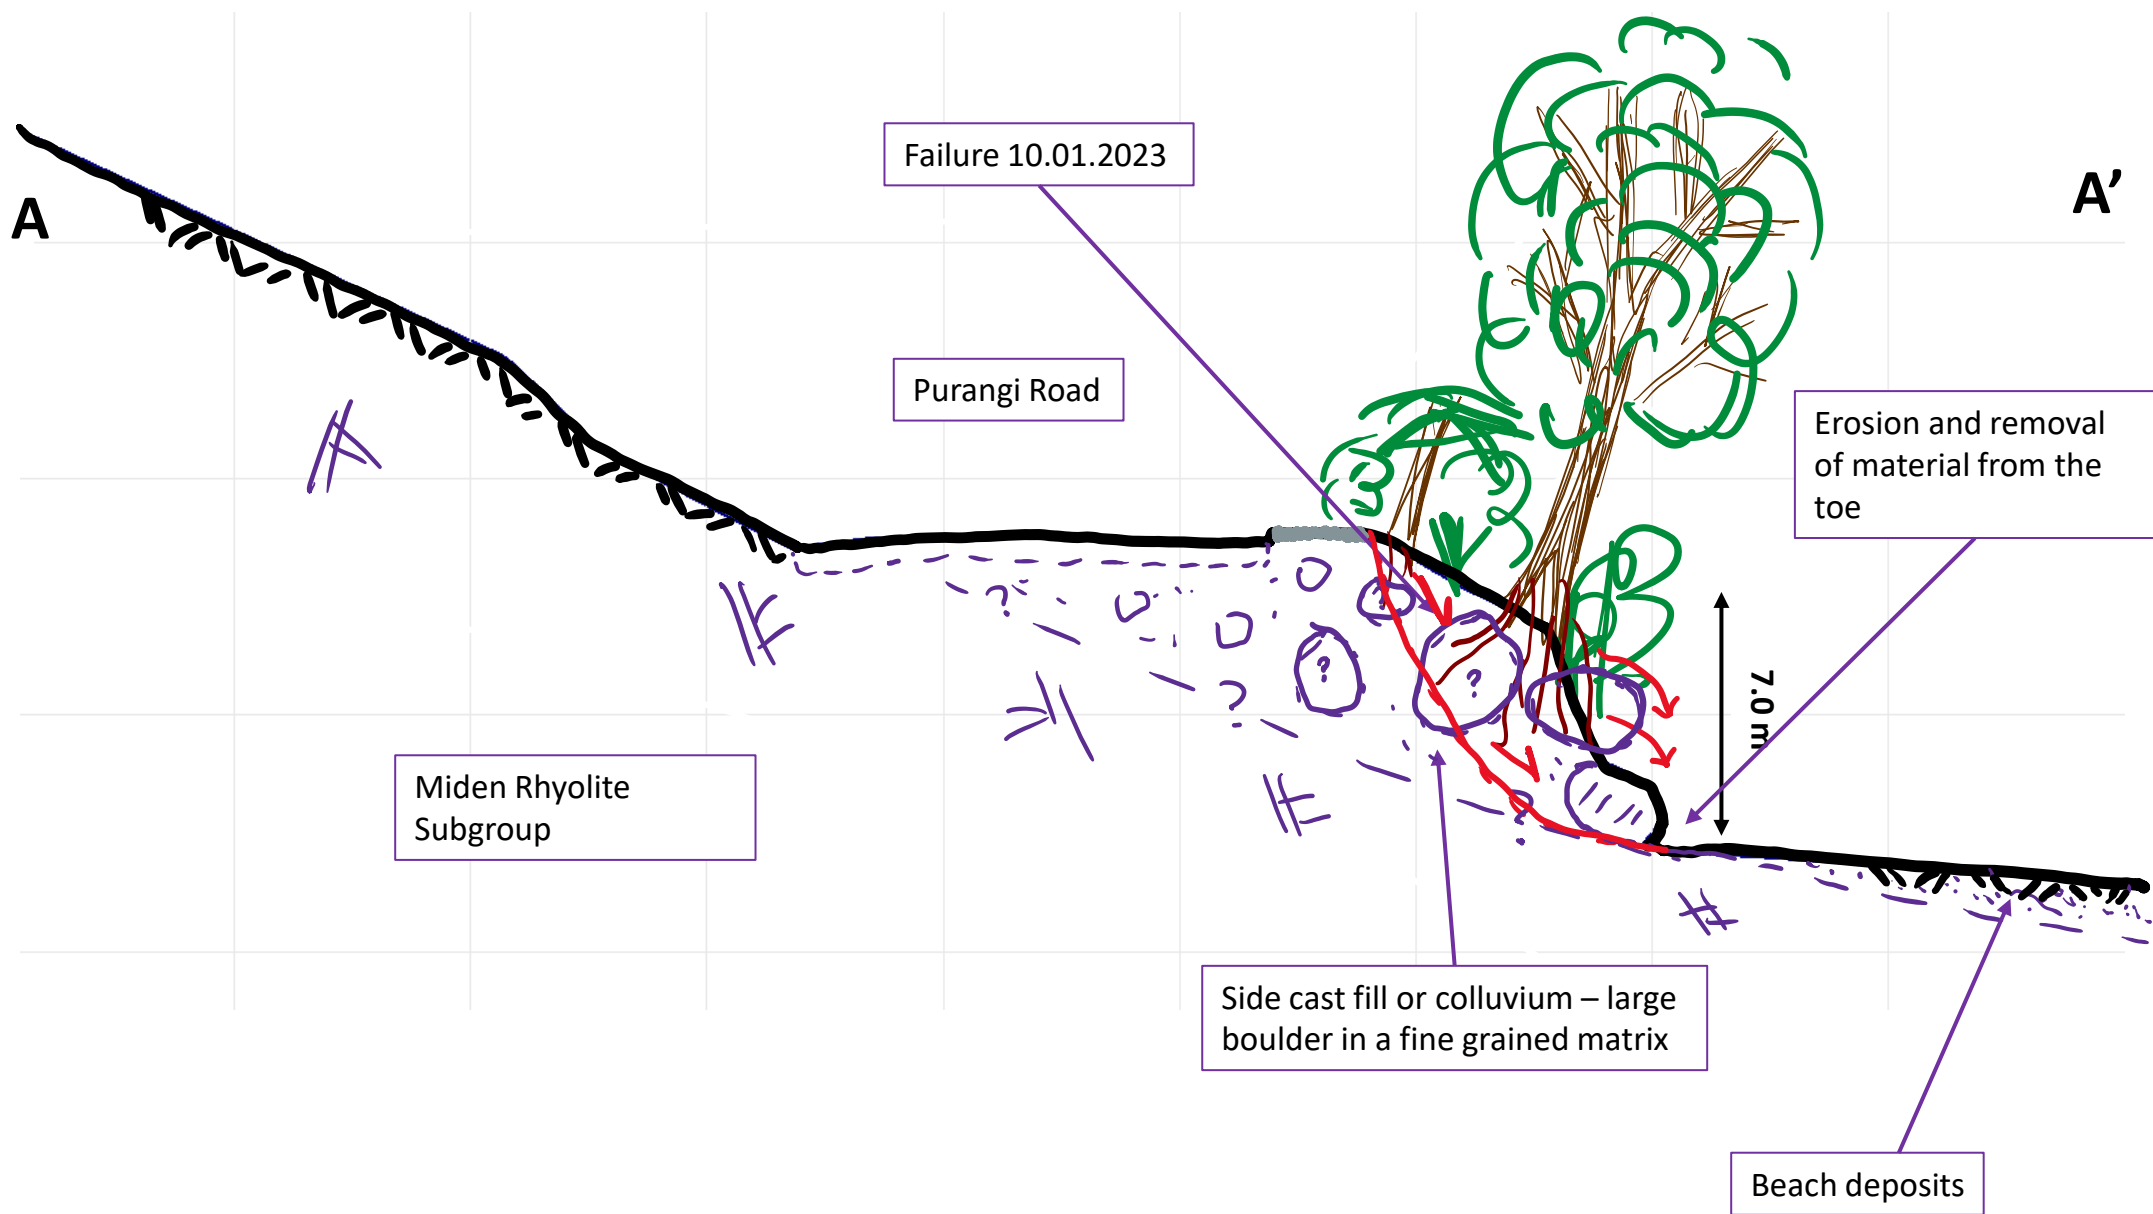
TITLE: Schematic section

The TRHS slope either side of the slip is about 5 - 7 m high and sloping between 60 – 70 degrees down to the foreshore. Large Pohutukawa trees on the outside edge of the shoulder are sitting on what appears to be side-cast fill or colluvium that is comprised of small to large boulders (<0.5 m to 2m dia) in a fine-grained matrix. The Minden Rhyolite Subgroup is exposed at the toe of the slope on the foreshore. There are obvious signs of coastal erosion at the toe of the slope which is over-steepening the base and allowing the large boulders to fall out, removing support to the trees above. The road is 6.7 m wide and a 45-degree slope is located on the TLHS of the road which is heavily vegetated.

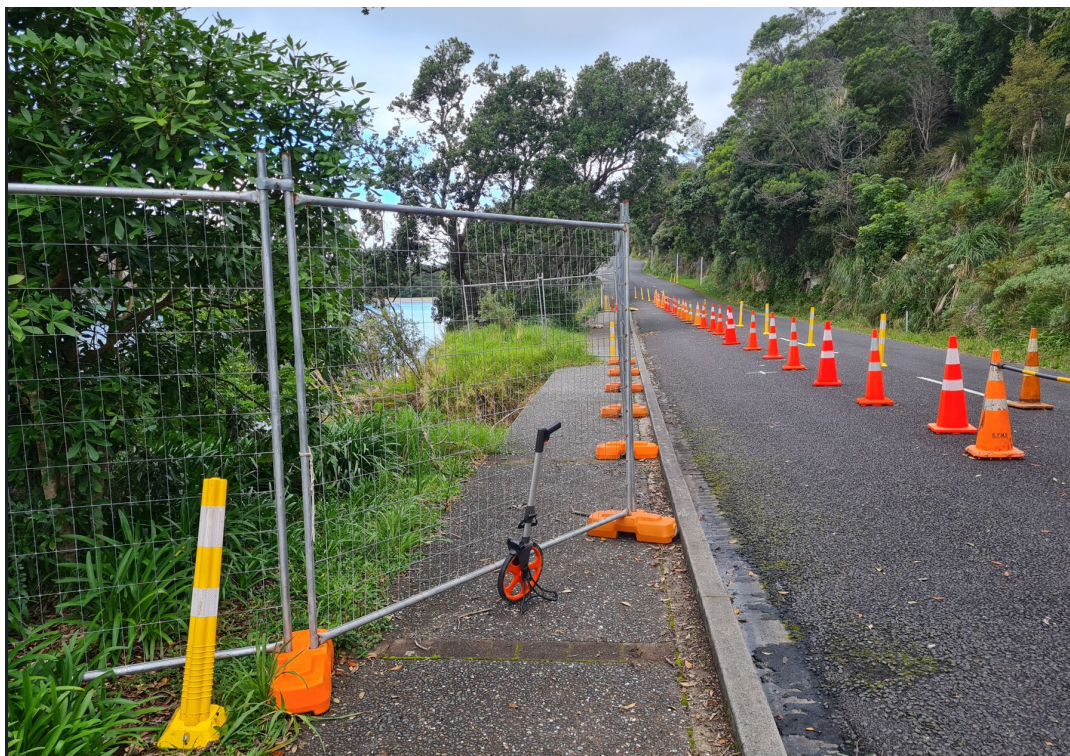
Figure 2-3. The dangerous footpath at Purangi Road.

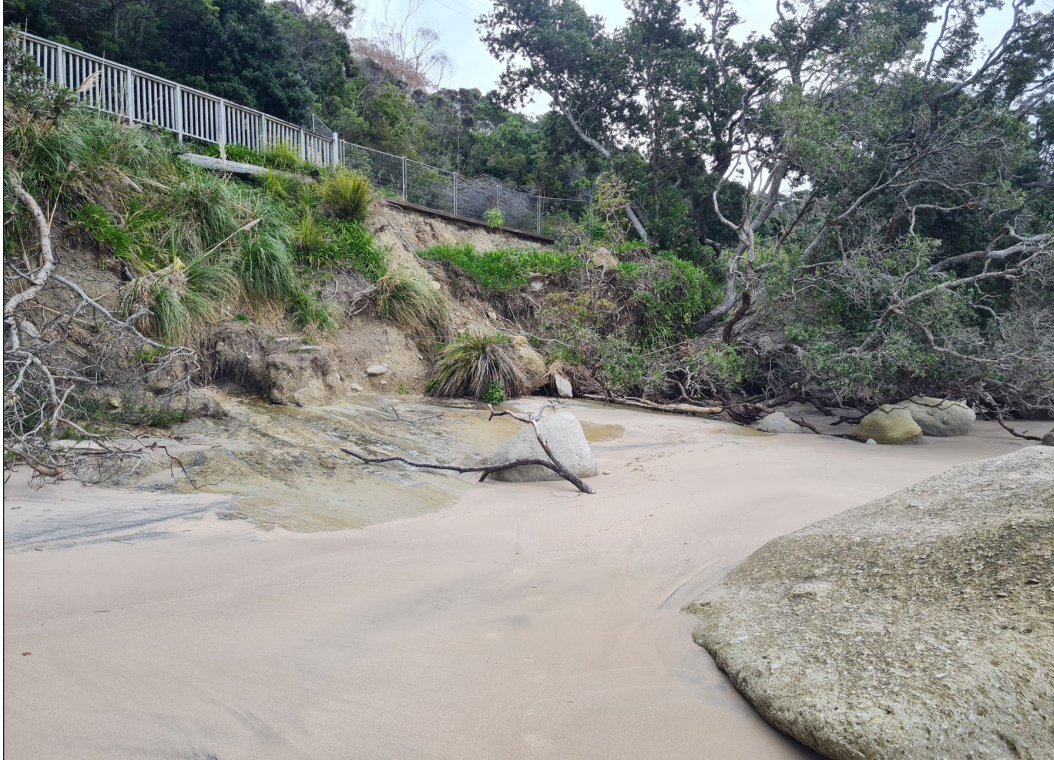
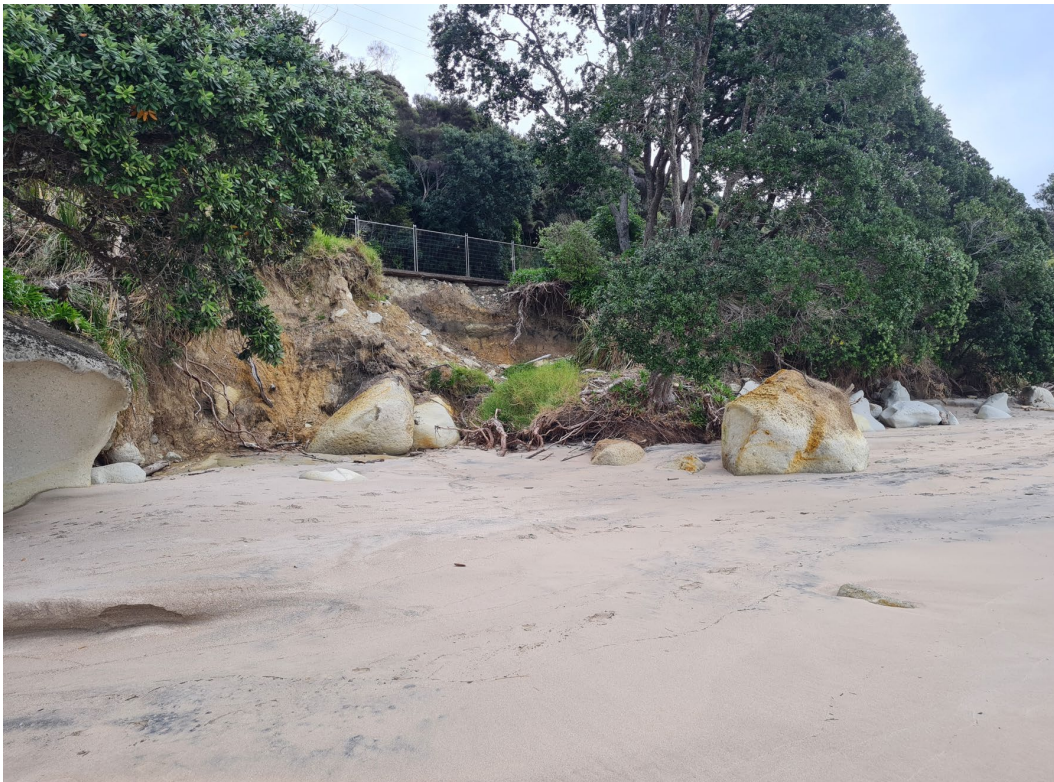
Figure 2-4. The damaged road that requires protecting from extreme wave events is the perched above a sand beach with occasional large boulders.

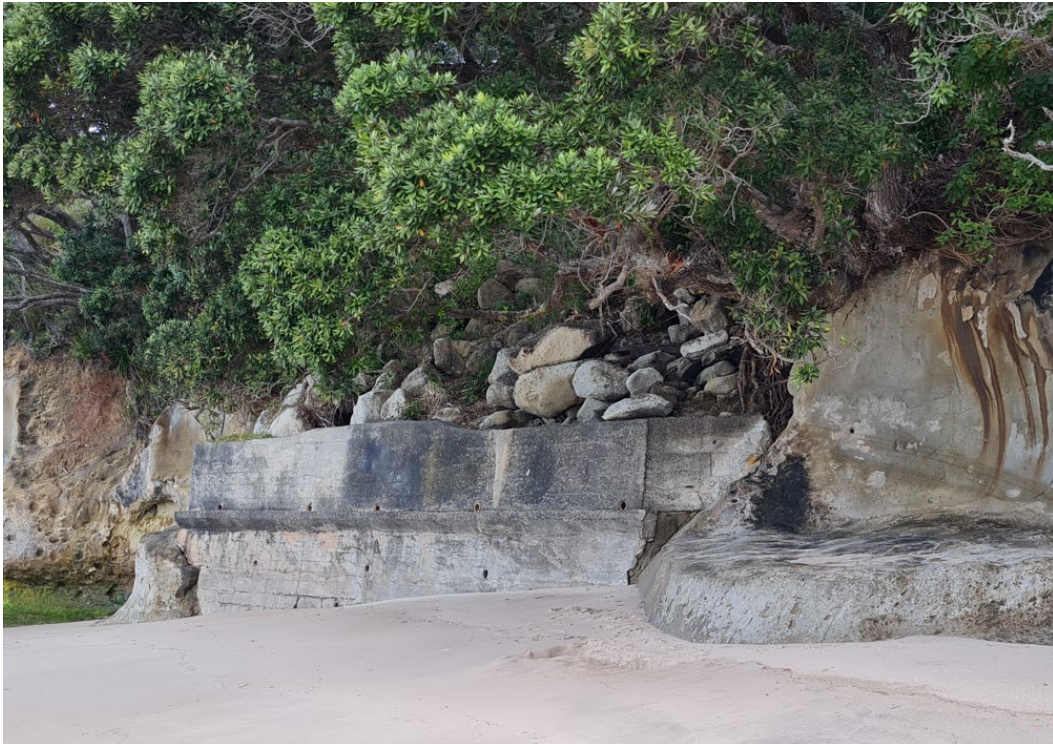
Figure 2-5. A concrete buttress protecting the cliff and road above it to the east of the slip.

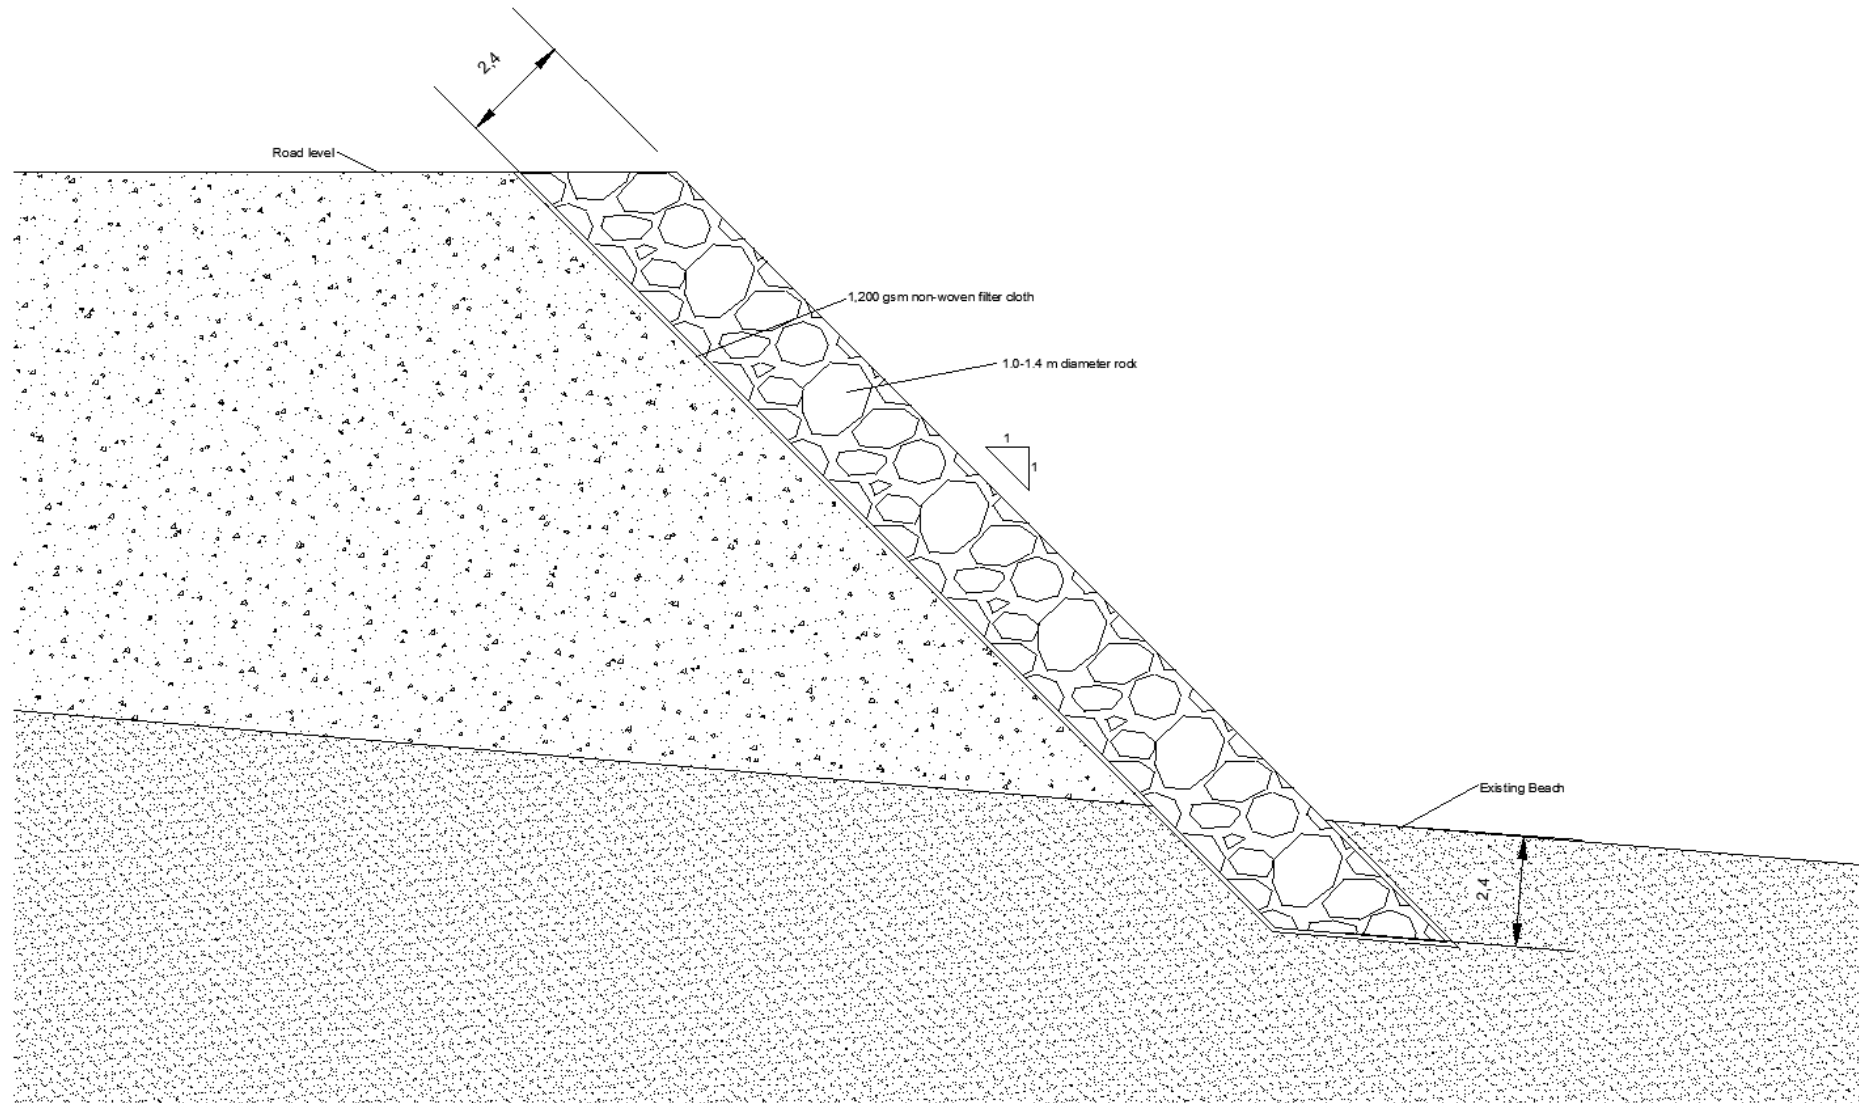
Figure 3-3. Generic cross-section for the revetment at Purangi Road.

For an extreme wave height of 1.41 m at 12 seconds (i.e., the longest fetch 100-year wind generated waves), a slope of 1:1 (V:H) given the steep nature of the cliff, basalt rock and a K_D value of 2 were applied. The recommended size of rock was found to have a nominal diameter (D_{50}) of 1.21 m (with a 10% safety factor). This rock size was also determined using the Van de Meer shallow water formula, which is considered to be more conservative for small wave climates; this resulted in nominal diameter (D_{50}) of 1.27 m. From these calculations, a mix of rocks with diameters¹ ranging from 1.0 to 1.4 m are suitable for the site (nominal diameter of 1.2 m), or rock weight of 1,410 to 3,880 kg. The armour layer should be 2.4 m thick (i.e., 2x

the nominal rock size), placed on 1,200 gsm non-woven filter cloth. A generic cross-section is shown in Figure 3-2.

Should additional material be required for gradient the soil under the revetment, clean back fill can be used prior to installation of the non-woven geofabric. The toe of the revetments should extend into the sand beach to the same depth as the thickness of the armour (i.e., 2.4 m; Figure 3-2), or onto the bedrock if this is struck before the depth is achieved.

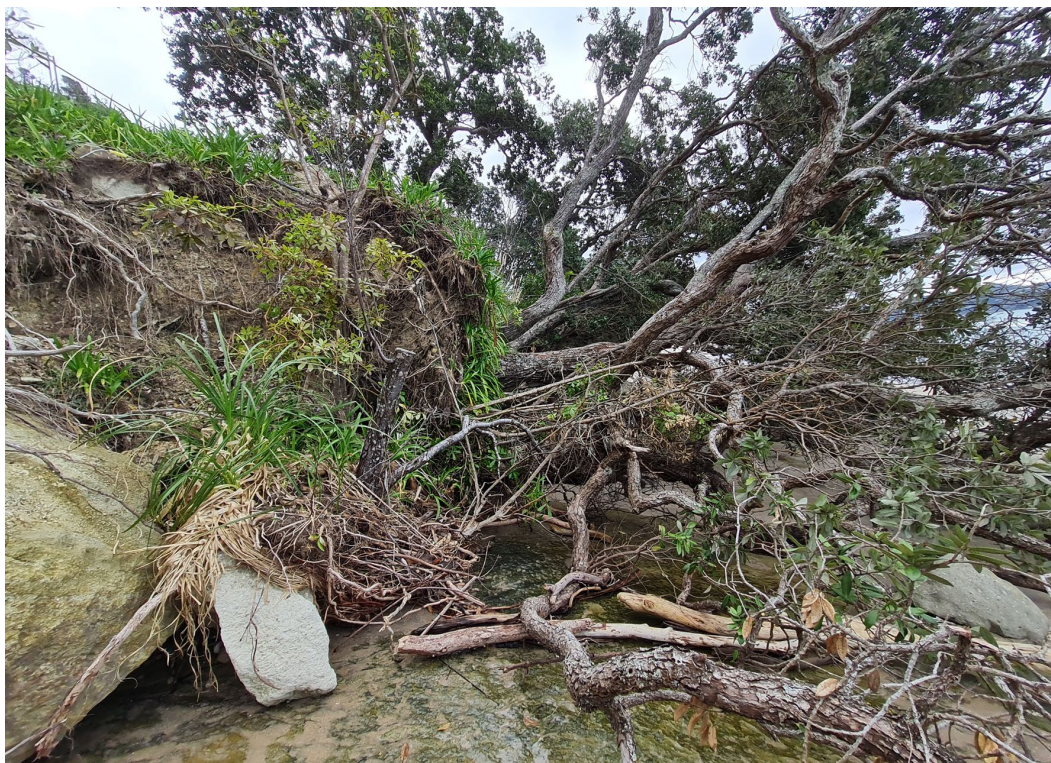
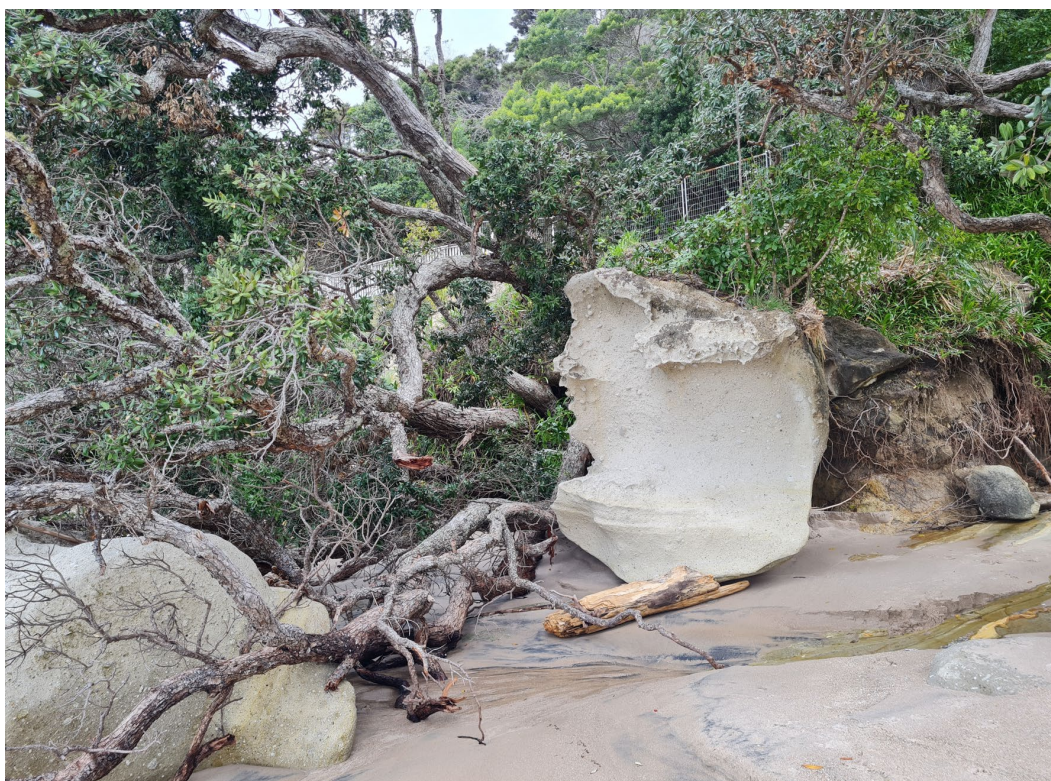
Figure 4-4. The still living Pohutakawa that slipped down the cliff when it failed.

impacts will be less than minor. However, of note are some large Pohutukawa trees adjacent to the site, including a still living tree that came down with the slip. It is recommended that an arborist is consulted prior to construction of revetments to assess whether the central Pohutakawa is removed and what kind of measures should be included in the CEMP to ensure adjacent trees are not damaged..
