# Old Kopu Bridge

*Technical Review Memo of Historic Kopu Bridge Society Proposal,  
Structural Assessments and Other Supporting Documentation*

Document Version: Final  
14 June 2014

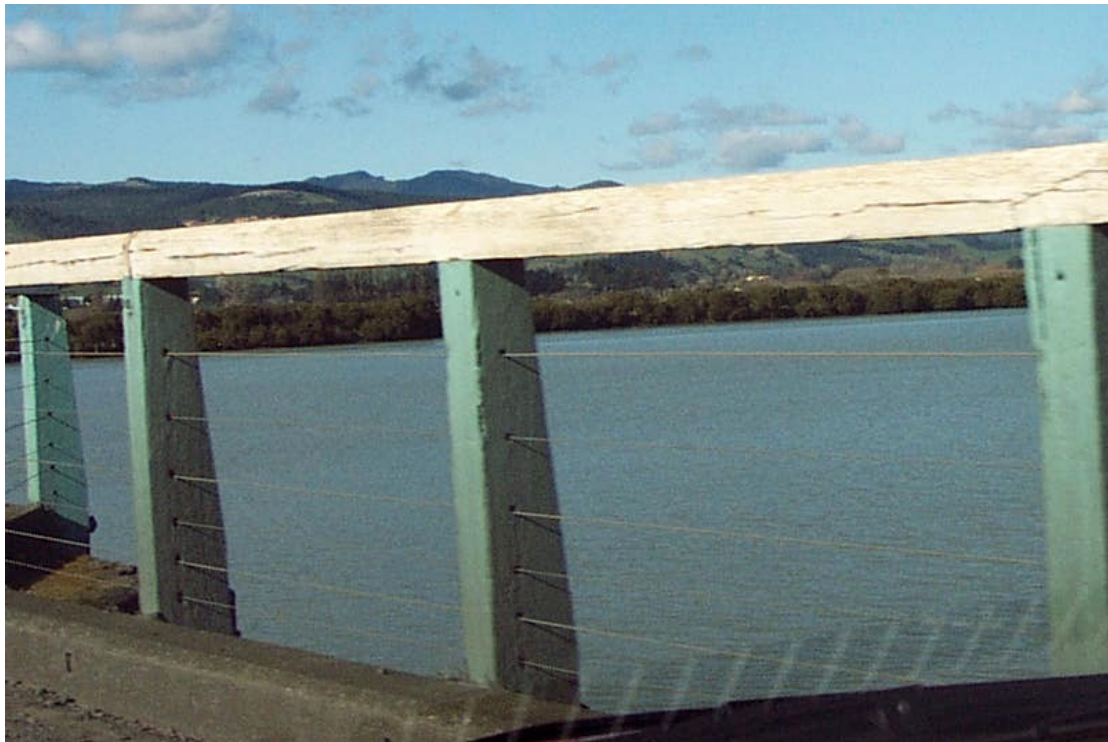
The current handrail consists of timber post and top rail with six horizontal strands of cable as shown in the photo below.

The NZTA proposed removal of the existing edge protection is based on a rate of \$70/m. The installation of the new edge protection or handrail is in accordance with building code and based on a rate of \$930/m. The cost calculations also include Preliminary & General and (pedestrian) traffic management. The value of the removal component is \$100,000 and the new handrail is estimated at \$770,000 by BECA. The BBO estimate is \$450,000, which includes removal of the old railing. The life expectancy of the new asset isn't stated.

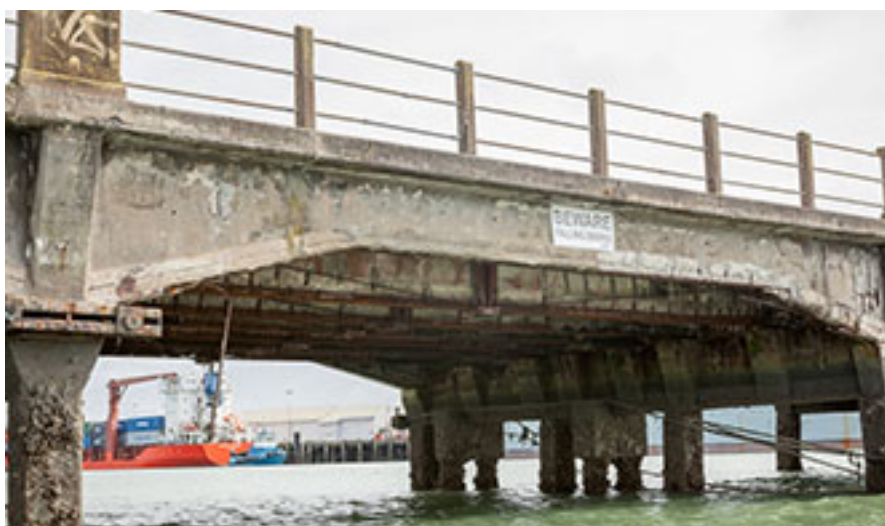
- **Handrails:** The renewal of the handrails only include repair and painting as it is not intended to replace this component of the historic bridge. The repair costs were assessed by Opus engineers and quantified after conducting a detailed inspection. The cost projected for these items is therefore vastly different to the BBO projection in 2012. There are no compliance issues as previously mentioned. The only concern would be users and in particular, unattended children. Pedestrian access is however not a new activity or use of the bridge. The current Kopu Bridge handrails offer a bit more protection than handrails present at the recently repurposed old Mangere Bridge.
