Attachment A
Thames-Coromandel District Council
13 December 2022

Comprehensive Report: 1 October 2022 Storm Event – Event Summary

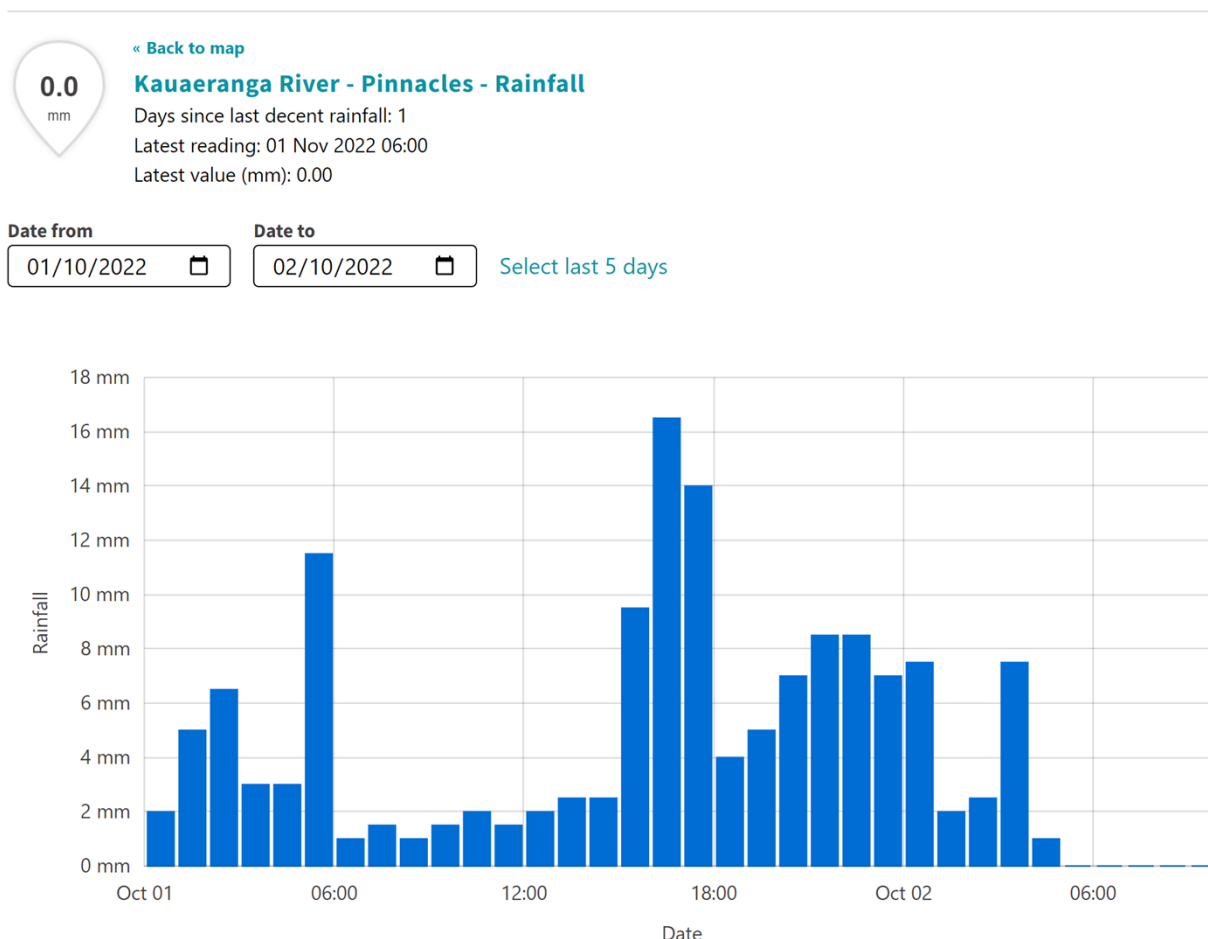
Data from the Waikato Regional Council rainfall gauge at the Pinnacles in the graph below shows in excess of 156mm in a 24-hour period on 1 October 22. This is an average recurrence interval (ARI) of 1.58 years however the rain gauges are quite some distance from the slip sites and there is no available rain gauge data nearby.

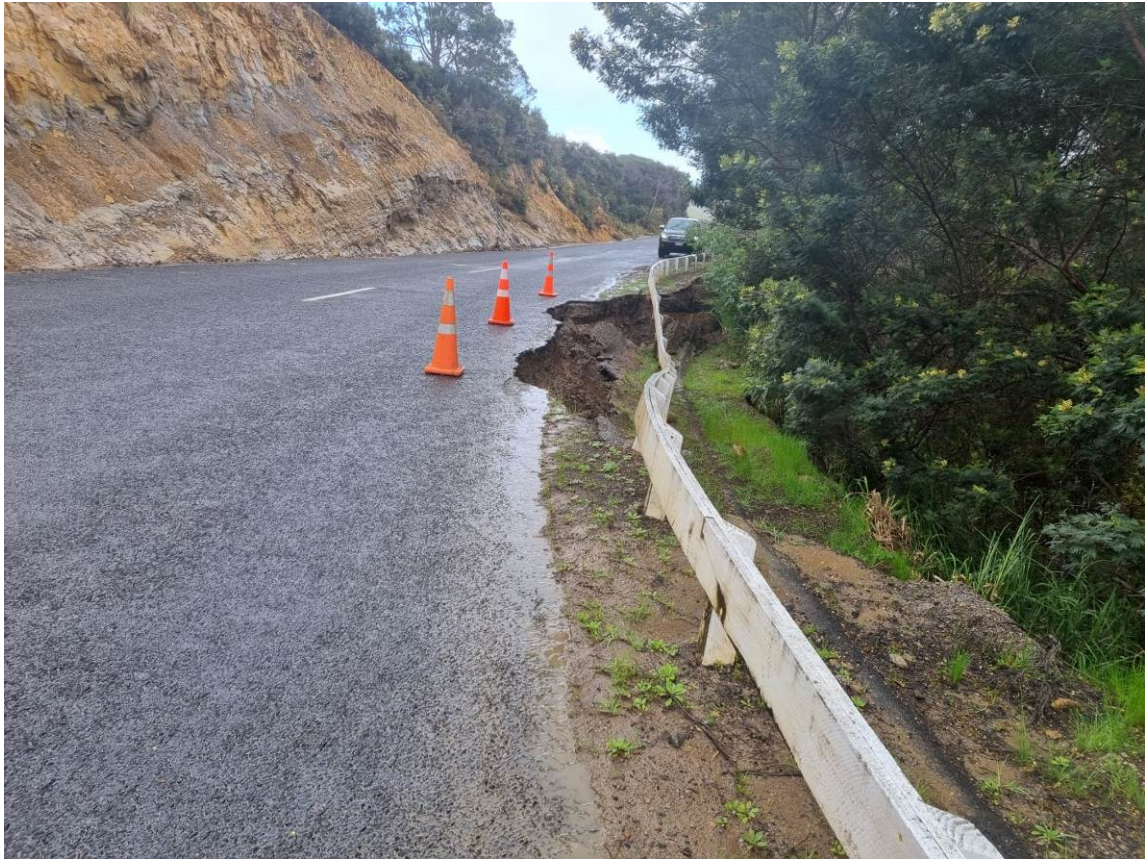
Site 1 - Colville Road – RP16.1

Permanent Reinstatement site list & estimated Investigation & Design costs			
Road	Location & Issue	Investigation & Design Scope	Cost
Colville Road	RP16.1 – Underslip into traffic lane	Site Investigation & boreholes and design and construction docs	\$59,000
The 309 Road	RP16.6 – Overslip through narrow 1 lane section with historic underslip on downhill side	Site investigation & design & contract docs	\$20,000
Total Phase 1 Investigation/Design Professional Services			\$79,000

Permanent Reinstatement site list & estimated construction & MSQA costs			
Road	Location & Issue	Permanent Repair	Cost
Colville Road	RP16.1 – Underslip into traffic lane	Timber Post & Panel Wall	\$350,000
The 309 Road	RP16.6 – Overslip through narrow 1 lane section with historic underslip on downhill side	Gabion Wall with Rock buttress	\$150,000
Total Physical works permanent reinstatement			\$500,000
Professional Services			
Contract Tendering & Admin and MSQA Costs			\$50,000
Total Professional Services			\$50,000
Total Permanent Reinstatement			\$550,000
