Whangamata Skate Park Report

Date 20/6/2017

Skate Park	Whangamata Skate Park									
Date Visited	7/11/2016									
Park Location	Martyn road Whangamata									
Skate Park Description	1980's Snake run. Precast ,1990's style street park, Fat bars, metal rails and mix of wedge banks and transition									
Size of Skate Park	Approx 2000m2									
Year of Construction	Late 1980's. early 2000's									
Surface Type	Concrete	Wood	Metal	Asphalt	Paving	Other				
	✓									
Surface Condition	Extremely poor		Poor		Average		Good		Very Good	
	1	2	3	4	5	6	7	8	9	10
Steel Coping Condition	1	2	3	4	5	6	7	8	9	10
Concrete edge Condition	1	2	3	4	5	6	7	8	9	10
Drainage	1	2	3	4	5	6	7	8	9	10
Rubbish and Debris Accumulation	1	2	3	4	5	6	7	8	9	10
Condition of Landscaping	1 N/A	2 N/A	3 N/A	4 N/A	5 N/A	6 N/A	7 N/A	8 N/A	9 N/A	10 N/A
Overall Condition of Skate Park	1	2	3	4	5	6	7	8	9	10
Park Safety Rating	Severe Hazard		Serious Hazard		Moderate Hazard		Slight Hazard		Minimal Hazard

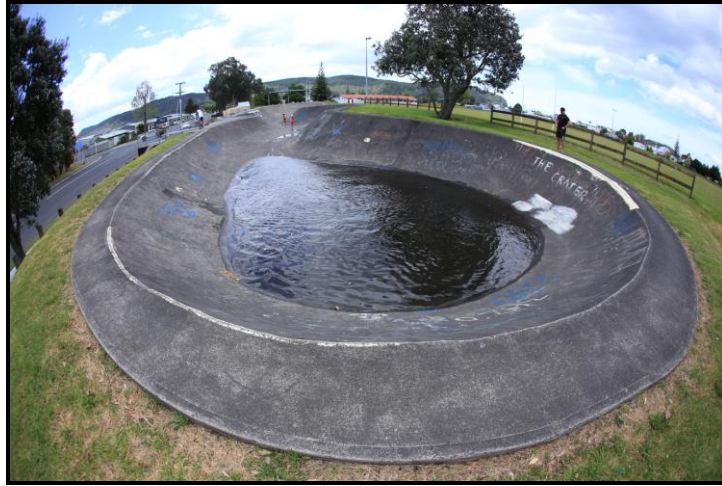
Figure 1 Severe flooding, from blocked Drain

Hazard Rating , Severe

The Drainage at the end of the snake is completely blocked.

- Clean out all drain holes to western side of skate park.
- Drill additional 75mm holes in areas where water is pooling.
- Investigate whether or not the snake run drainage is a soak pit or connected to a storm water drain.
- If drainage is connected to a storm water drain, clean the line right back to the sump in the snake run.
- If drainage is connected to a soak pit, replace soak pit with a modern design and clean the line back to the sump in the snake run.

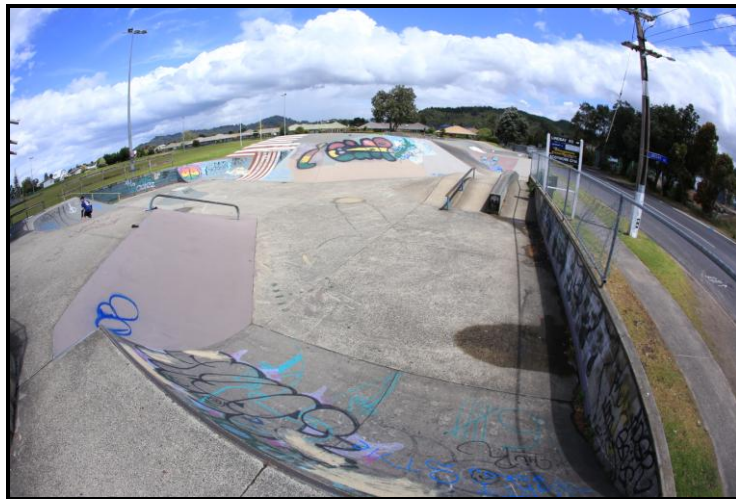
Figure 2. Water Pooling, From Poor/Blocked Drainage

Hazard Rating, Serious

Drainage is poor towards the western side of the skate park, although there are some drainage holes, they are blocked with debris, and there is not enough of them.

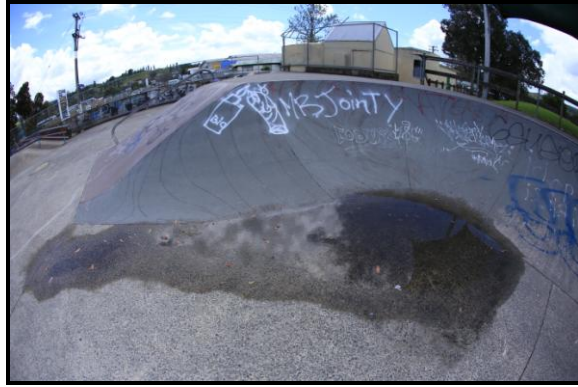
Figure 3. Water Pooling From Poor Design.

Hazard Rating, Serious

There is also water pooling through out the skatepark due to not enough fall in the initial construction of the skate park and or parts where the park has sunk.

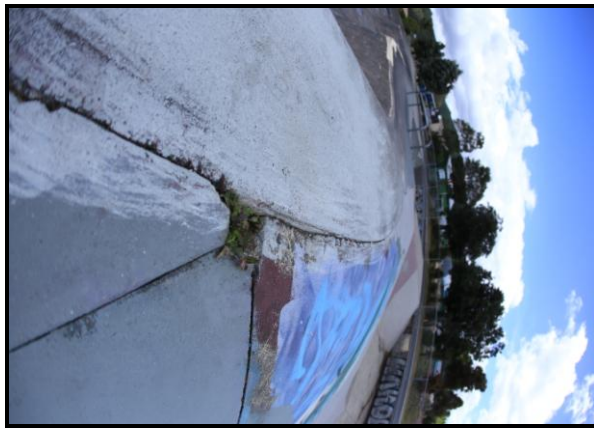
Figure 4. Damaged Concrete, Chipped and Broken Concrete Slab.

Hazard Rating, Serious

There is some damage and broken concrete through out the park, which is major hazard for the park user.

- Fill broken and chipped concrete with high strength concrete epoxy, and grind back smooth
- Where broken and concrete edges are joining to other concrete slabs, use a flexible urethane filler 70 D.
- Grind back all concrete surfaces to a smooth 100 grit finish.
- Polish all concrete surfaces to 200 grit finish.
- Apply lithium based densifier Peter Fell C2 super hard.

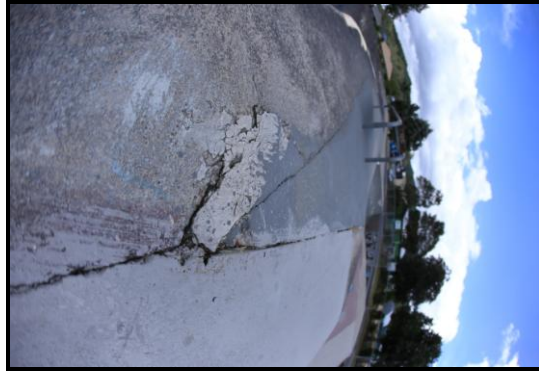
Figure 5. Old Repair Failing, Broken/Chipped Concrete.

Hazard Rating, Serious

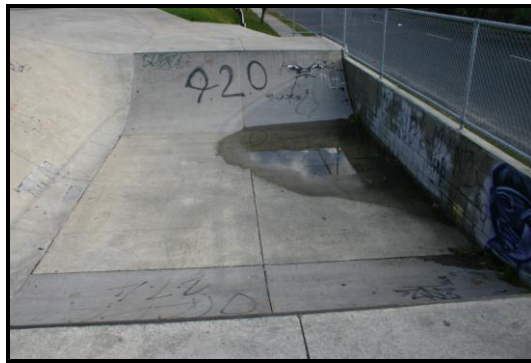
Figure 6. Water Pooling, From Poor/Blocked Drainage.

Hazard Rating, Serious

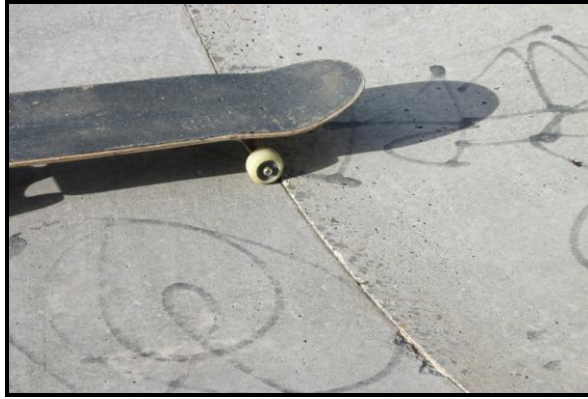
Figure 7. Slab Movement.

Hazard Rating, Severe

Structurally all the precast panels are in a poor condition as they are not tied together or tied into any of the flat concrete slabs with rebar. They are basically floating on a compacted subgrade.

There has been grinding of these panels, to try and fix the movement problems. Unfortunately the movement in these panels will continue to move.

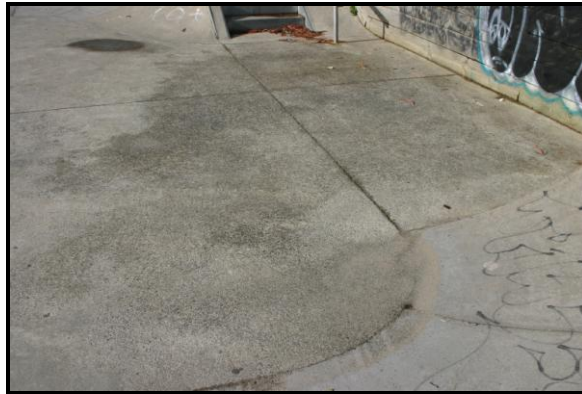
Figure 8. Rough Exposed Concrete

Hazard Rating, Serious

The skate park surface is very pitted and worn with the majority of the concrete exposed. Concrete this rough is unsafe for park user to slide/fall on even with protective pads. The concrete is so rough that protective gear will grab and be pulled off the user resulting in an accident.

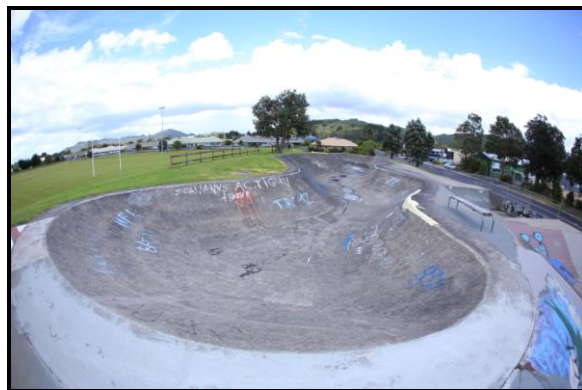
Figure 9. Rough Exposed Concrete

Hazard Rating, Serious
