Attachment B – Comprehensive Report
 Thames-Coromandel District Council
 8 November 2022

Comprehensive Report: Description of Major Works – 25th July 22

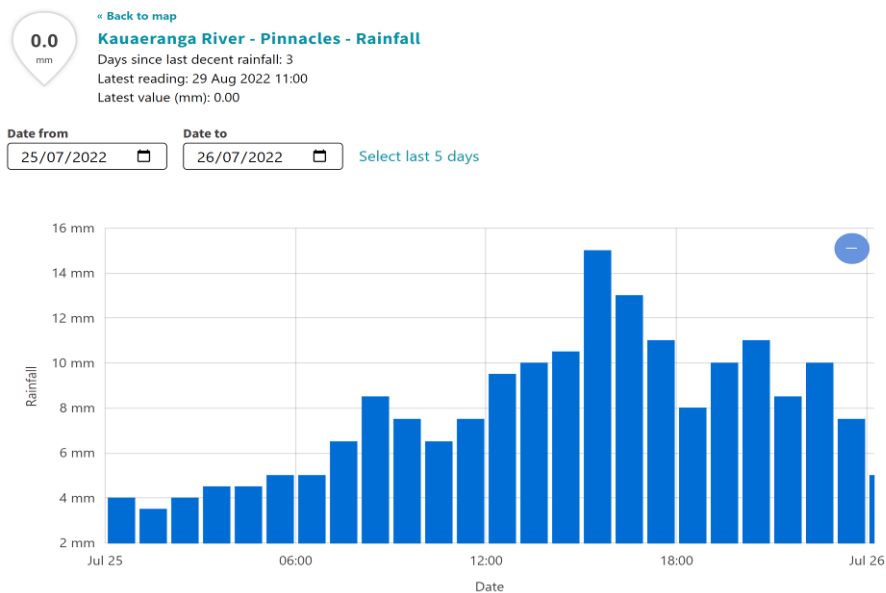
Data from the 2 nearest Waikato Regional Council rainfall gauge at the Pinnacles in the graph below shows in excess of 200mm in a 24 hour period on 25th July 22. This is a ARI of 1.58 years however the rain gauges are quite some distance from the slip sites and there is no available rain gauge data nearby.

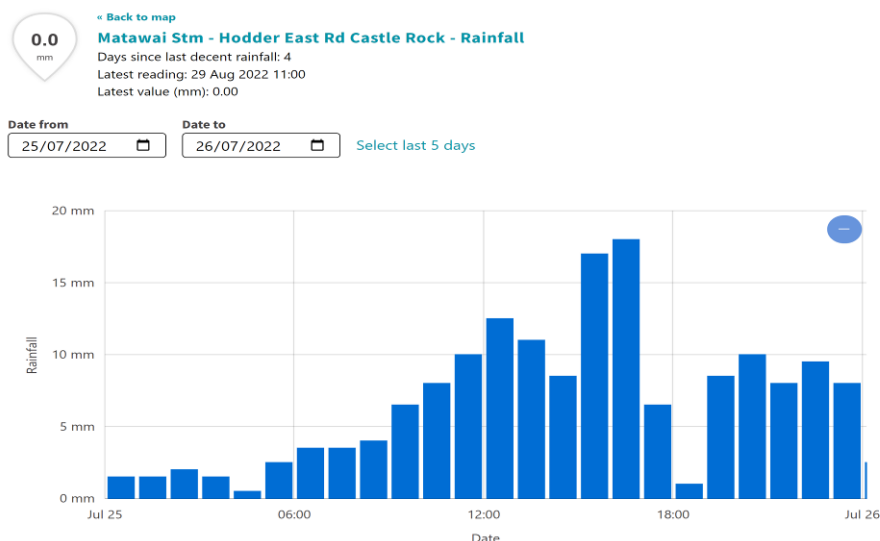
The data for Castle Rock rainfall gauge shows in excess of 160mm in a 24 hour period on 25th July 22.

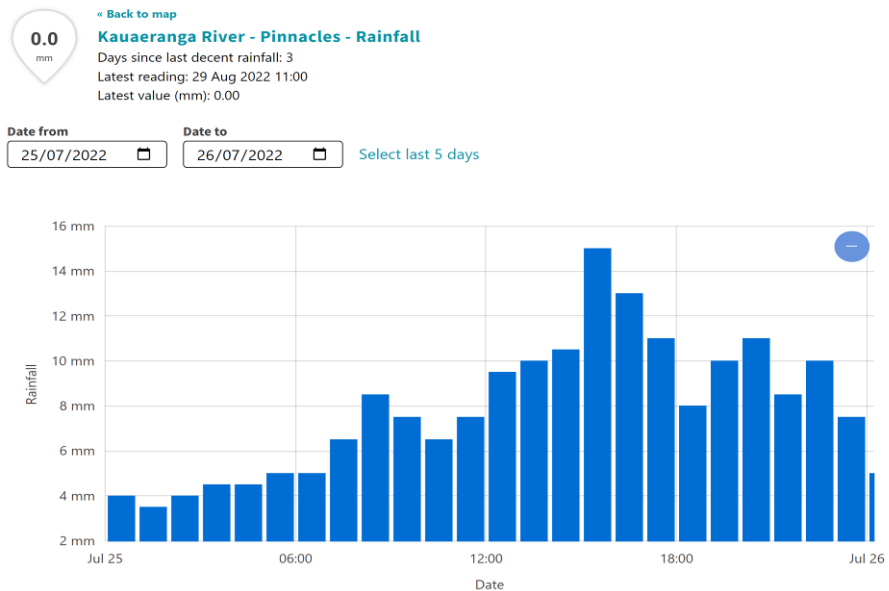
Data from the 2 nearest Waikato Regional Council rainfall gauge at the Pinnacles in the graph below shows in excess of 200mm in a 24 hour period on 25th July 22. This is a ARI of 1.58 years however the rain gauges are quite some distance from the slip sites and there is no available rain gauge data nearby.

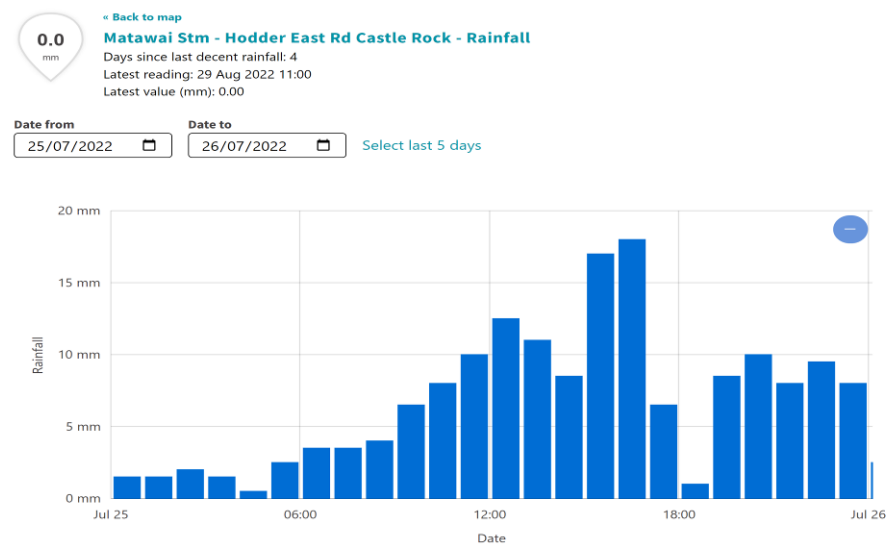
The data for Castle Rock rainfall gauge shows in excess of 160mm in a 24 hour period on 25th July 22.

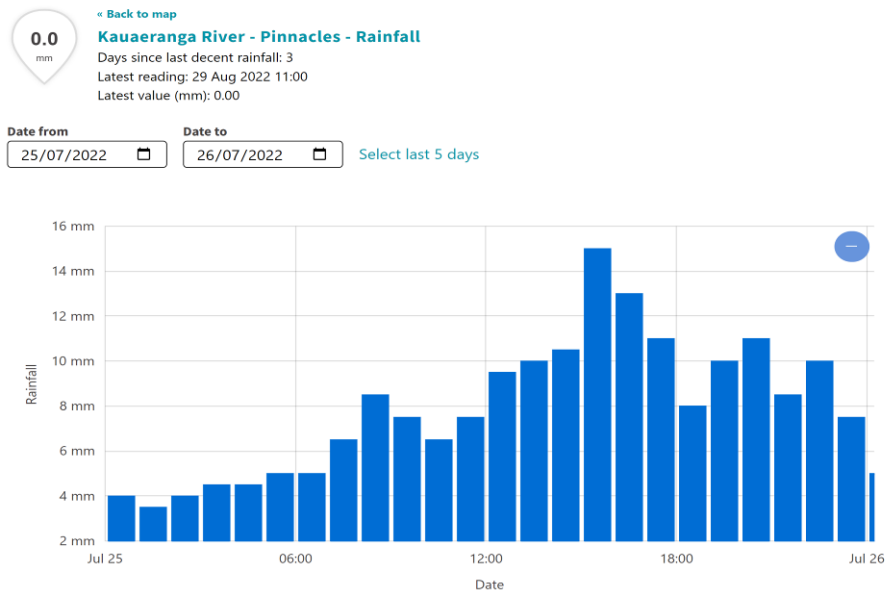
Data from the 2 nearest Waikato Regional Council rainfall gauge at the Pinnacles in the graph below shows in excess of 200mm in a 24 hour period on 25th July 22. This is a ARI of 1.58 years however the rain gauges are quite some distance from the slip sites and there is no available rain gauge data nearby.

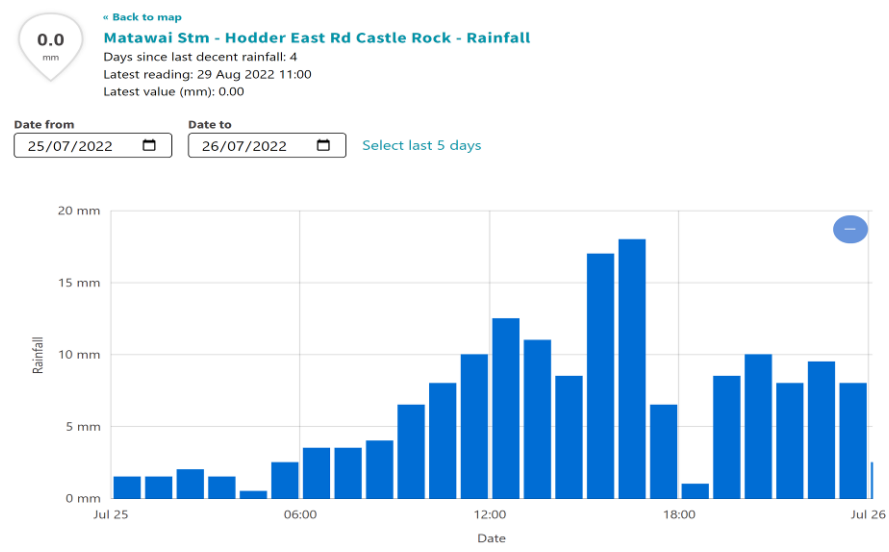
The data for Castle Rock rainfall gauge shows in excess of 160mm in a 24 hour period on 25th July 22.

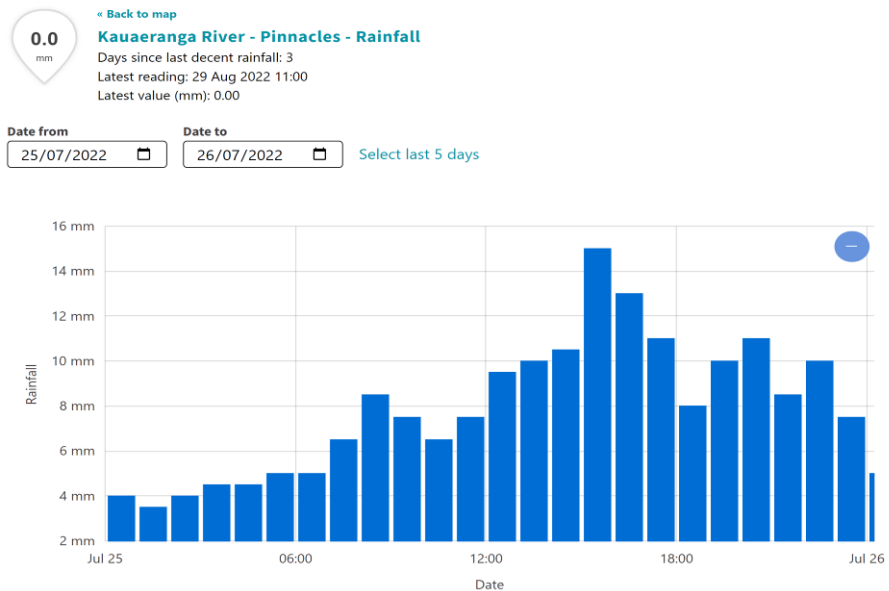
Data from the 2 nearest Waikato Regional Council rainfall gauge at the Pinnacles in the graph below shows in excess of 200mm in a 24 hour period on 25th July 22. This is a ARI of 1.58 years however the rain gauges are quite some distance from the slip sites and there is no available rain gauge data nearby.

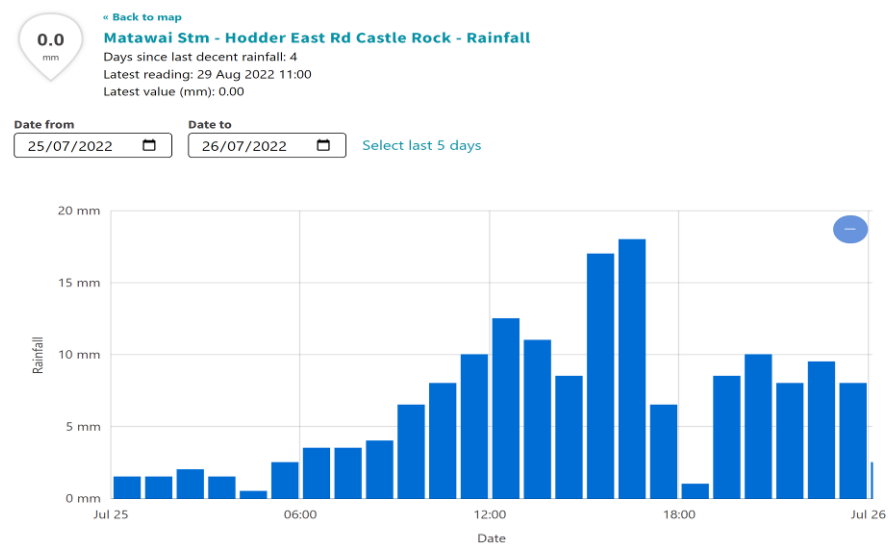
The data for Castle Rock rainfall gauge shows in excess of 160mm in a 24 hour period on 25th July 22.

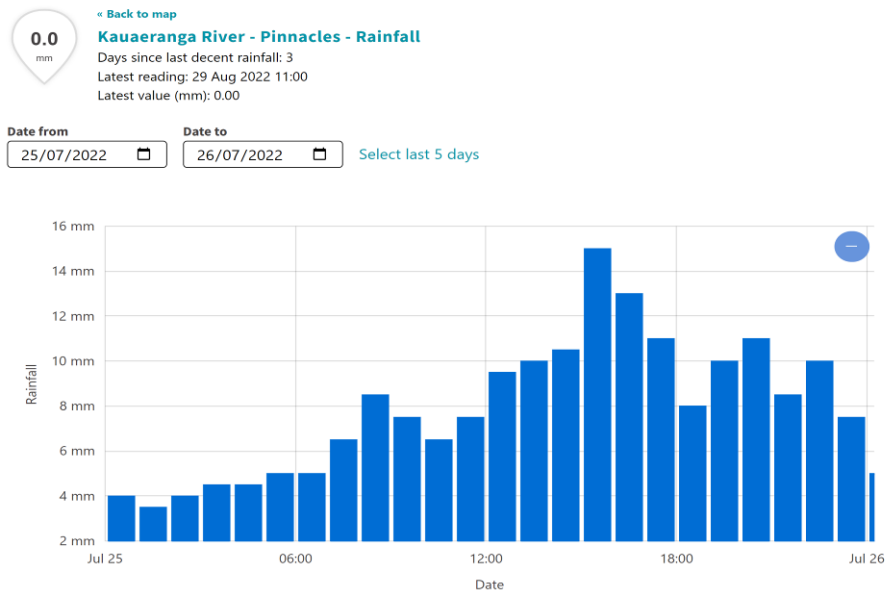
Data from the 2 nearest Waikato Regional Council rainfall gauge at the Pinnacles in the graph below shows in excess of 200mm in a 24 hour period on 25th July 22. This is a ARI of 1.58 years however the rain gauges are quite some distance from the slip sites and there is no available rain gauge data nearby.

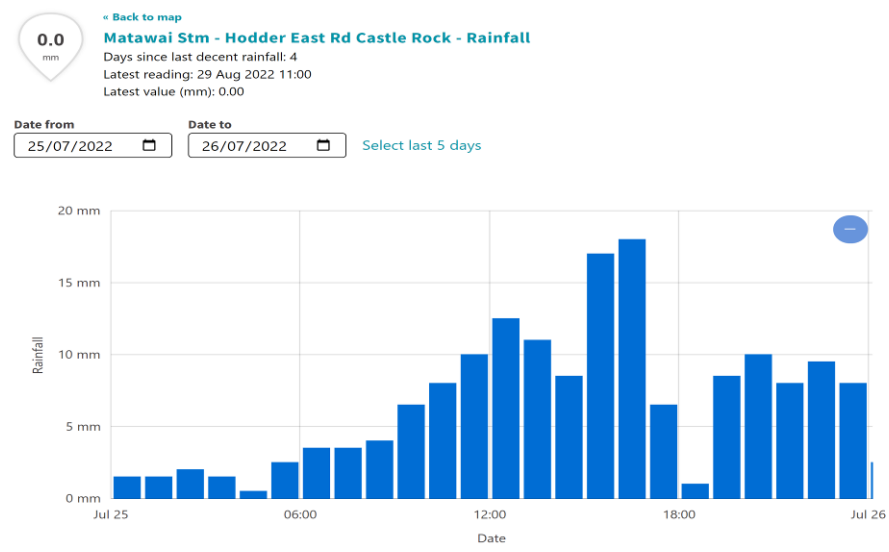
The data for Castle Rock rainfall gauge shows in excess of 160mm in a 24 hour period on 25th July 22.

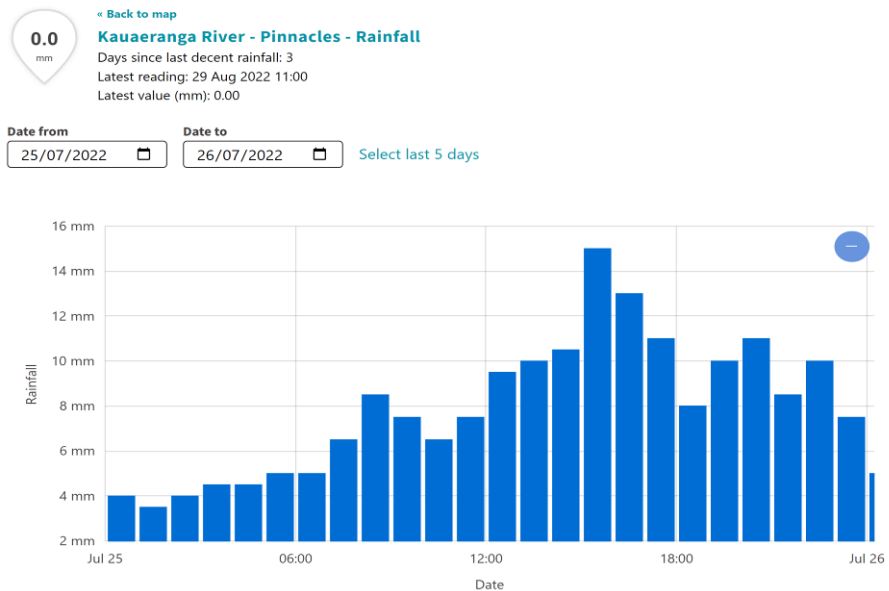
Data from the 2 nearest Waikato Regional Council rainfall gauge at the Pinnacles in the graph below shows in excess of 200mm in a 24 hour period on 25th July 22. This is a ARI of 1.58 years however the rain gauges are quite some distance from the slip sites and there is no available rain gauge data nearby.

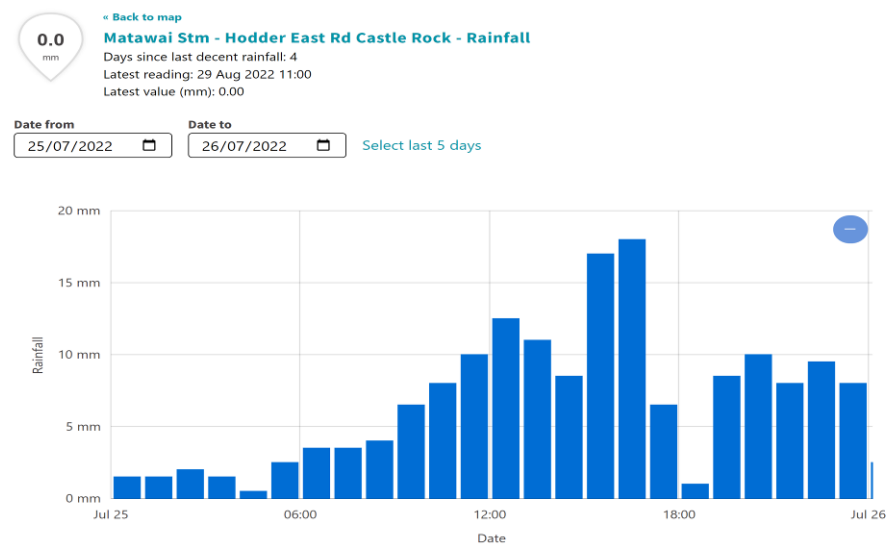
The data for Castle Rock rainfall gauge shows in excess of 160mm in a 24 hour period on 25th July 22.

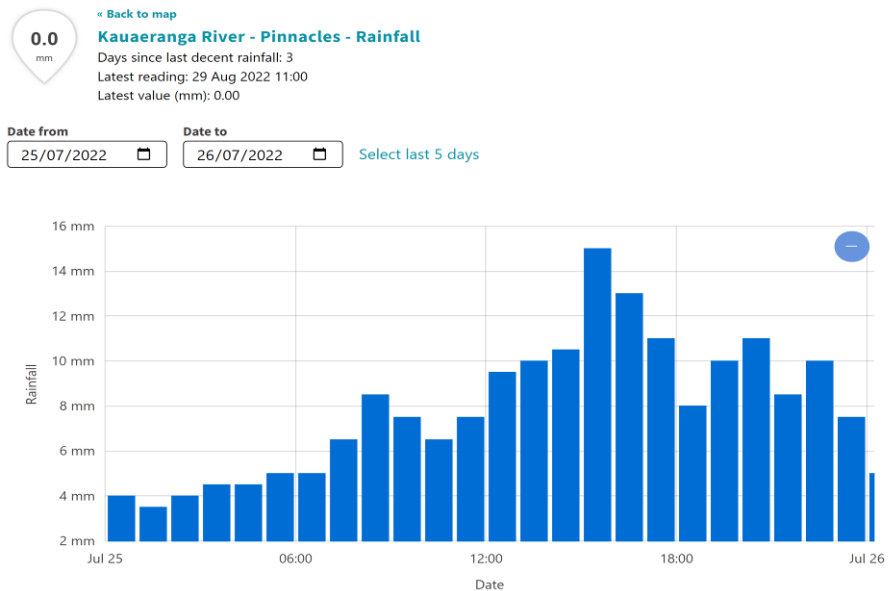
Data from the 2 nearest Waikato Regional Council rainfall gauge at the Pinnacles in the graph below shows in excess of 200mm in a 24 hour period on 25th July 22. This is a ARI of 1.58 years however the rain gauges are quite some distance from the slip sites and there is no available rain gauge data nearby.

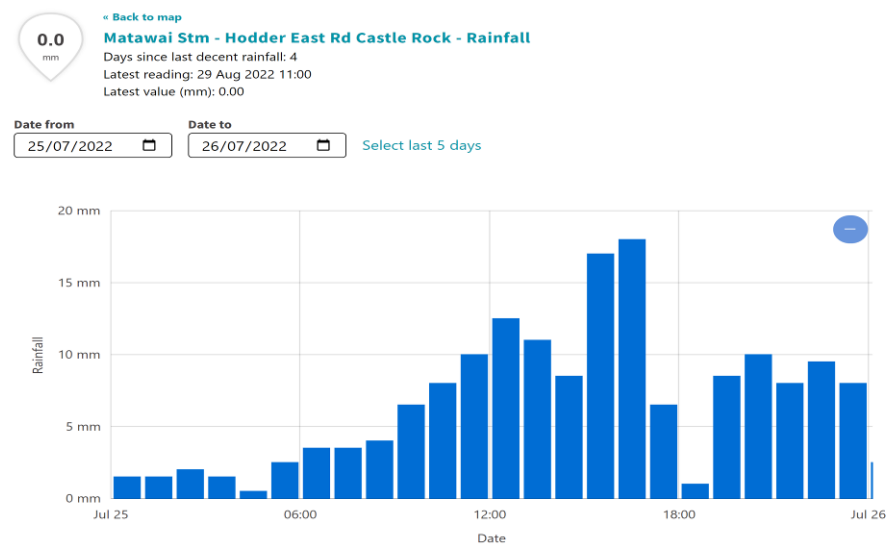
The data for Castle Rock rainfall gauge shows in excess of 160mm in a 24 hour period on 25th July 22.

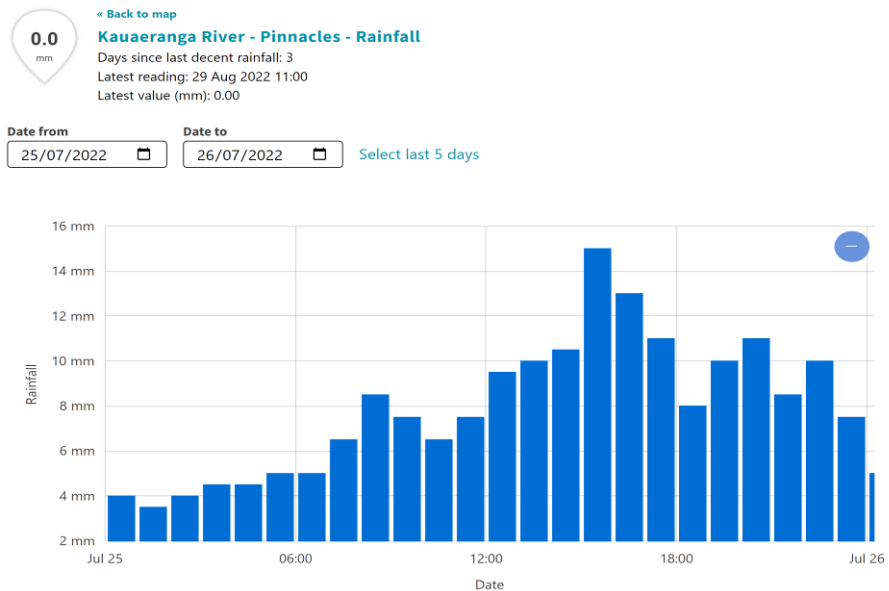
Data from the 2 nearest Waikato Regional Council rainfall gauge at the Pinnacles in the graph below shows in excess of 200mm in a 24 hour period on 25th July 22. This is a ARI of 1.58 years however the rain gauges are quite some distance from the slip sites and there is no available rain gauge data nearby.

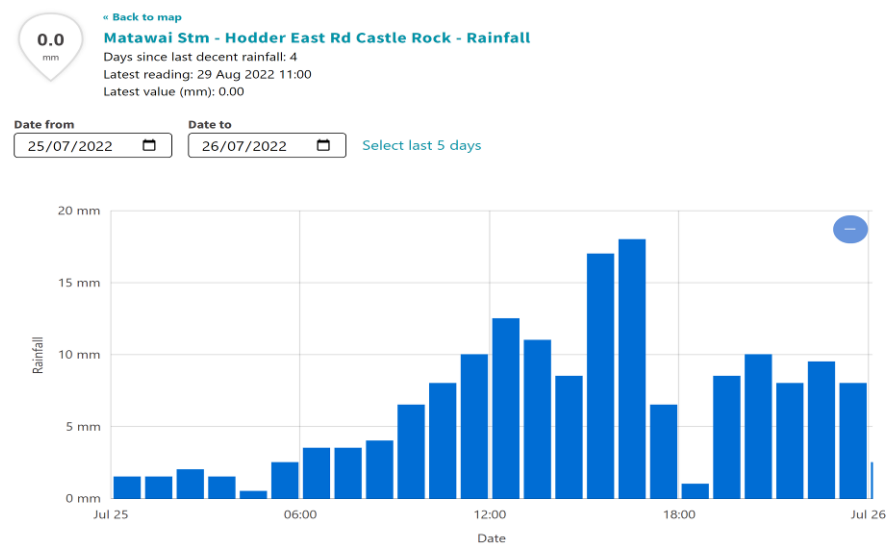
The data for Castle Rock rainfall gauge shows in excess of 160mm in a 24 hour period on 25th July 22.

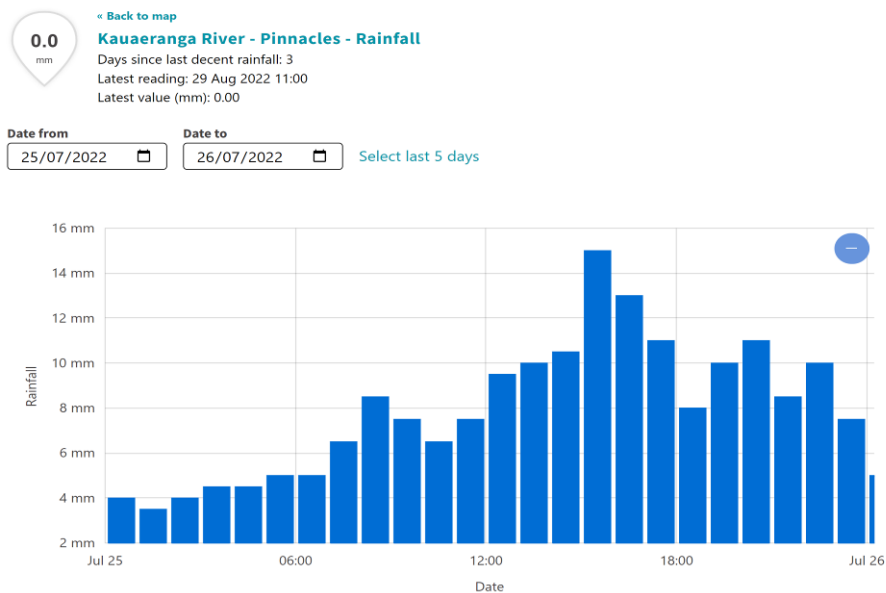
Data from the 2 nearest Waikato Regional Council rainfall gauge at the Pinnacles in the graph below shows in excess of 200mm in a 24 hour period on 25th July 22. This is a ARI of 1.58 years however the rain gauges are quite some distance from the slip sites and there is no available rain gauge data nearby.

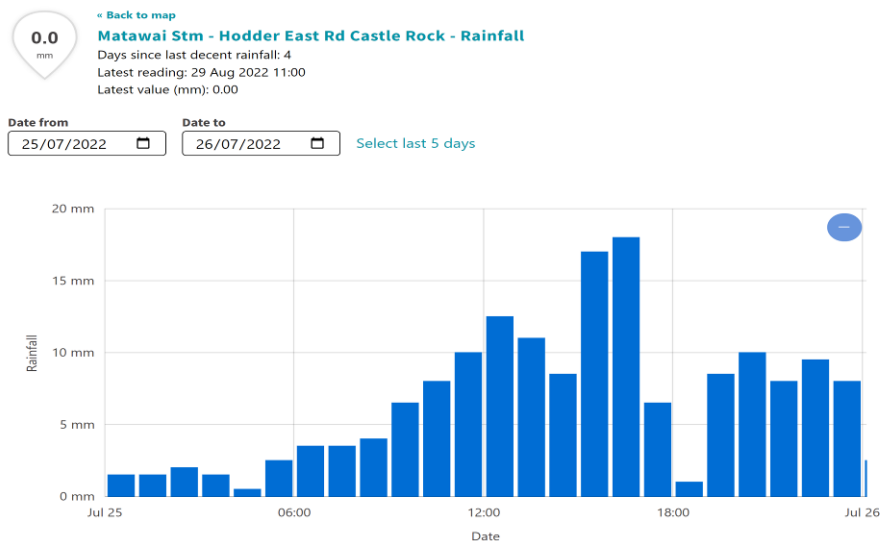
The data for Castle Rock rainfall gauge shows in excess of 160mm in a 24 hour period on 25th July 22.
