# Flaxmill Bay: Beach Nourishment and Geotextile Groynes

Summary of Monitoring Outcomes and Future Options

JANUARY 2026

Bronwen Gibberd  
4D Environmental Ltd  
for  
Jamie Boyle  
Thames Coromandel District Council

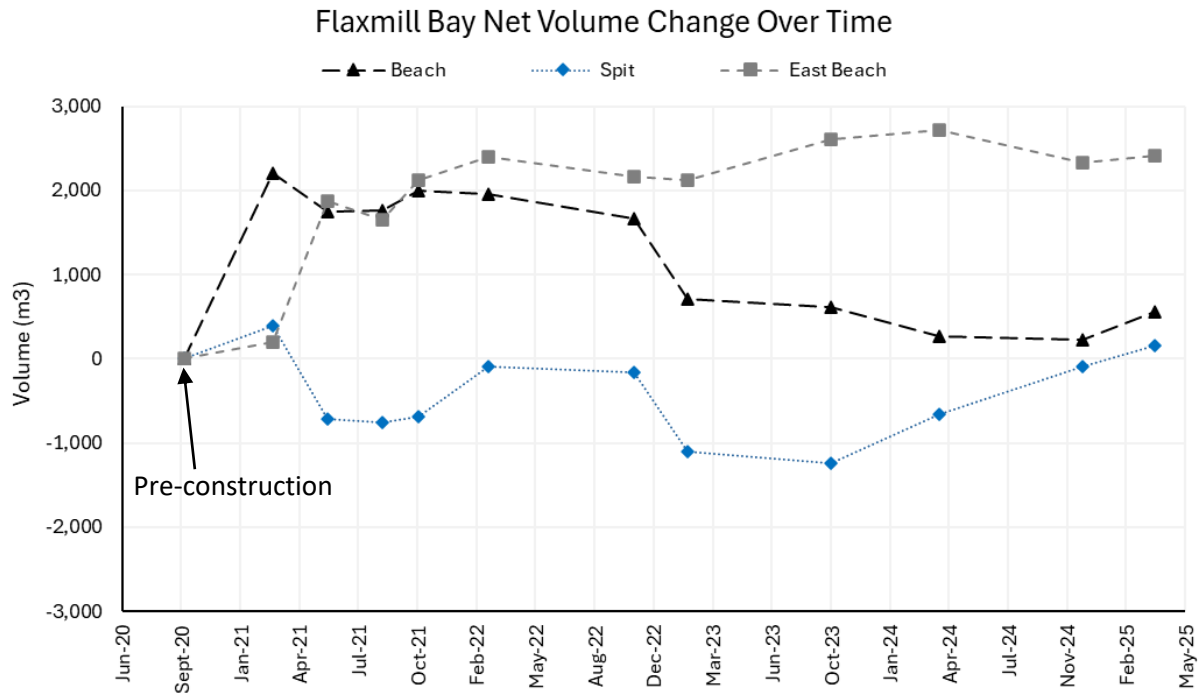
Figure 1: Changes in the volume of key morphological features over the monitoring period. Note the first data point was collected prior to construction and nourishment so figures are net change compared with the pre-construction state.

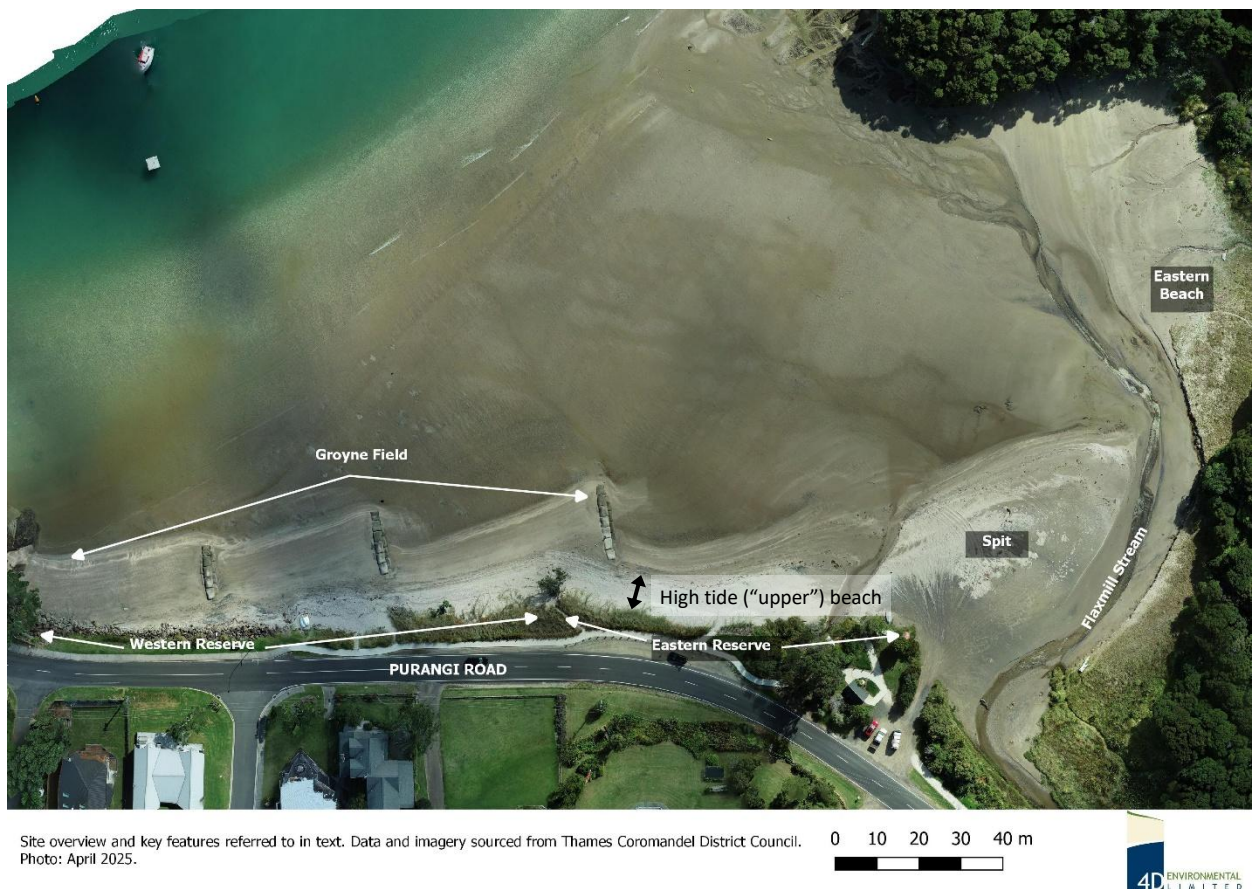
Figure 2: Flaxmill Bay with key features and areas as discussed in text.

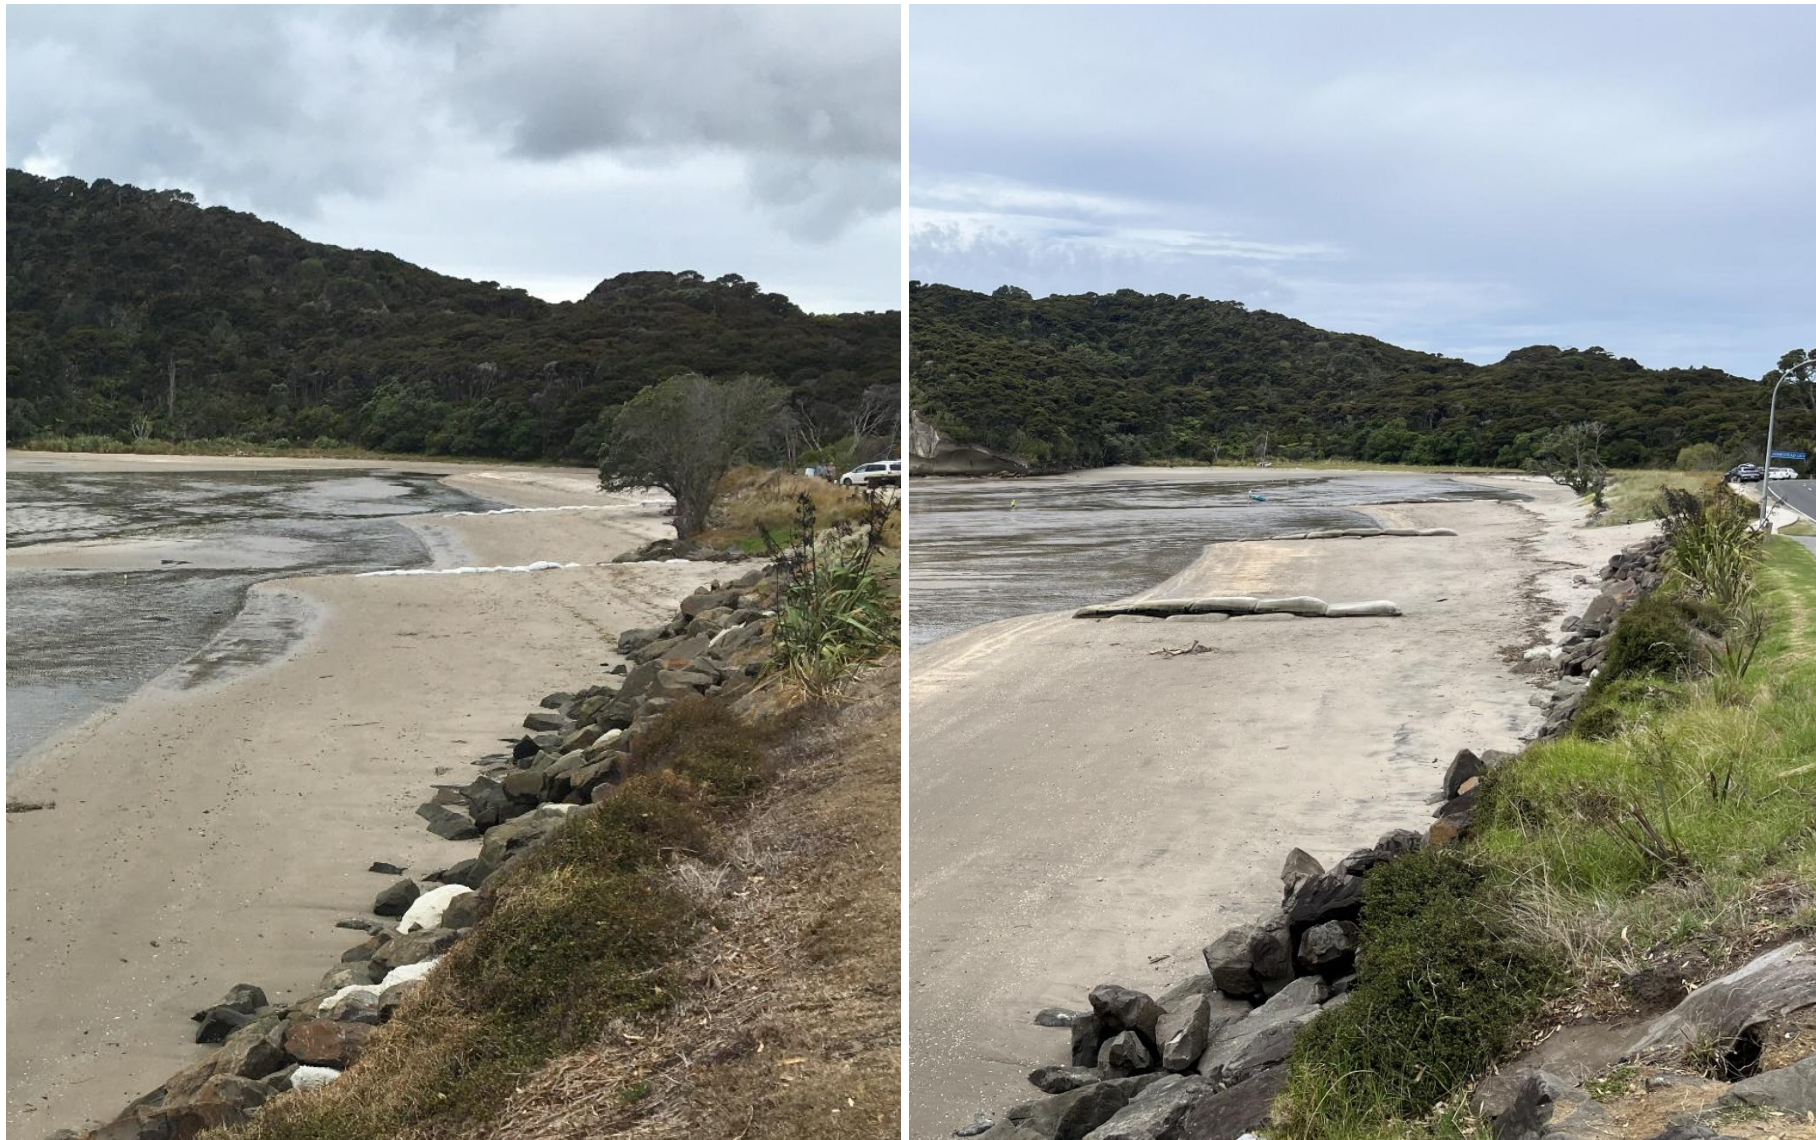
Figure 3: Flaxmill Bay in March 2020 (left), showing unconsented groyne structures constructed by a local resident and in February 2025 showing the three consented geotextile groyne structures (right).

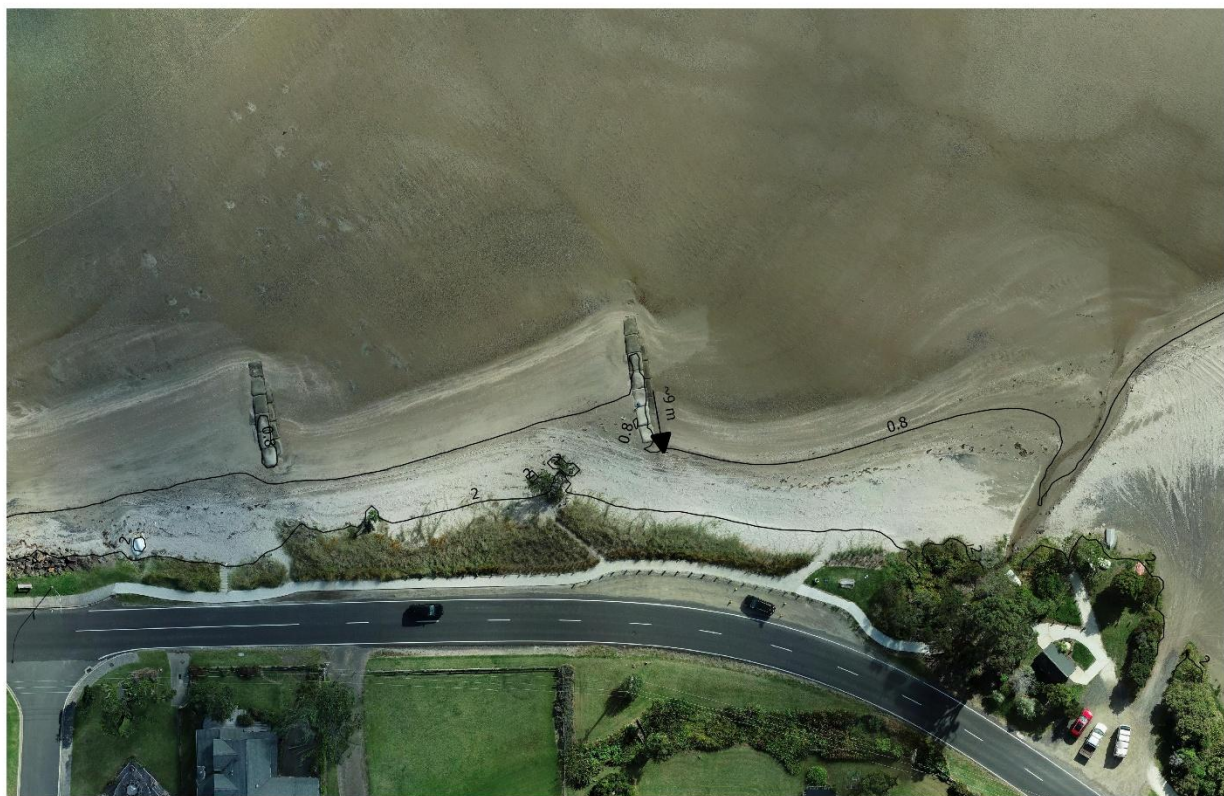
Net eastwards longshore sediment transport causes sand to accumulate against the western side of the groynes, generating a horizontal offset in beach width and a vertical offset in the level of the intertidal beach. The horizontal offset of the high-water mark adjacent to the groynes increased over time following construction, to up to 10 m in early 2023 adjacent to the eastern groyne (where the offset is greatest). In response to the exceedance of this and other triggers, the Council removed the two landward bags of the top layer of the central and eastern groynes in August 2023. The Council also undertook small scale nourishment of the upper beach and dune face with locally sourced sand. This provided for increased longshore sediment transport on the upper beach and supplemented the upper beach and dune face. Monitoring results indicate that this has slightly mitigated the horizontal offset of the upper beach (8-9 m in April 2025) (Figure 4).

This trigger is therefore exceeded if applied to the offset of beach width at the approximate high-water level. The horizontal offset in the dune line is more difficult to define quantitatively, but there is a change in shoreline orientation due to past erosion of the dune east of the eastern groyne (Figure 4). The notable increase in shoreline erosion east of the groyne field further supports the conclusion that this trigger has been exceeded. As shoreline recovery occurs relatively slowly, more time will be required to determine with certainty whether the adjustment made to the groyne structure has sufficiently mitigated the effect on the adjacent shoreline.

Beach offset at eastern groyne, April 2025. Data and imagery sourced from Thames Coromandel District Council.

Figure 4: Horizontal offset in the 0.8 m contour (approximately MHWS) in April 2025.

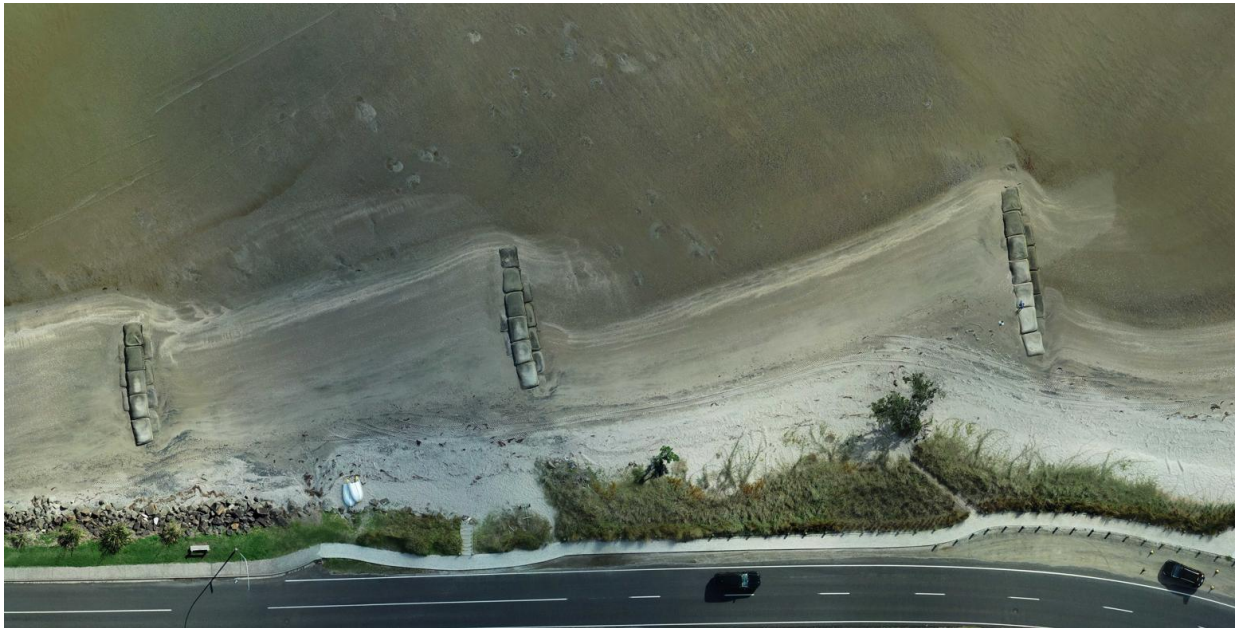
The defined trigger for exposure of the groynes has been consistently exceeded since soon after construction, and exposure of the structure will continue to increase with a loss of nourished beach volume. In April 2025, the geotextile bags are exposed along the full length of the crest, and the second layer of bags is exposed along much of the length of the groynes on the downdrift (eastern) side (Figure 5). At the western and central groynes, the upper face of some bags in the second layer are exposed on the updrift side.

*Figure 5: Exposure of the groynes in April 2025. The crests are exposed along the full length of the structures, and the second layer of geotextile bags are exposed on the downdrift (eastern) side of all three groynes, and on the updrift side of the western and central groynes.*

The trigger relating to the exposure of the seaward bags is likely to be frequently exceeded. The groynes will not influence sediment transport on the beach until the crest is at or above the bed level. Buried groynes are not actively influencing sediment transport on the beach. As groynes intercept sediment transport alongshore, at least the downdrift side of the groynes is likely to remain consistently exposed.

Nourishment activities have targeted the upper beach and dune and have not reduced the exposure of the groynes or the vertical offset. While some exposure is inevitable, the spatial extent and depth to which the groynes are exposed could be significantly reduced with more frequent and extensive beach nourishment. This mitigation is identified in the adaptation plan. With ongoing longshore sediment transport to the east, the structures will become gradually exposed after a nourishment, particularly on the downdrift (eastern) side.

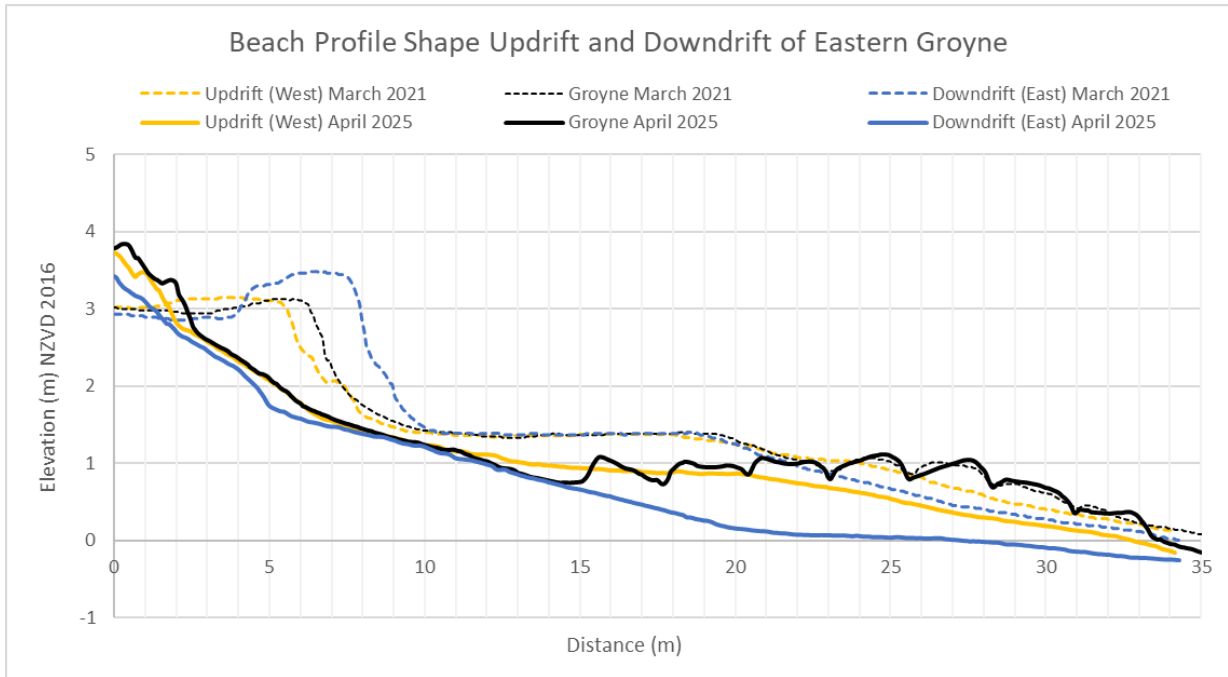
Sediment accumulation against the structure has created a vertical difference between the updrift and downdrift intertidal beach level, which has been exacerbated by a significant drop in beach level since construction, particularly downdrift of the structures (Figure 6). A vertical offset of 0.7 m was measured in April 2025, which is a small reduction since February 2023, when there was a vertical offset of up to 0.9 m. The periodic occurrence of localised depressions near the seaward end of the groynes also indicates that turbulence from wave action may exacerbate erosion adjacent to the structure.

Figure 6: Differences in beach cross section immediately adjacent to the updrift (western) and downdrift (eastern) side of the eastern groyne in March 2021 (soon after construction) and April 2025. Figure also shows change in upper groyne due to removal of upper bags. Note beach lowering has been significantly greater downdrift of the groyne compared with the beach updrift.

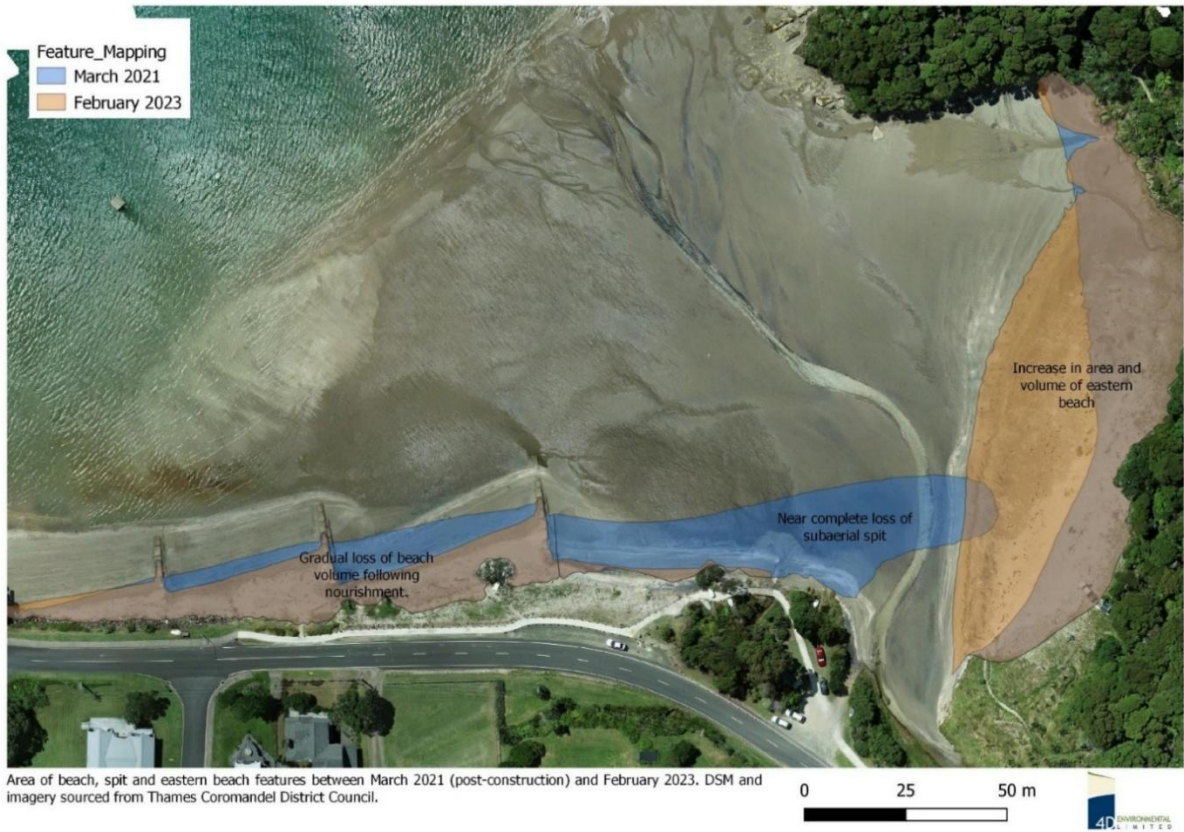
The volume and area of the spit was greatly reduced in the first two years following the construction of the groynes (Figure 7). This change exceeded the defined triggers for further intervention. In accordance with the AMP, two landward bags of the top layer of the central and eastern groynes were removed in August 2023 (supported by small scale nourishment). Monitoring data from October 2023 showed some loss of sediment from the beach adjacent to the central groyne but little immediate response to this in terms of recovery of the beach and spit. Data collected since April 2024 shows minor ongoing loss of beach area and volume, and a rapid and ongoing increase in spit area and volume (Figure 8). The spit volume is now similar to that measured prior to construction of the groynes (Table 4), though the spatial extent of the spit feature is further landward (Figure 10).

Figure 7: Changes in the aerial extent of the beach, spit and eastern beach following nourishment (March 2021-February 2023).

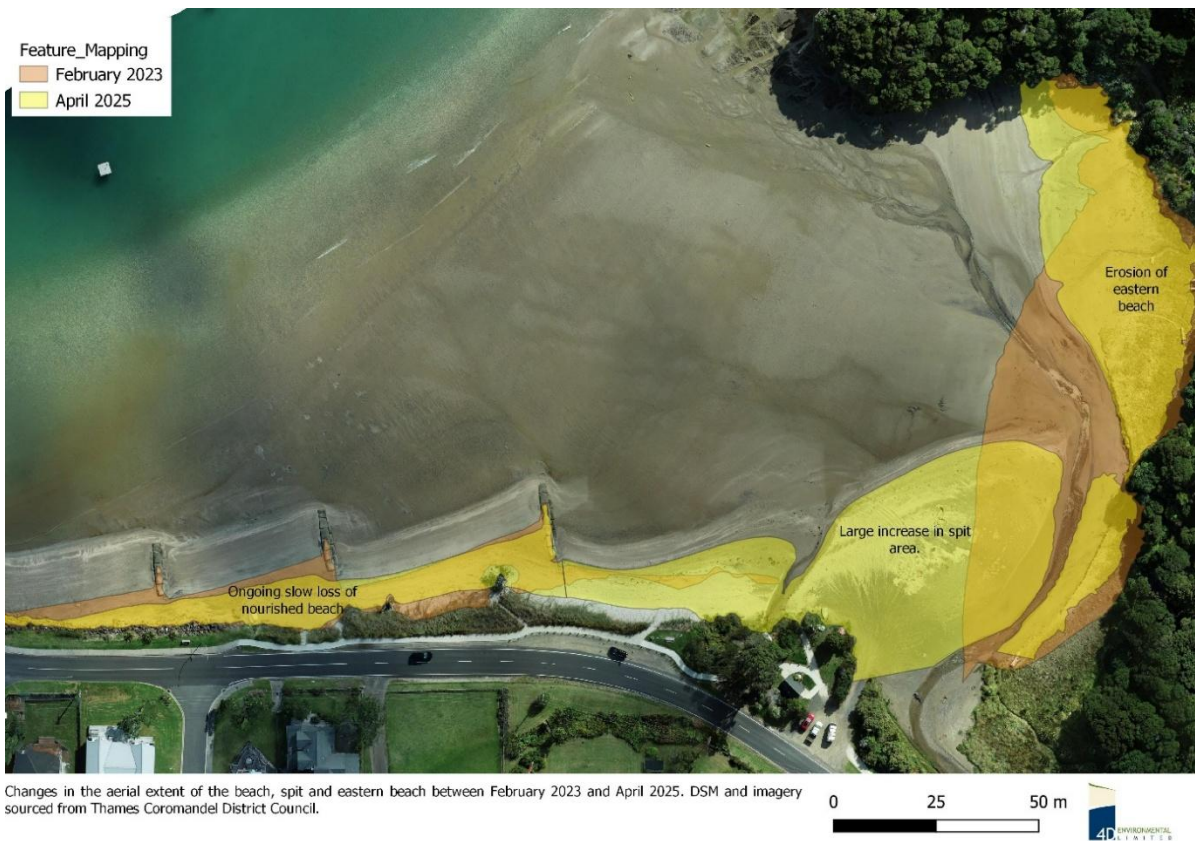
These outcomes suggest that lowering of the groyne crests has improved sediment supply to the spit, but data also suggests that mobilisation of sediment from the beach within the groyne field has been insufficient to supply the observed recovery (Figure 1, Table 4). Over the same period, there has been significant eastwards migration of the stream entrance and erosion of the south section of the eastern beach (Figure 8), which may also have contributed to spit recovery.

Figure 8: Changes in the aerial extent of the beach, spit and eastern beach February 2023-April 2025 (since removal of upper bags on central and eastern groyne).

This trigger was exceeded during the monitoring period, and subsequent recovery of the spit following adjustment of the groyne structure means the trigger is no longer exceeded. Irrespective of the chosen management option, natural fluctuations may occur in the future that exceed the defined trigger, suggesting that the value of this trigger as currently defined is in question.

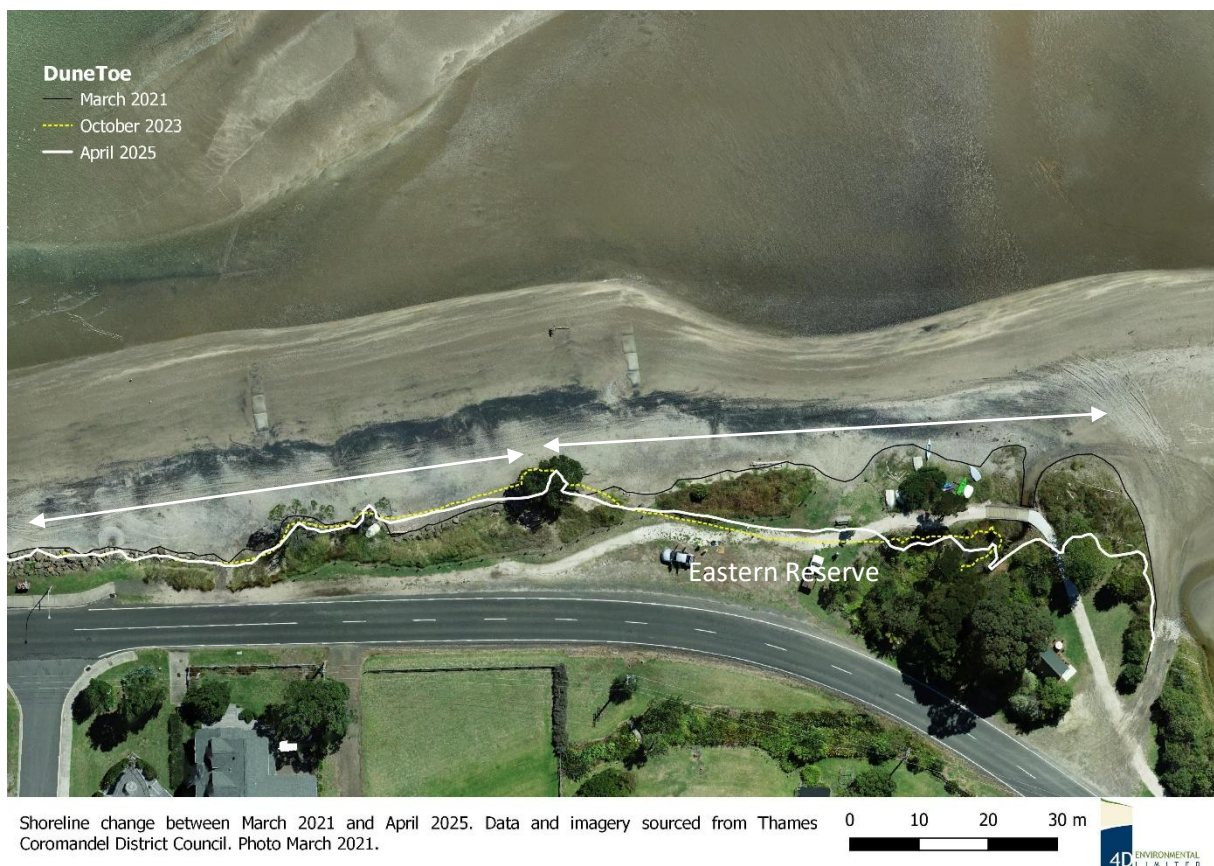
The monitoring data indicates that the groynes and nourished beach (supplemented by small-scale maintenance nourishment and beach scraping) has prevented ongoing erosion of the shoreline within the groyne field (i.e. west of the eastern groyne). There has, however been loss of beach volume and severe erosion (over 10 m in some places) of the unprotected shoreline adjacent to and (most significantly) east of the eastern groyne between 2021 and 2023 (Figure 9). This erosion occurred as the shoreline became exposed following loss of the beach and spit feature and has been more severe than any erosion observed from historical aerial photography.

Figure 9: Change in dune toe position over monitoring period. Note severe erosion adjacent to and east of the eastern groyne.

It is likely that the groynes exacerbated erosion downdrift of the eastern groyne by restricting sediment transport to the eastern portion of the reserve and to the spit area. Although this impact has been mitigated by alterations made to the groynes, these structures will continue to have some ongoing influence on the sediment supply to the area. There is insufficient data to determine whether the adjustment made to the groyne structure has sufficiently mitigated the effect on the adjacent shoreline to allow ongoing shoreline recovery.

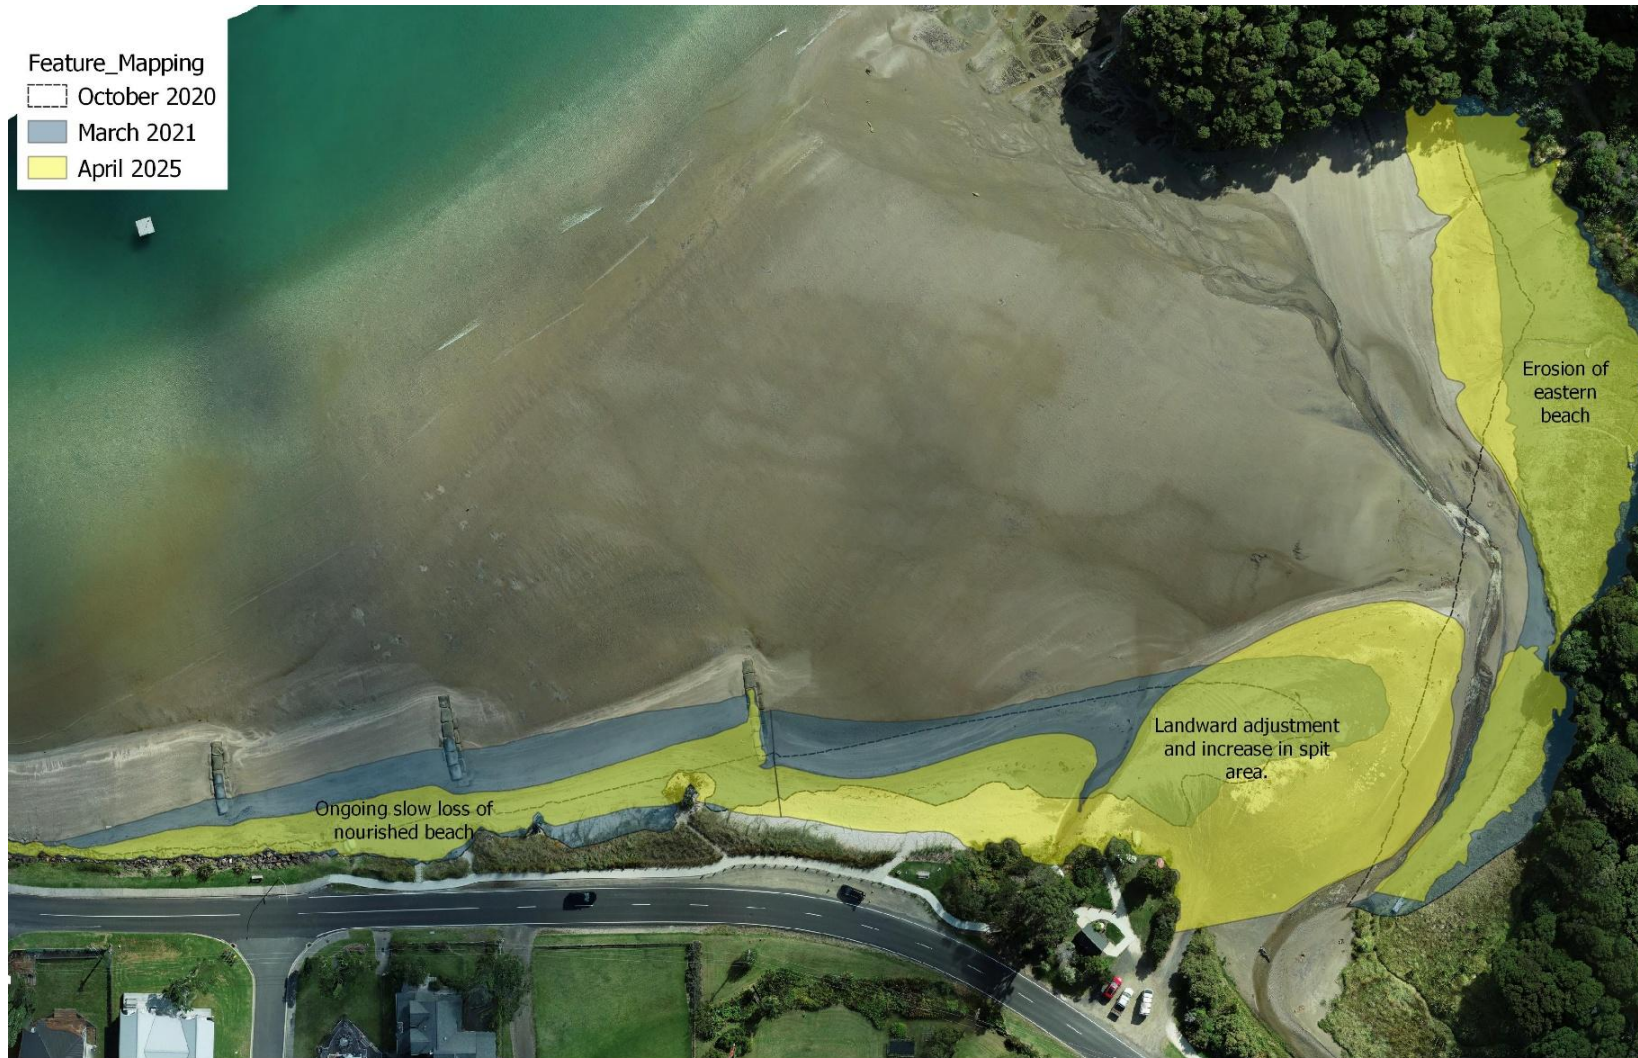
Changes in the aerial extent of the beach, spit and eastern beach between October 2020 and April 2025. DSM and imagery sourced from Thames Coromandel District Council.

Figure 10: Changes in the aerial extent of the beach, spit and eastern beach between-October 2020 (pre-construction), March 2021 (post-construction) and April 2025.

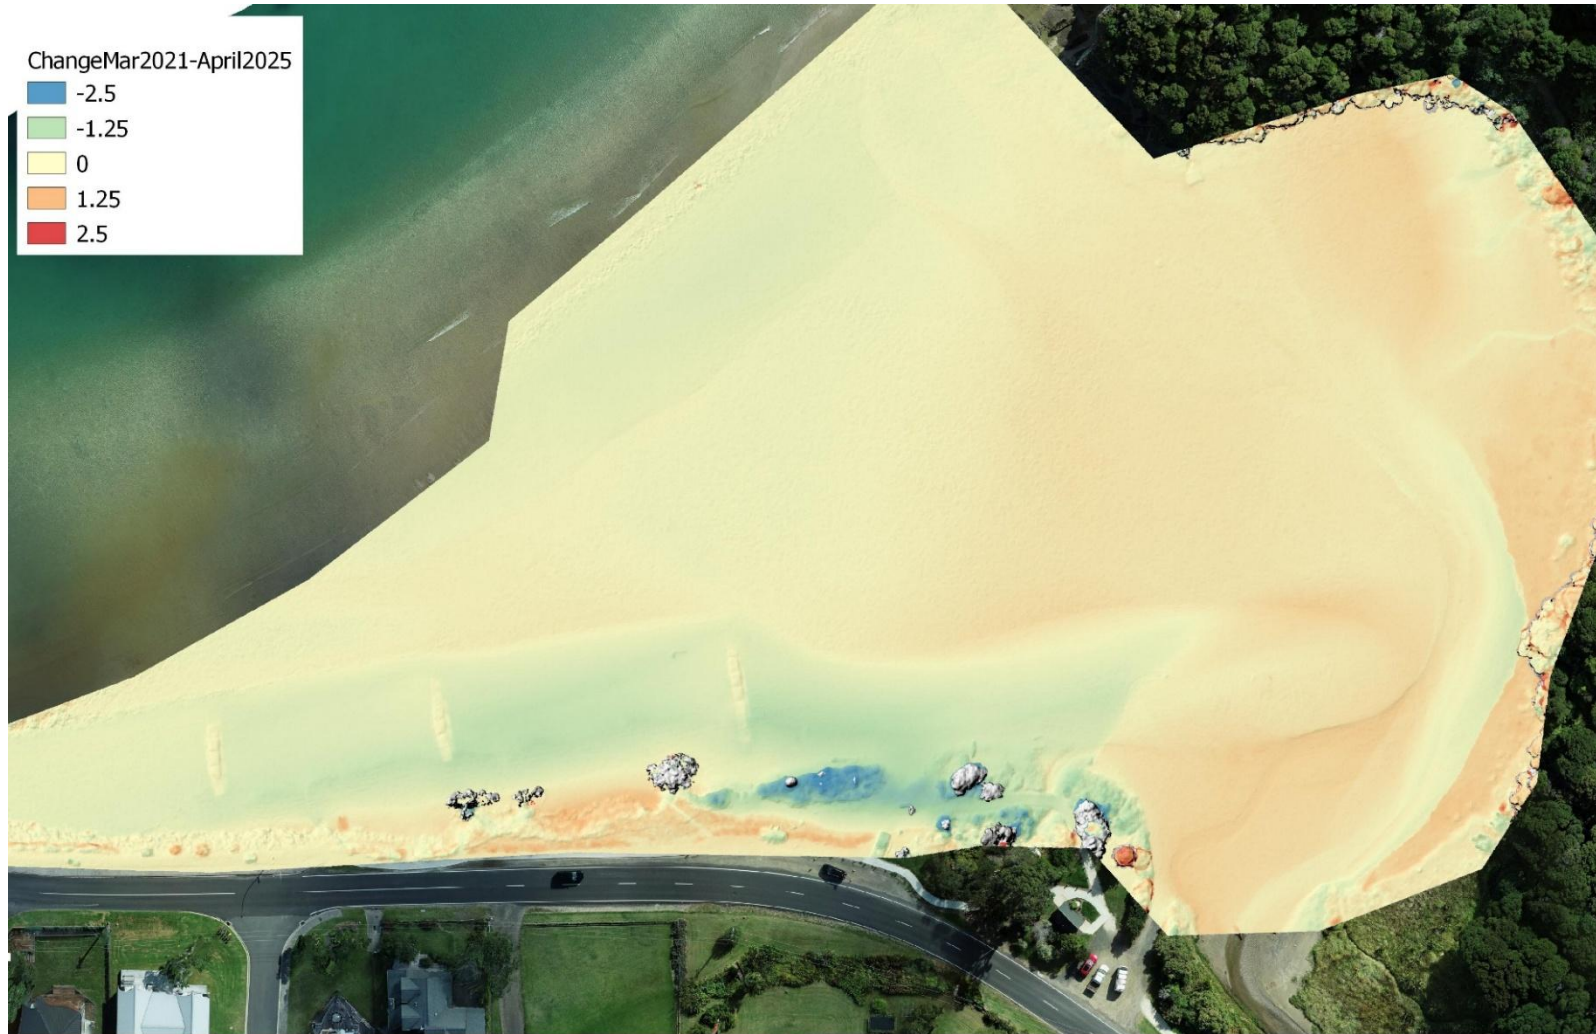
Changes in sediment level between March 2021 and April 2025. DSM and imagery sourced from Thames Coromandel District Council.

Figure 11: Changes in sediment level between March 2021 (first dataset post-nourishment) and April 2025. Red areas indicate sediment accretion while blue and green areas show lowering of the sediment surface. Yellow areas suggest little or no change.

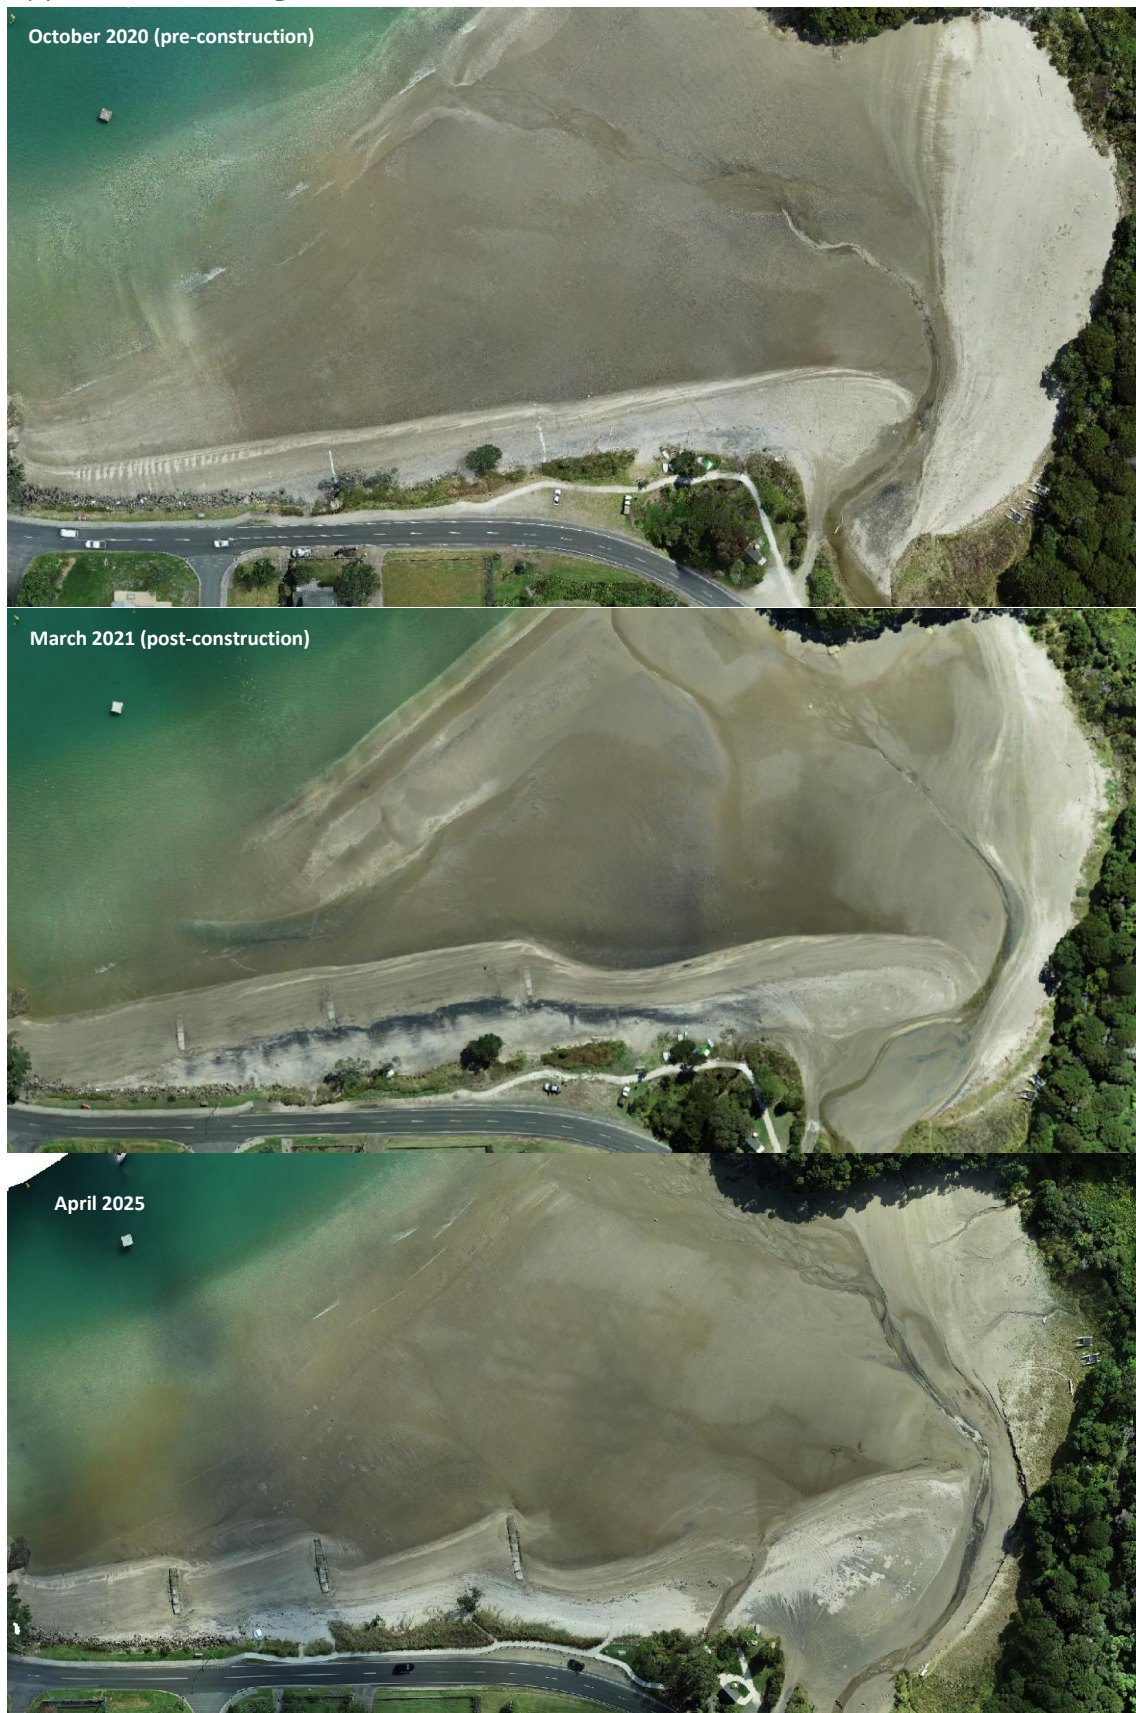
Figure 12: Changes in sediment distribution and shoreline position from pre-construction (top – October 2020), post construction (middle – March 2021) and most recent (bottom – April 2025).
