HD2740 – Purangi Road RP 11.1 – Inspection of underslip

PROJECT: Purangi Road RP 10.8

Coastal Processes, Engineering and Ecological Assessment for Purangi Road Coastal Protection

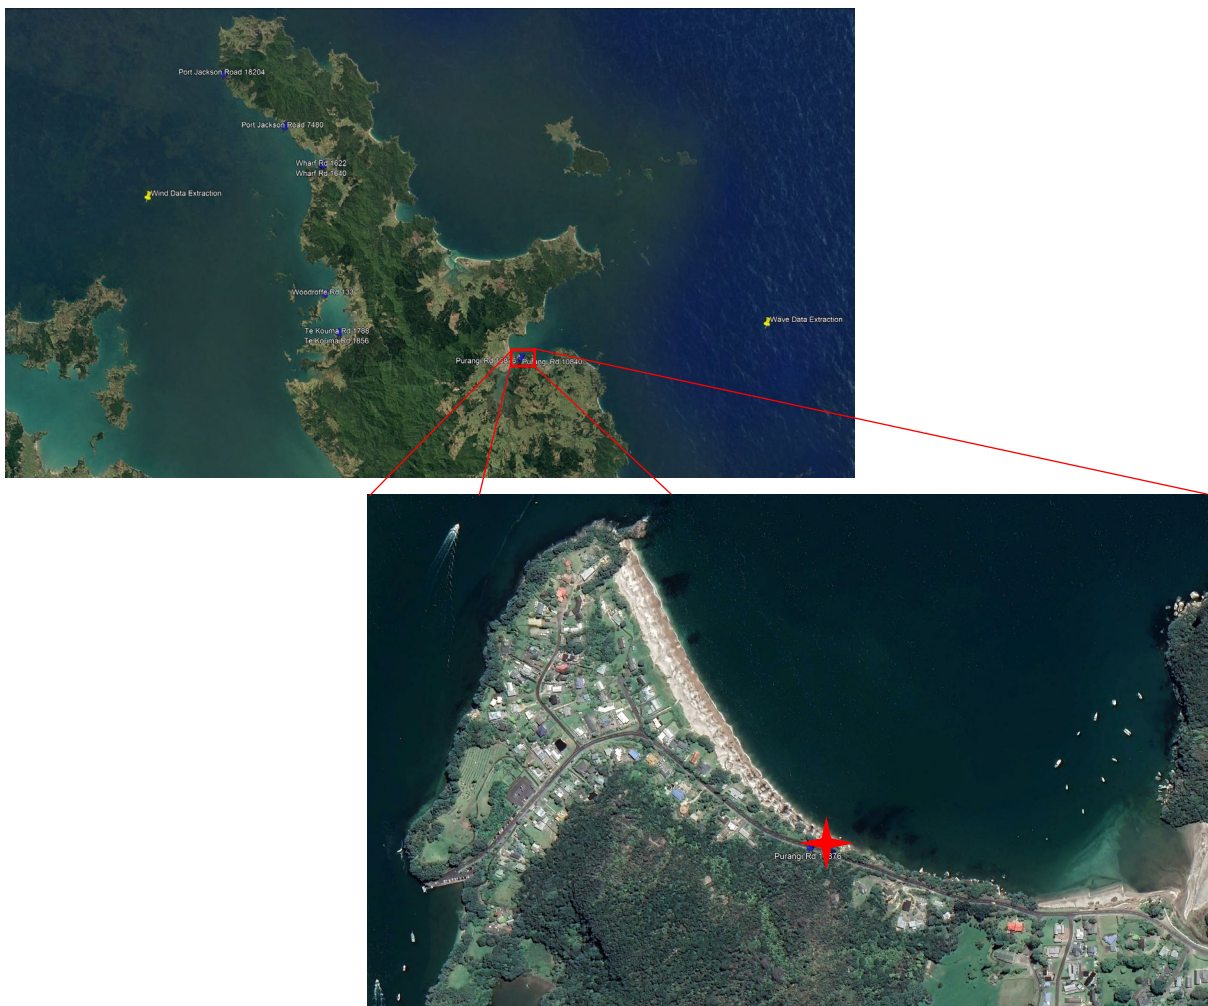
Figure 1-1. Locations of the Purangi Road site that require coastal protection measures.

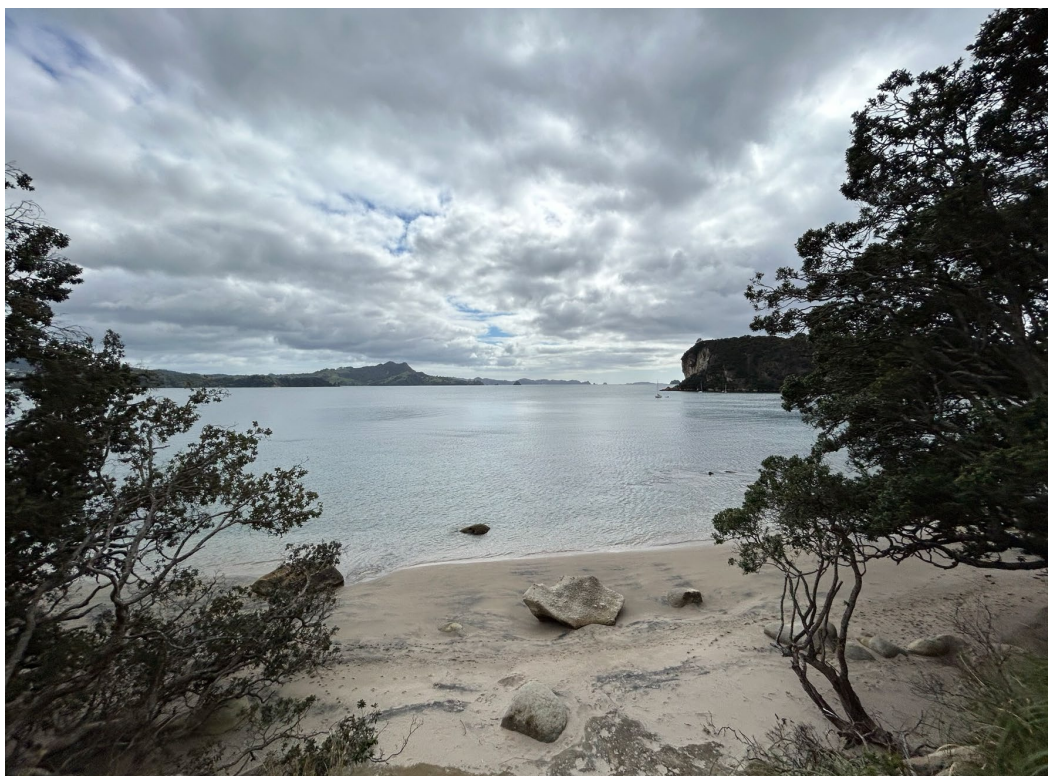
Flaxmill Bay has a yellow/white sand beach with a gradient of approximately 1:25 (V:H), with large boulders around the high tide mark, which is relatively close to the toe of the cliff at the site on Purangi Road (Figure 2-1). The top of the is mostly terrestrial grasses and weeds (e.g., kikuyu, agapanthus and pampas grass), with a mix of exotic/invasive and native species along the cliff, most notably Pohutukawa trees (Figure 2-4). Just to the east of the slip there is a concrete buttress protecting the cliff and road above it (Figure 2-5).

Figure 2-1. Looking northeast from the eroded site at Purangi Road, with Shakespeare Cliffs headland in the middle right of the image.

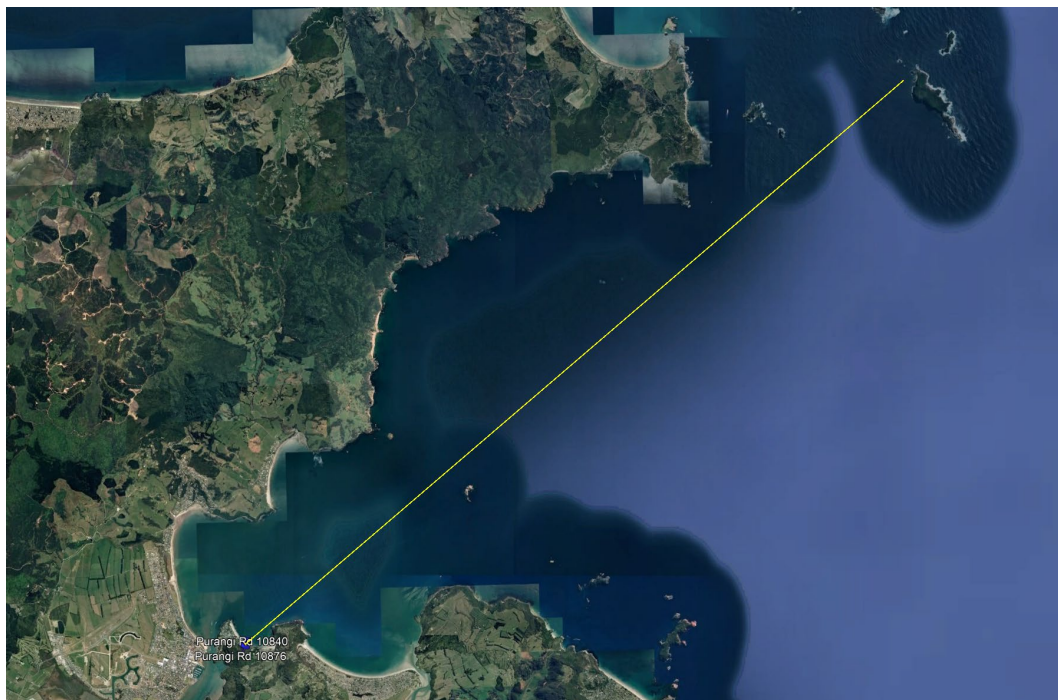
Figure 2-2. Although the site is protected by the headland to the east and has only an 18 km fetch to the Ohinmau Island, the process of refraction of long period waves means that it is still vulnerable to extreme events.

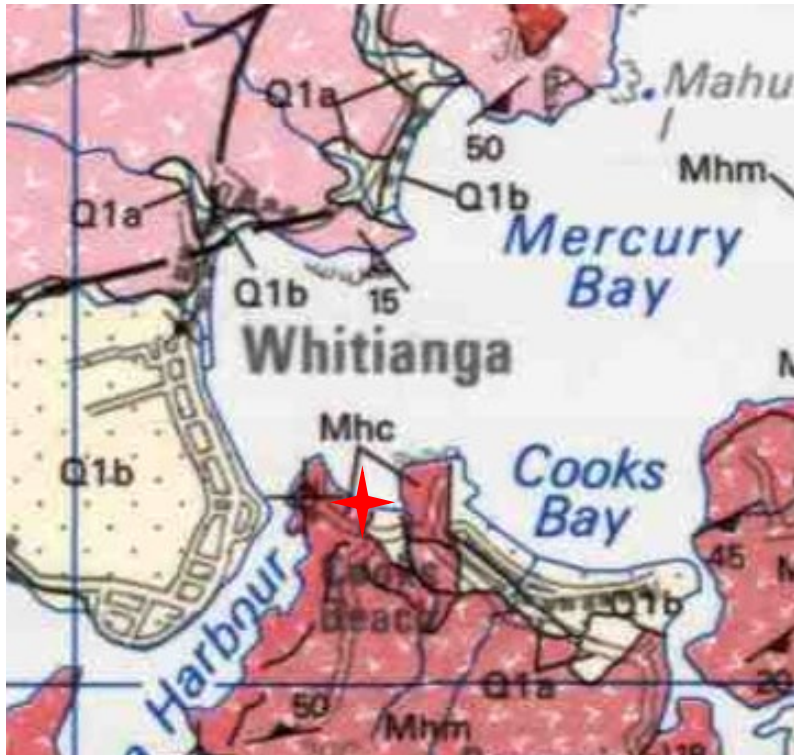
The geology at this site consists of the Coroglen Subgroup, typified by lithic and pumice-rich ignimbrite and local rhyolitic and obsidian rich pumice breccia deposits and tuff. (Figure 2-6). This mix of soils and rocks can be seen in the scoured slip area (Figure 2-4), above the beach comprised of medium grain sand at an approximate gradient of 1:25 (V:H). As noted above, the high tide mark is relatively close to the toe of the cliff; the high tide came to the base of the cliff/slip in the initial site visit and was ~5 m seaward of it during the second (Figure 2-4 and Figure 2-1, respectively). Maramaratotara Bay/Flax Mill Bay is a pocket beach bounded by headlands and orientated to be in equilibrium with the wave climate (i.e., there is very little alongshore sediment transport, as evidenced by the formation of beach cusps) (Figure 2-7).

Figure 2-6. The geology at this site consists of the Coroglen Subgroup, typified by lithic and pumice-rich ignimbrite and local rhyolitic and obsidian rich pumice breccia deposits and tuff. (Geological Map of the Auckland Area, 1:250 000 geological Map 3 by Institute of Geological and Nuclear Sciences).

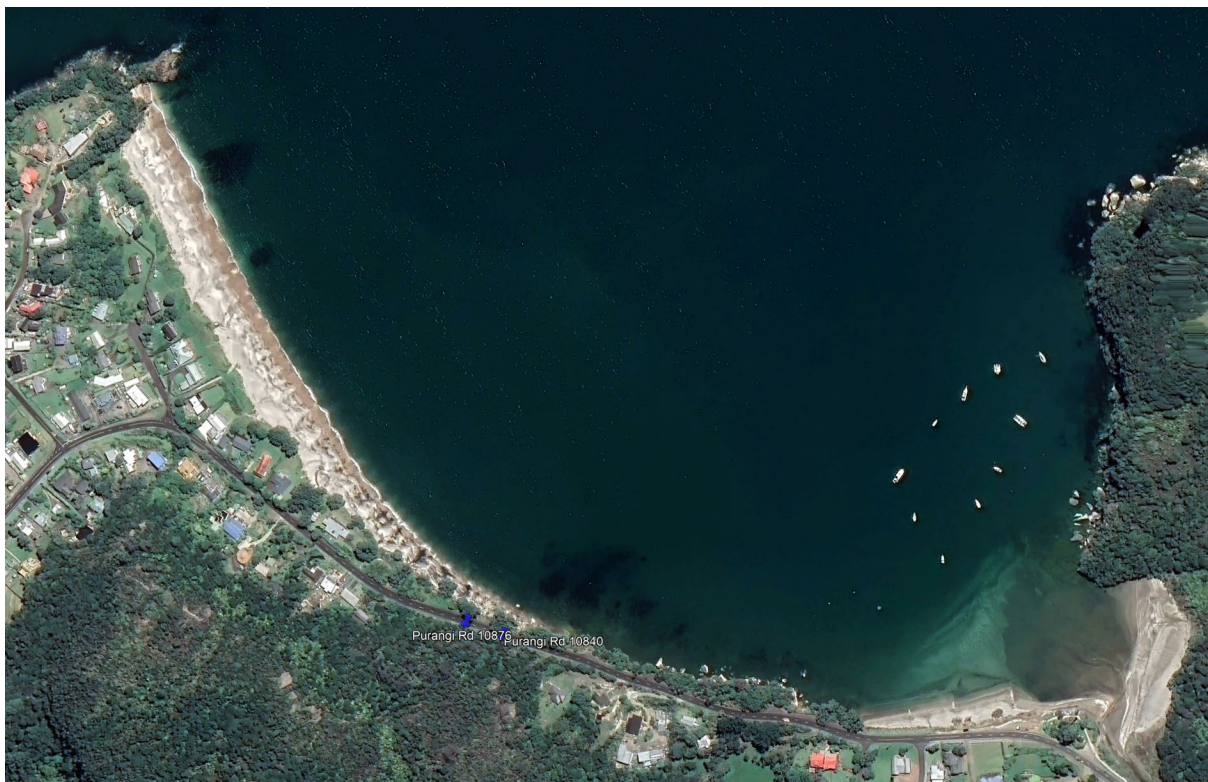
Figure 2-7. Maramaratotara Bay/Flax Mill Bay is a pocket beach bounded by headlands and orientated to be in equilibrium with the wave climate (i.e., there is very little alongshore sediment transport, as evidenced by the formation of beach cusps).

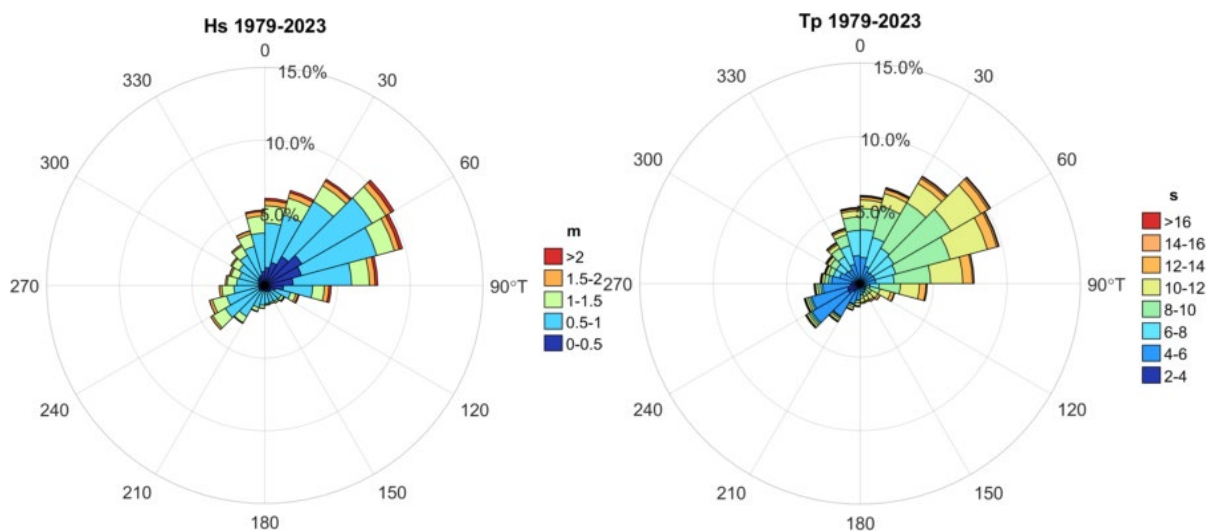
An extreme value analysis was carried out on the 44 years of 3-hourly wave data (Figure 3-1) using the WAFO Group (2011) toolbox developed by faculty of Engineering, Mathematical Statistics, Lund University, Sweden, which is a commonly used statistical toolbox for carrying out univariate extreme value analysis. The routines in WAFO were used for fitting a statistical distribution to the occurrence of wave heights. The analysis was carried out using a Peaks over Threshold (PoT) method and fitting the resultant data to a generalised Pareto distribution. The results of the analysis are presented in Table 3-1.

Figure 3-1. Wave roses (left wave height; right wave period) for the eastern side of the Coromandel Peninsula (Figure 1-1).

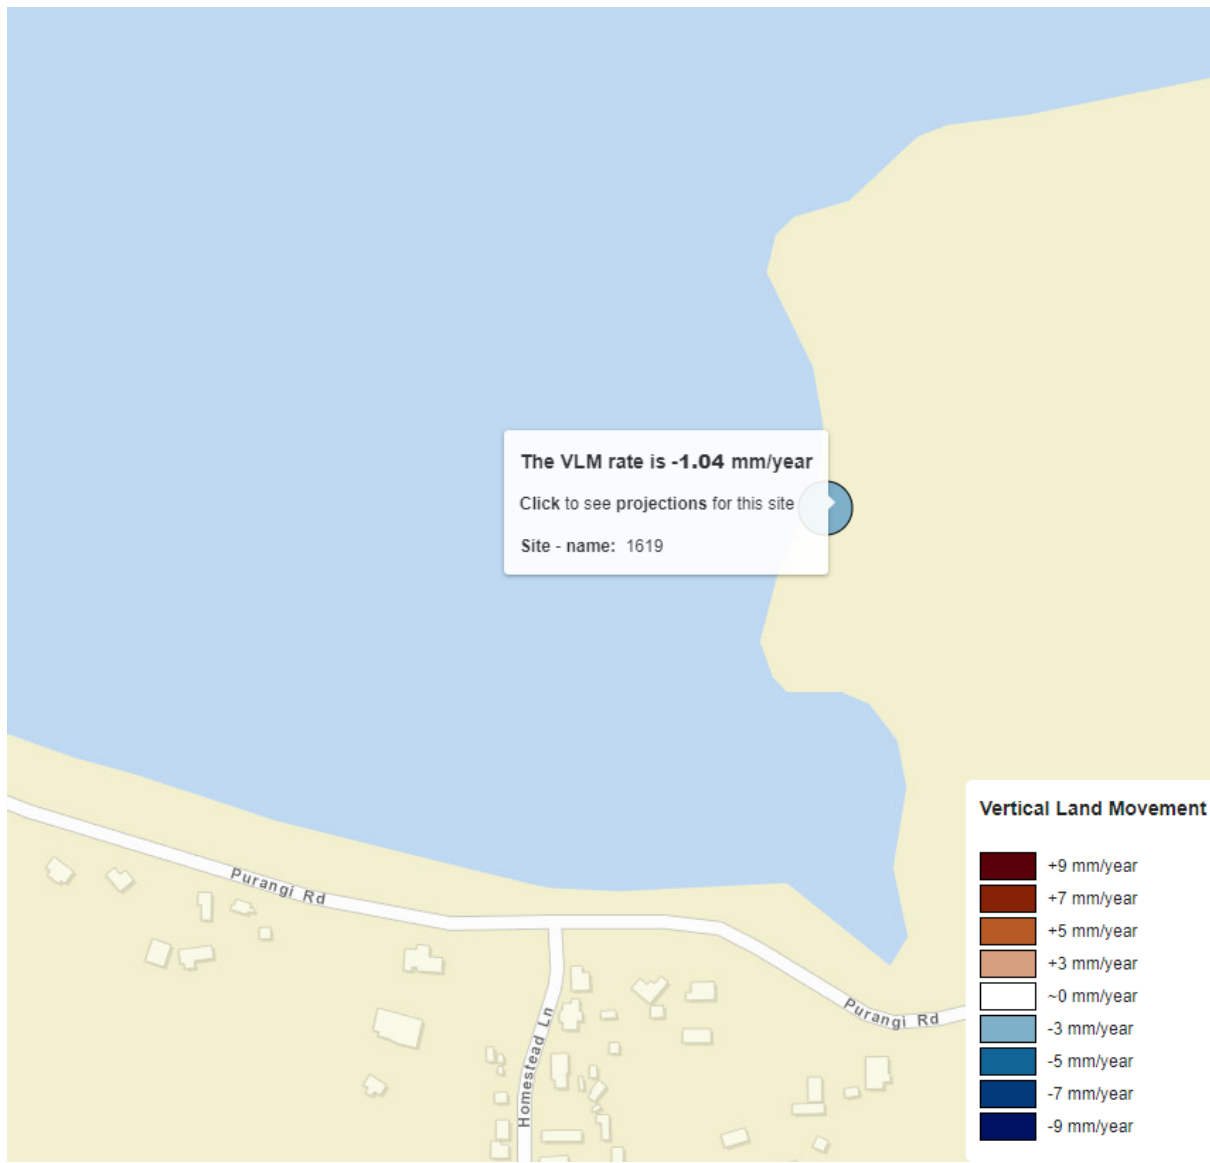
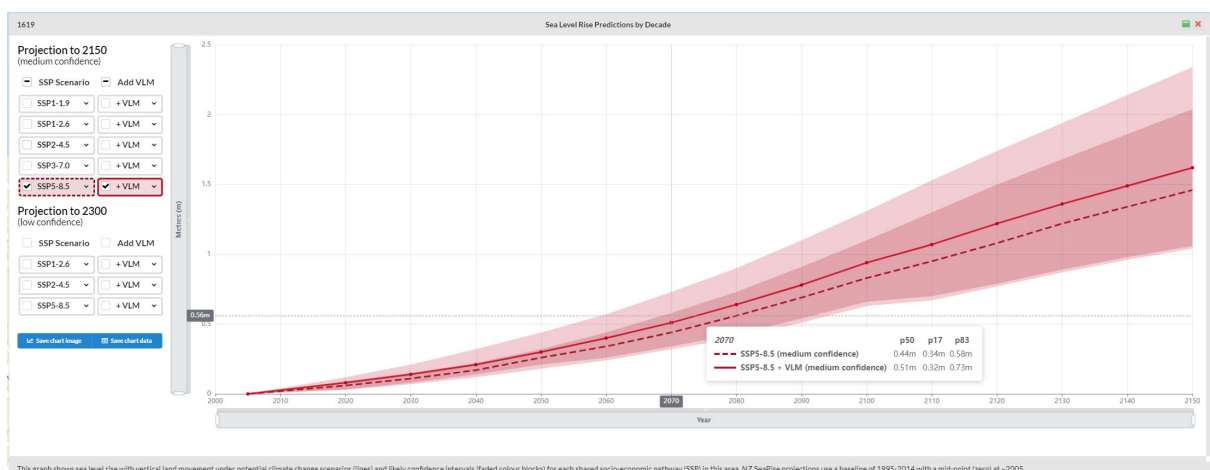
To consider potential depth in front of the structures using a 50-year planning horizon, a nearshore water depth has been calculated comprised of MHWS (2.1 m), 50 years of SLR including VLM (Figure 3-2; 0.56 m) and 0.5 m of storm surge (generally taken as the maximum that occurs in New Zealand). Note, wave set-up for short period waves is negligible. This results in a still water depth of approximately 1.06 m at the toe of the revetments, with wave breaking occurring in depths of 7.7 m during a 1 in 100 year event (using a depth-limited breaking ratio of 0.78); i.e., breaking over 550 m offshore of the beach

Figure 3-2. 50-years of SLR applying the most conservative projection (SSP5-8.5) is 0.48 m, however, VLM at this site (#1619) is downwards at -1.04 mm/yr, which increases the actual SLR to 0.56 m.

the nominal rock size), placed on 1,200 gsm non-woven filter cloth. A generic cross-section is shown in Figure 3-2.

Should additional material be required for gradient the soil under the revetment, clean back fill can be used prior to installation of the non-woven geofabric. The toe of the revetments should extend into the sand beach to the same depth as the thickness of the armour (i.e., 2.4 m; Figure 3-2), or onto the bedrock if this is struck before the depth is achieved.

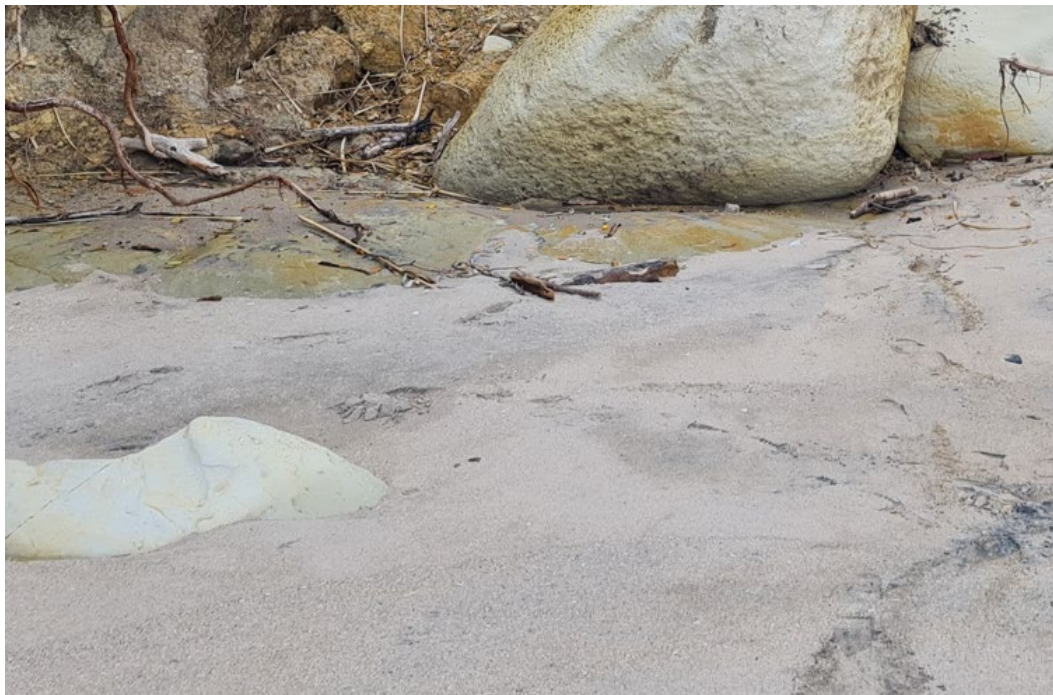
At all the sites visited and surveyed (9 sites around the Coromandel Peninsula), little to no marine life was found in the intertidal zone. At this site, at the toe of the slip/cliff there is a sand beach with a gradient of approximately 1:25 (V:H), with large boulders around the high tide mark (Figure 4-1). No living marine organisms were found along the toe of the slip, or further down the beach; mobile beach sand is an abrasive habitat for marine organisms, although it is expected that ephemeral sand hoppers (*Bellorchestia* spp.) would occasionally be found in flotsam at the top of the beach.

Figure 4-1. The sand beach and large boulders around the high tide mark at the toe of the slip.

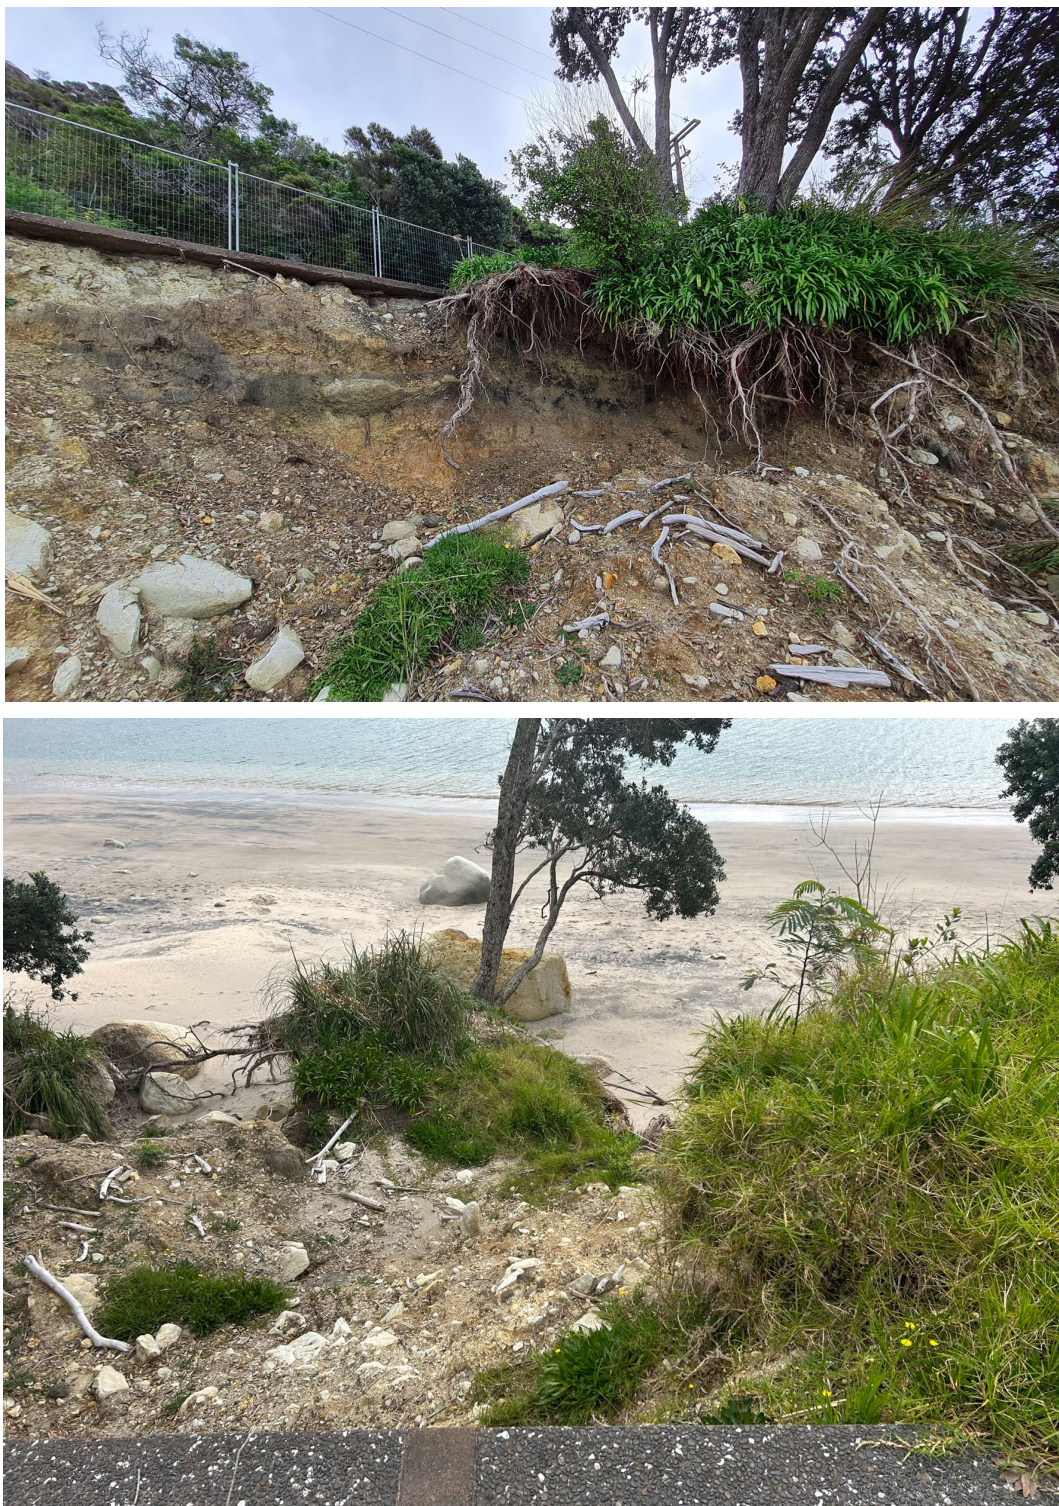
With respect to terrestrial ecology, the top of the is mostly terrestrial grasses and weeds such as kikuyu (*Cenchrus clandestinus*), agapanthus (*Agapanthus praecox*) buttercup (*Ranunculus repens*) and pampas grass (*Cortaderia* sp.) . Along the cliff adjacent to the slip is a mix of exotic/invasive and native species including Pohutukawa (*Metrosideros excelsa*), fivefinger (*Pseudopanax arboreus*), *Caprosma* sp., and golden wattle (*Acacia mearnsii*) (Figure 4-2 to Figure 4-4). Of note, there is a large Pohutakawa in the middle of the slip that is still living after slipping down the cliff when it failed (Figure 4-1). It is recommended that an arborist is consulted prior to construction of revetments to assess whether the central Pohutakawa is removed and what kind of measures should be included in the CEMP to ensure adjacent trees are not damaged.

Figure 4-2. The top of the slip is mostly terrestrial grasses and weeds (e.g., kikuyu, agapanthus and pampas grass), with a mix of exotic/invasive and native species along the cliff.

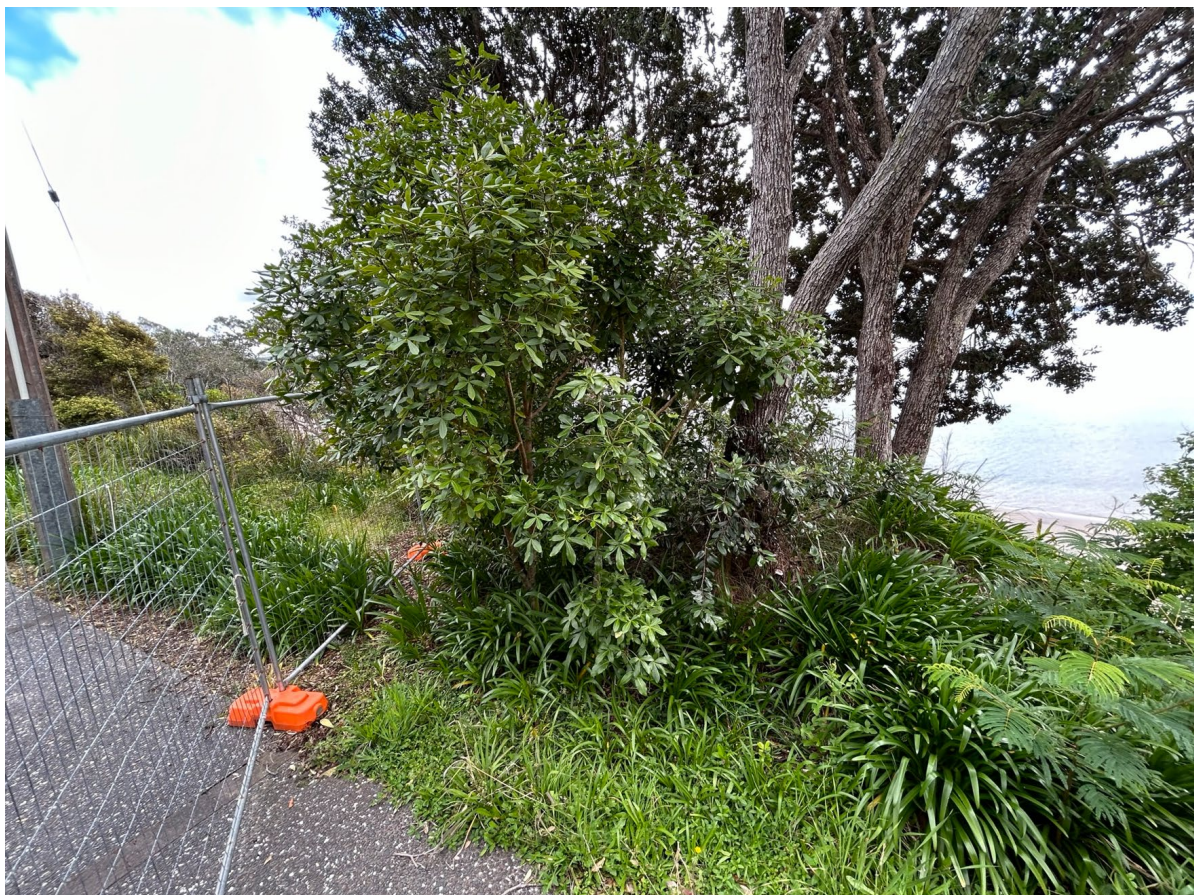
Figure 4-3. The mix of terrestrial grasses and weeds and exotic/invasive and native species along the cliff.

impacts will be less than minor. However, of note are some large Pohutukawa trees adjacent to the site, including a still living tree that came down with the slip. It is recommended that an arborist is consulted prior to construction of revetments to assess whether the central Pohutakawa is removed and what kind of measures should be included in the CEMP to ensure adjacent trees are not damaged..
