Thames Coastal Protection Project - Feasibility Study

Fluvial Modelling Report Update

Client: Thames-Coromandel District Council

Reference: PA3520-101-101

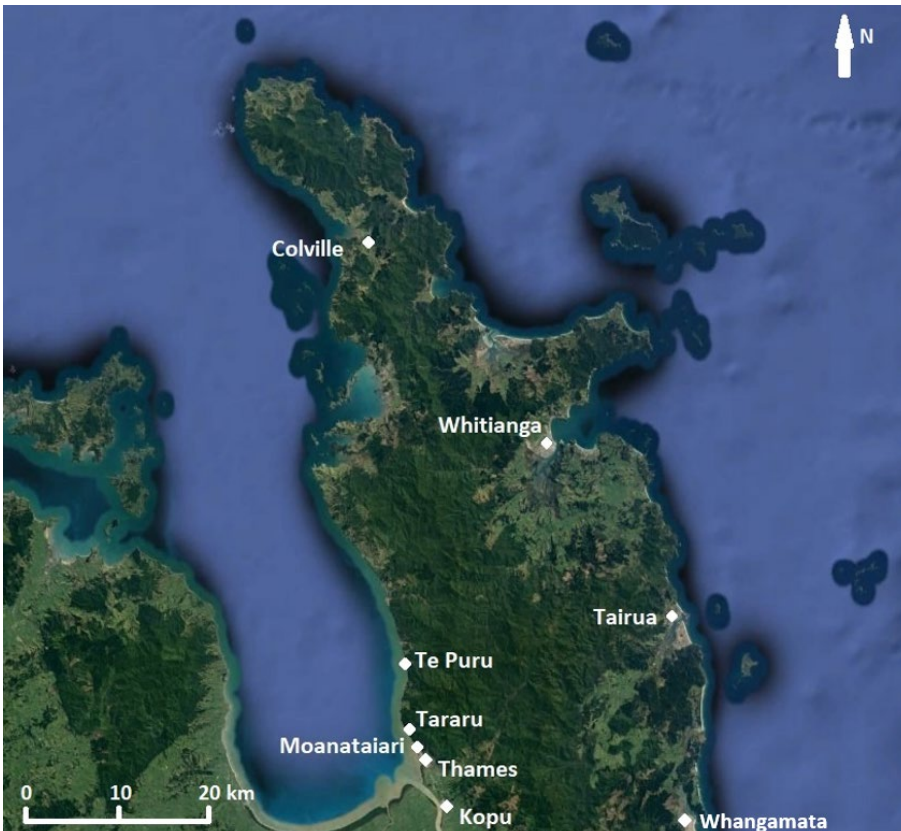
Figure 1-1 Feasibility Study for Coastal Protection Measures in the Coromandel Peninsula (RHDHV, 2022)

Thames Coromandel District Council (TCDC) engaged Royal HaskoningDHV (RHDHV) in 2019 to undertake a feasibility study for coastal protection measures at nine locations in the Coromandel Peninsula for TCDC's Shoreline Management Plan (SMP) (RHDHV, 2022) shown in **Figure 1-1** below.

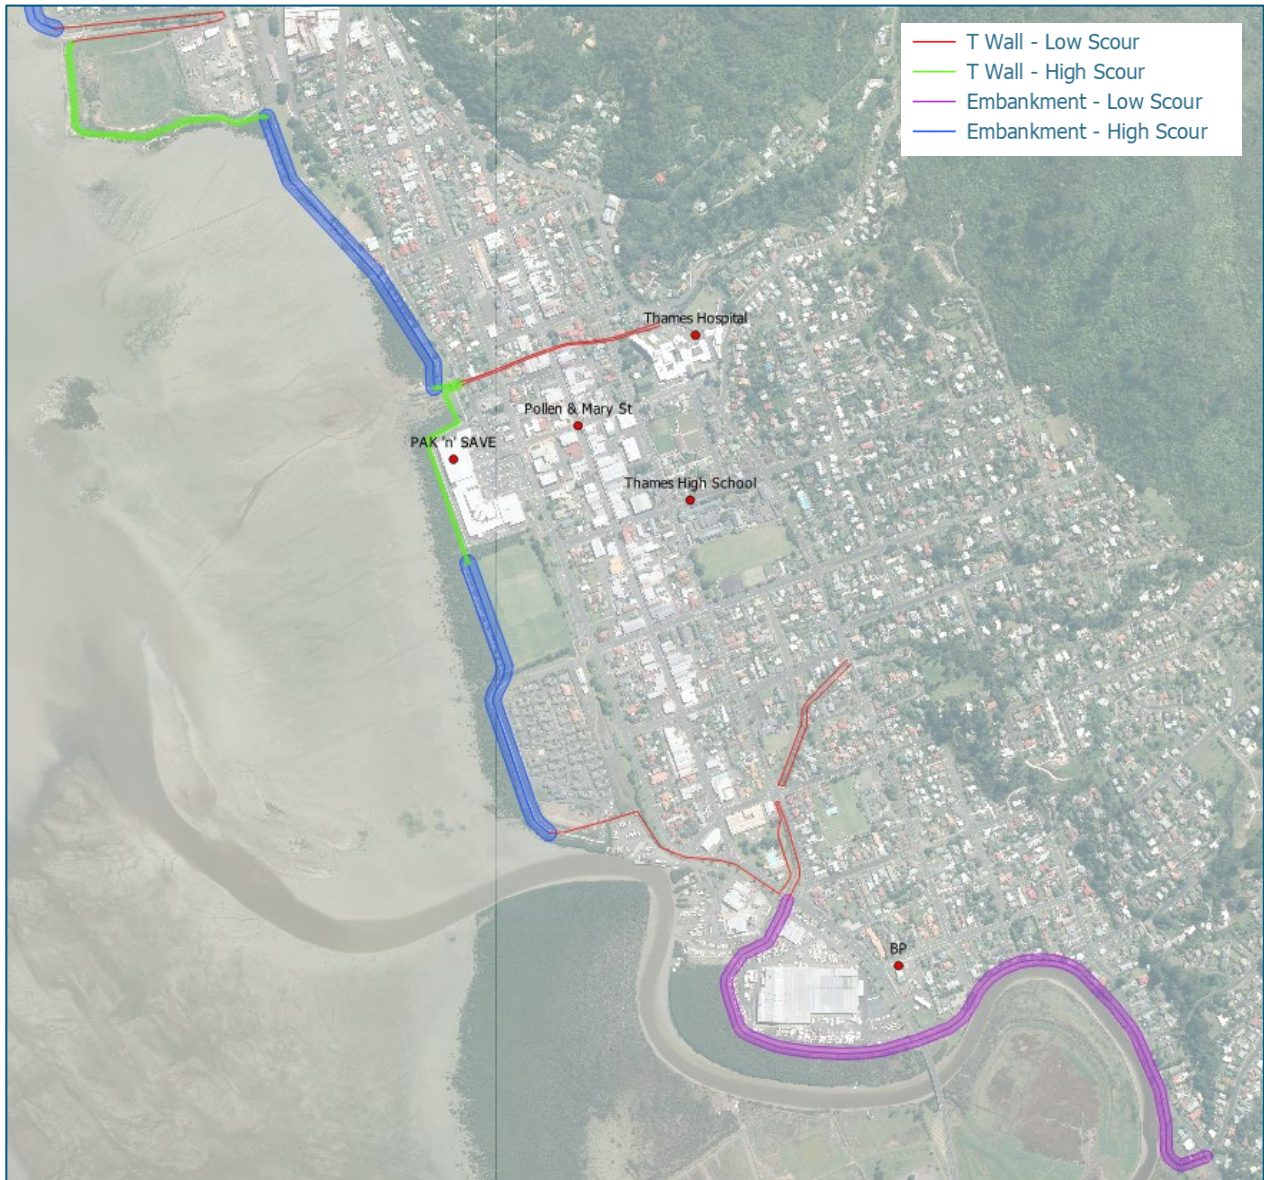
Figure 1-2: Thames Coastal Protection - Preliminary Concept Design (RHDHV, 2022)

One of the locations was Thames, where the proposed coastal protection measures included a combination of earth embankments and concrete T-Walls. The extent of the possible defence solutions is presented in **Figure 1-2**, with approximately 2,962 m of embankment (shown in blue and purple) and 4,200 m of concrete wall (shown in green and red). The pumping of stormwater runoff retained behind the raised sea defences was included in this solution, albeit based on fundamental hydrology and hydraulic assumptions, and the specific size and location of the proposed gates and pumps was not defined.

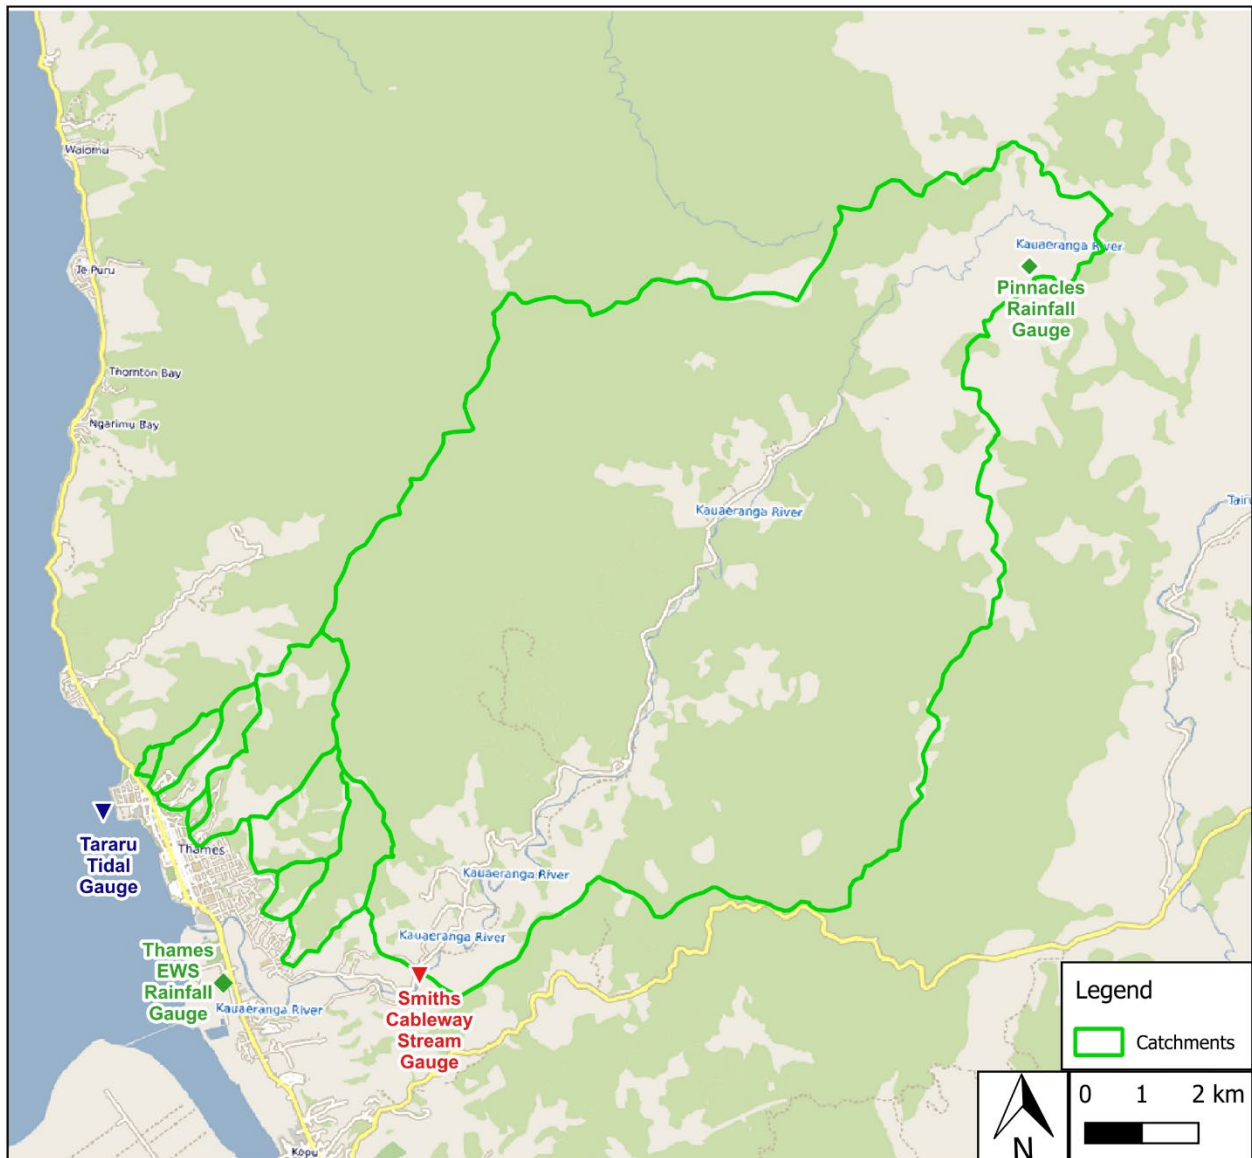
Figure 4-1: Catchment Layout

The largest catchment affecting the township of Thames is the Kauaeranga River Catchment which has an area of approximately 119 km² draining to the Smiths Cableway Stream Gauge. Several other catchments drain to the Thames township which can be seen in more detail in **Figure 4-2**. The streams draining to the Thames township include the Moanataiari, Waiotahi, Karaka, Hape, Herewaka and Waikiekie Streams.

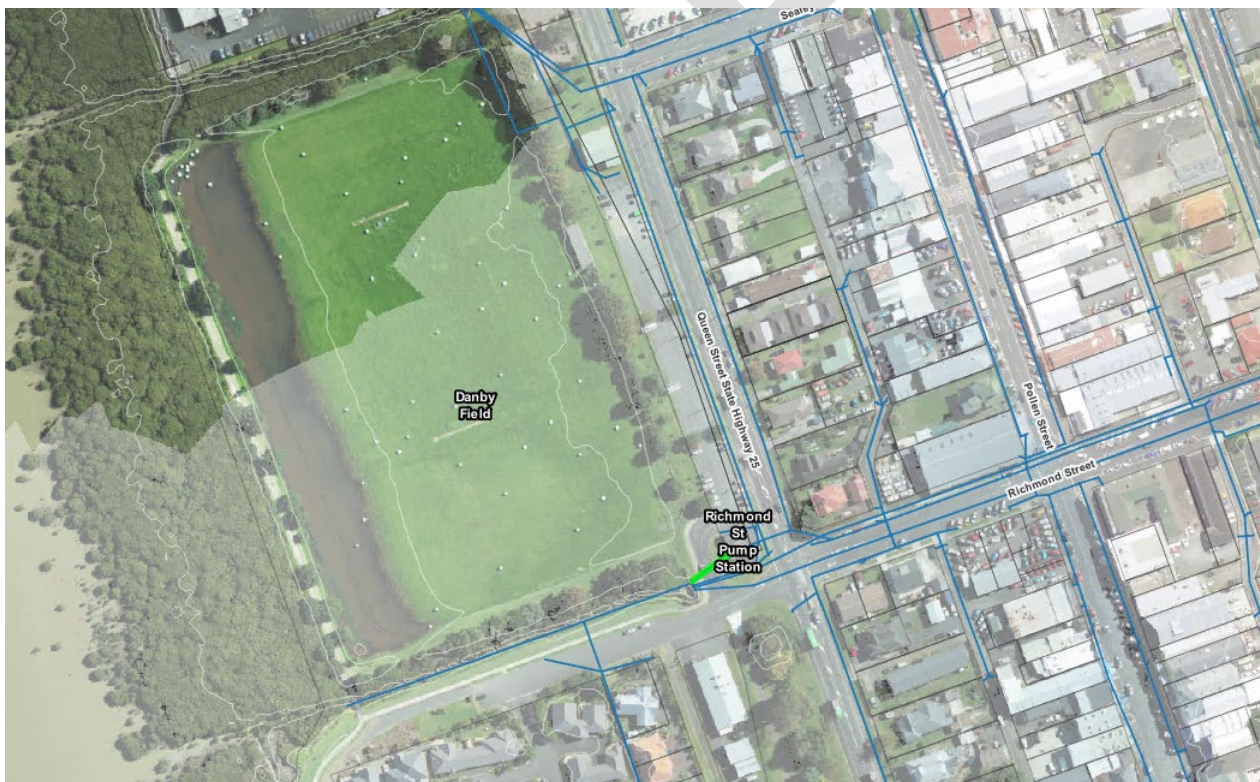
Figure 4-4: Richmond St Pump Station

- 2 x Model: Flygt 7055 / 680 pumps (one duty pump and one backup pump);
- Each pump has a capacity of 540 L/s (conservative estimate based on the technical specifications provided by TCDC and considering the head losses on the flapgates on the outfall);
- A DN1050 pipe flows into the pump sump, with a DN1050 overflow pipe which outlets in the channel to the south of Danby Field;
- The pumps operate from a single wet sump with a plan area of 5.6 m x 3.35 m, and a depth of approximately 3 m, however the pumps operate from a depth of approximately 1.2 m (below the lid of the sump) and standing water was observed to be in the sump below this level at the time of the Survey (meaning that there is approximately 1.2 m depth of storage above the pump intake level); and
- Pump operator controls for the duty and backup pump which were provided by TCDC.

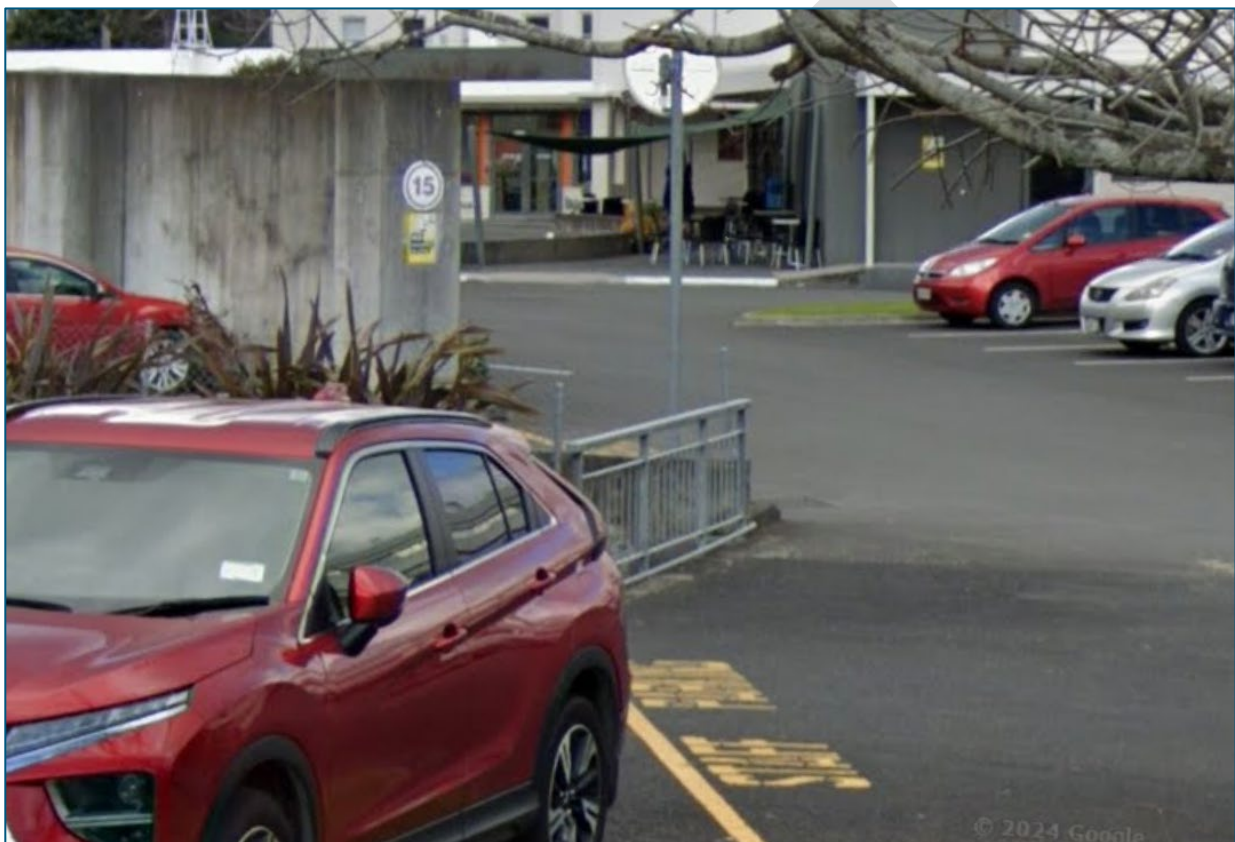
Figure 4-5: Concrete Walls on Karaka Stream (Taken from Google Streetview from Bella Street Looking East)

- Steep Channel Grade: The channel has a steep grade of more than 4%, resulting in high approach velocities;
- Limited waterway area of the culvert, which has a waterway area opening height of only 1.5 meters;
- Hydraulic Jump: The high velocities and change in hydraulic gradient cause a hydraulic jump when the flow reaches the Bella Street Culvert; and
- Concrete Walls: The stream has concrete walls on either side that contain the flow up to a height of approximately 2 – 2.5 m, which end at the upstream end of the culvert (shown on **Figure 4-5** below). The walls do not prevent the flow from spilling onto the road, causing a significant amount of water to spill out of the channel at the culvert;

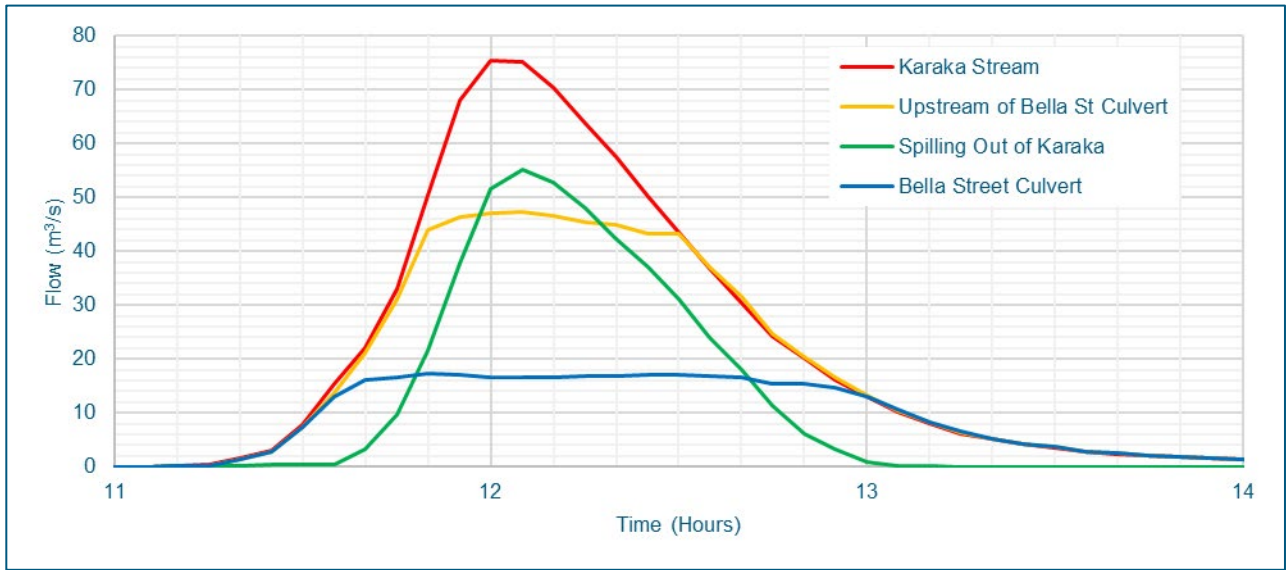
Figure 4-7: Flow Hydrographs in Karaka Stream – 50 year ARI – refer Figure 4-6

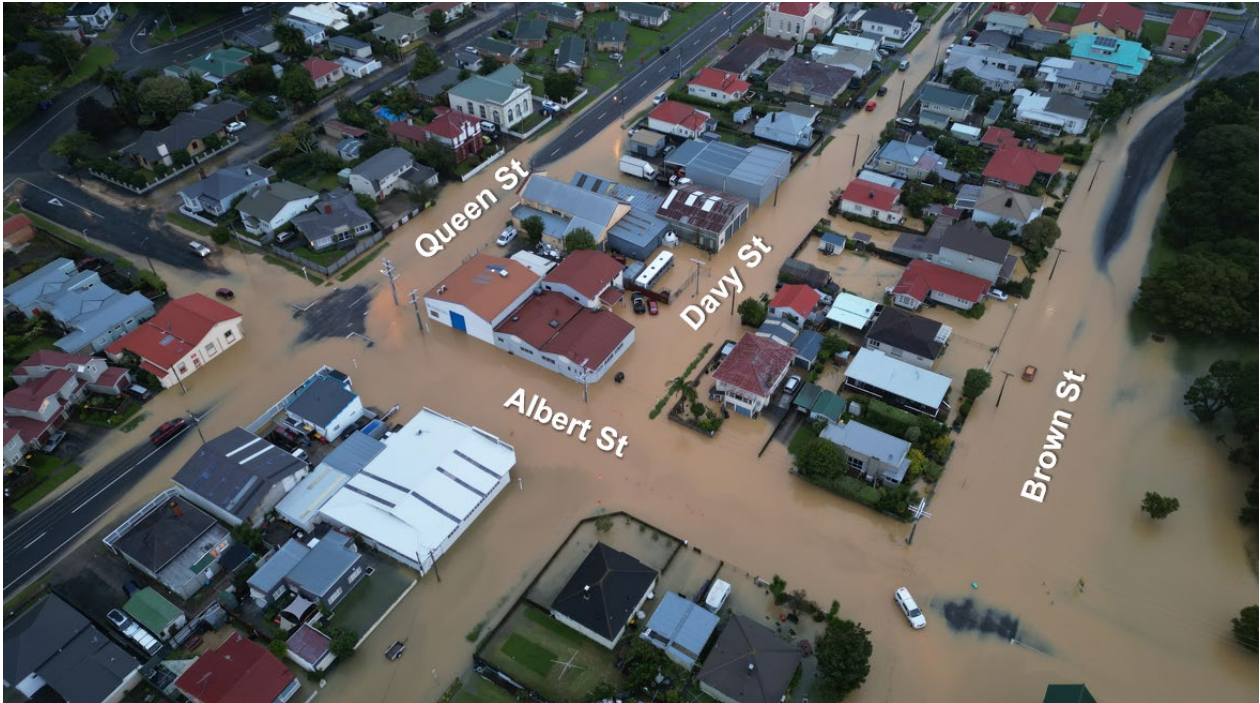
Figure 5-4: Drone Photograph of Flooding on Albert Street – Taken at 06:45AM on 14 February 2023 (Courtesy of Stuart Caisley)

Rainfall records and modelling indicate that the peak of the event occurred at approximately 01:00AM in the morning of 14 February, which is in agreement with anecdotal evidence. **Figure 5-4** and **Figure 5-5** show the flooding in Thames in the morning after the peak of the flood event in February 2023 taken using a drone at approximately 7AM on 14 February 2023 (courtesy of Stuart Caisley). **Figure 5-6** shows the TUFLOW model results at the same timestep as when the photographs were taken (after the peak subsided). A comparison of the flood extents is shown in **Figure 5-7** below which shows a good agreement between the observed and modelled flood extents. The initial and continuing losses were set to 10 mm and 4.5 mm/hr, respectively, to achieve a good match between recorded and observed flood extents. Of note in the comparison is that:

- Flood waters inundate Queen Street, Davy Street and Brown Street near the intersections with Albert St with roughly the same extent between the observed and modelled flooding;
- The intersection of Queen Street and Albert Street is dry, as well as the intersection of Brown Street and Albert Street;
- The water is a brown colour, indicating that the source of the water is the stream catchments, rather than the local catchment runoff, or from the overtopping of the coastal defences; and

- The roads and Victoria Park are roughly inundated to the same extent.

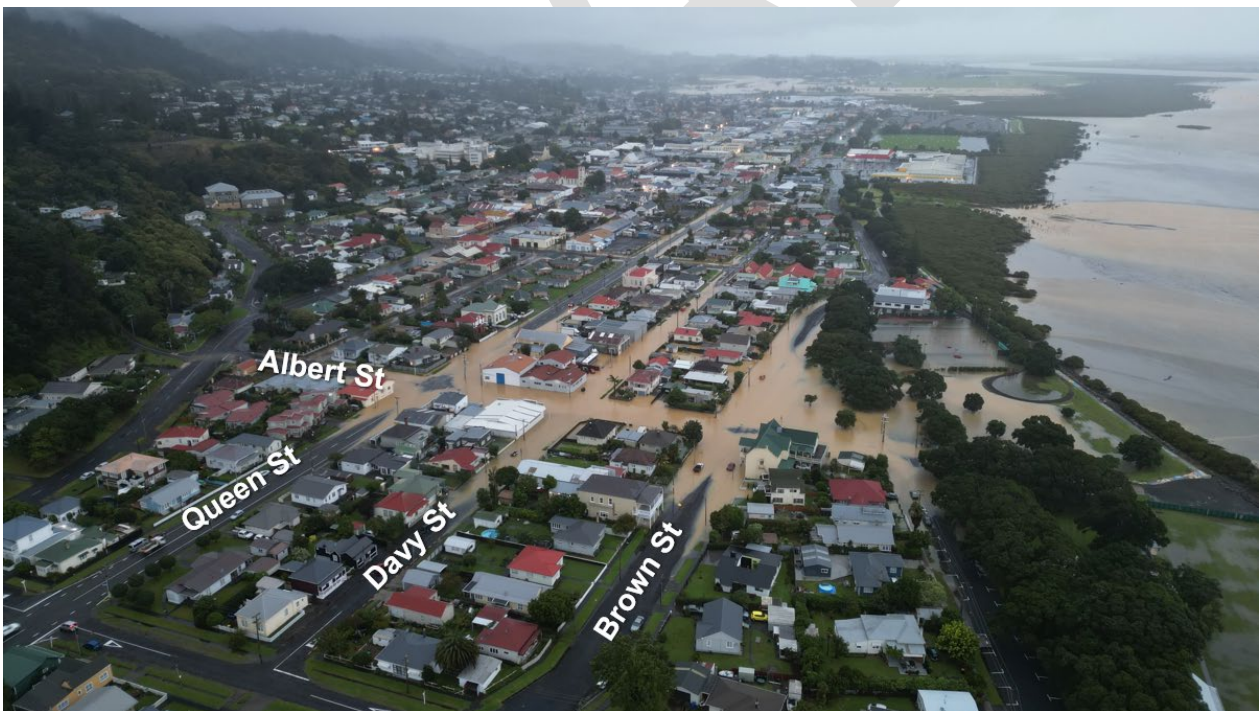
Figure 5-5: Drone Photograph of Flooding in Northern Thames – Taken at 06:48AM on 14 February 2023 (Courtesy of Stuart Caisley)

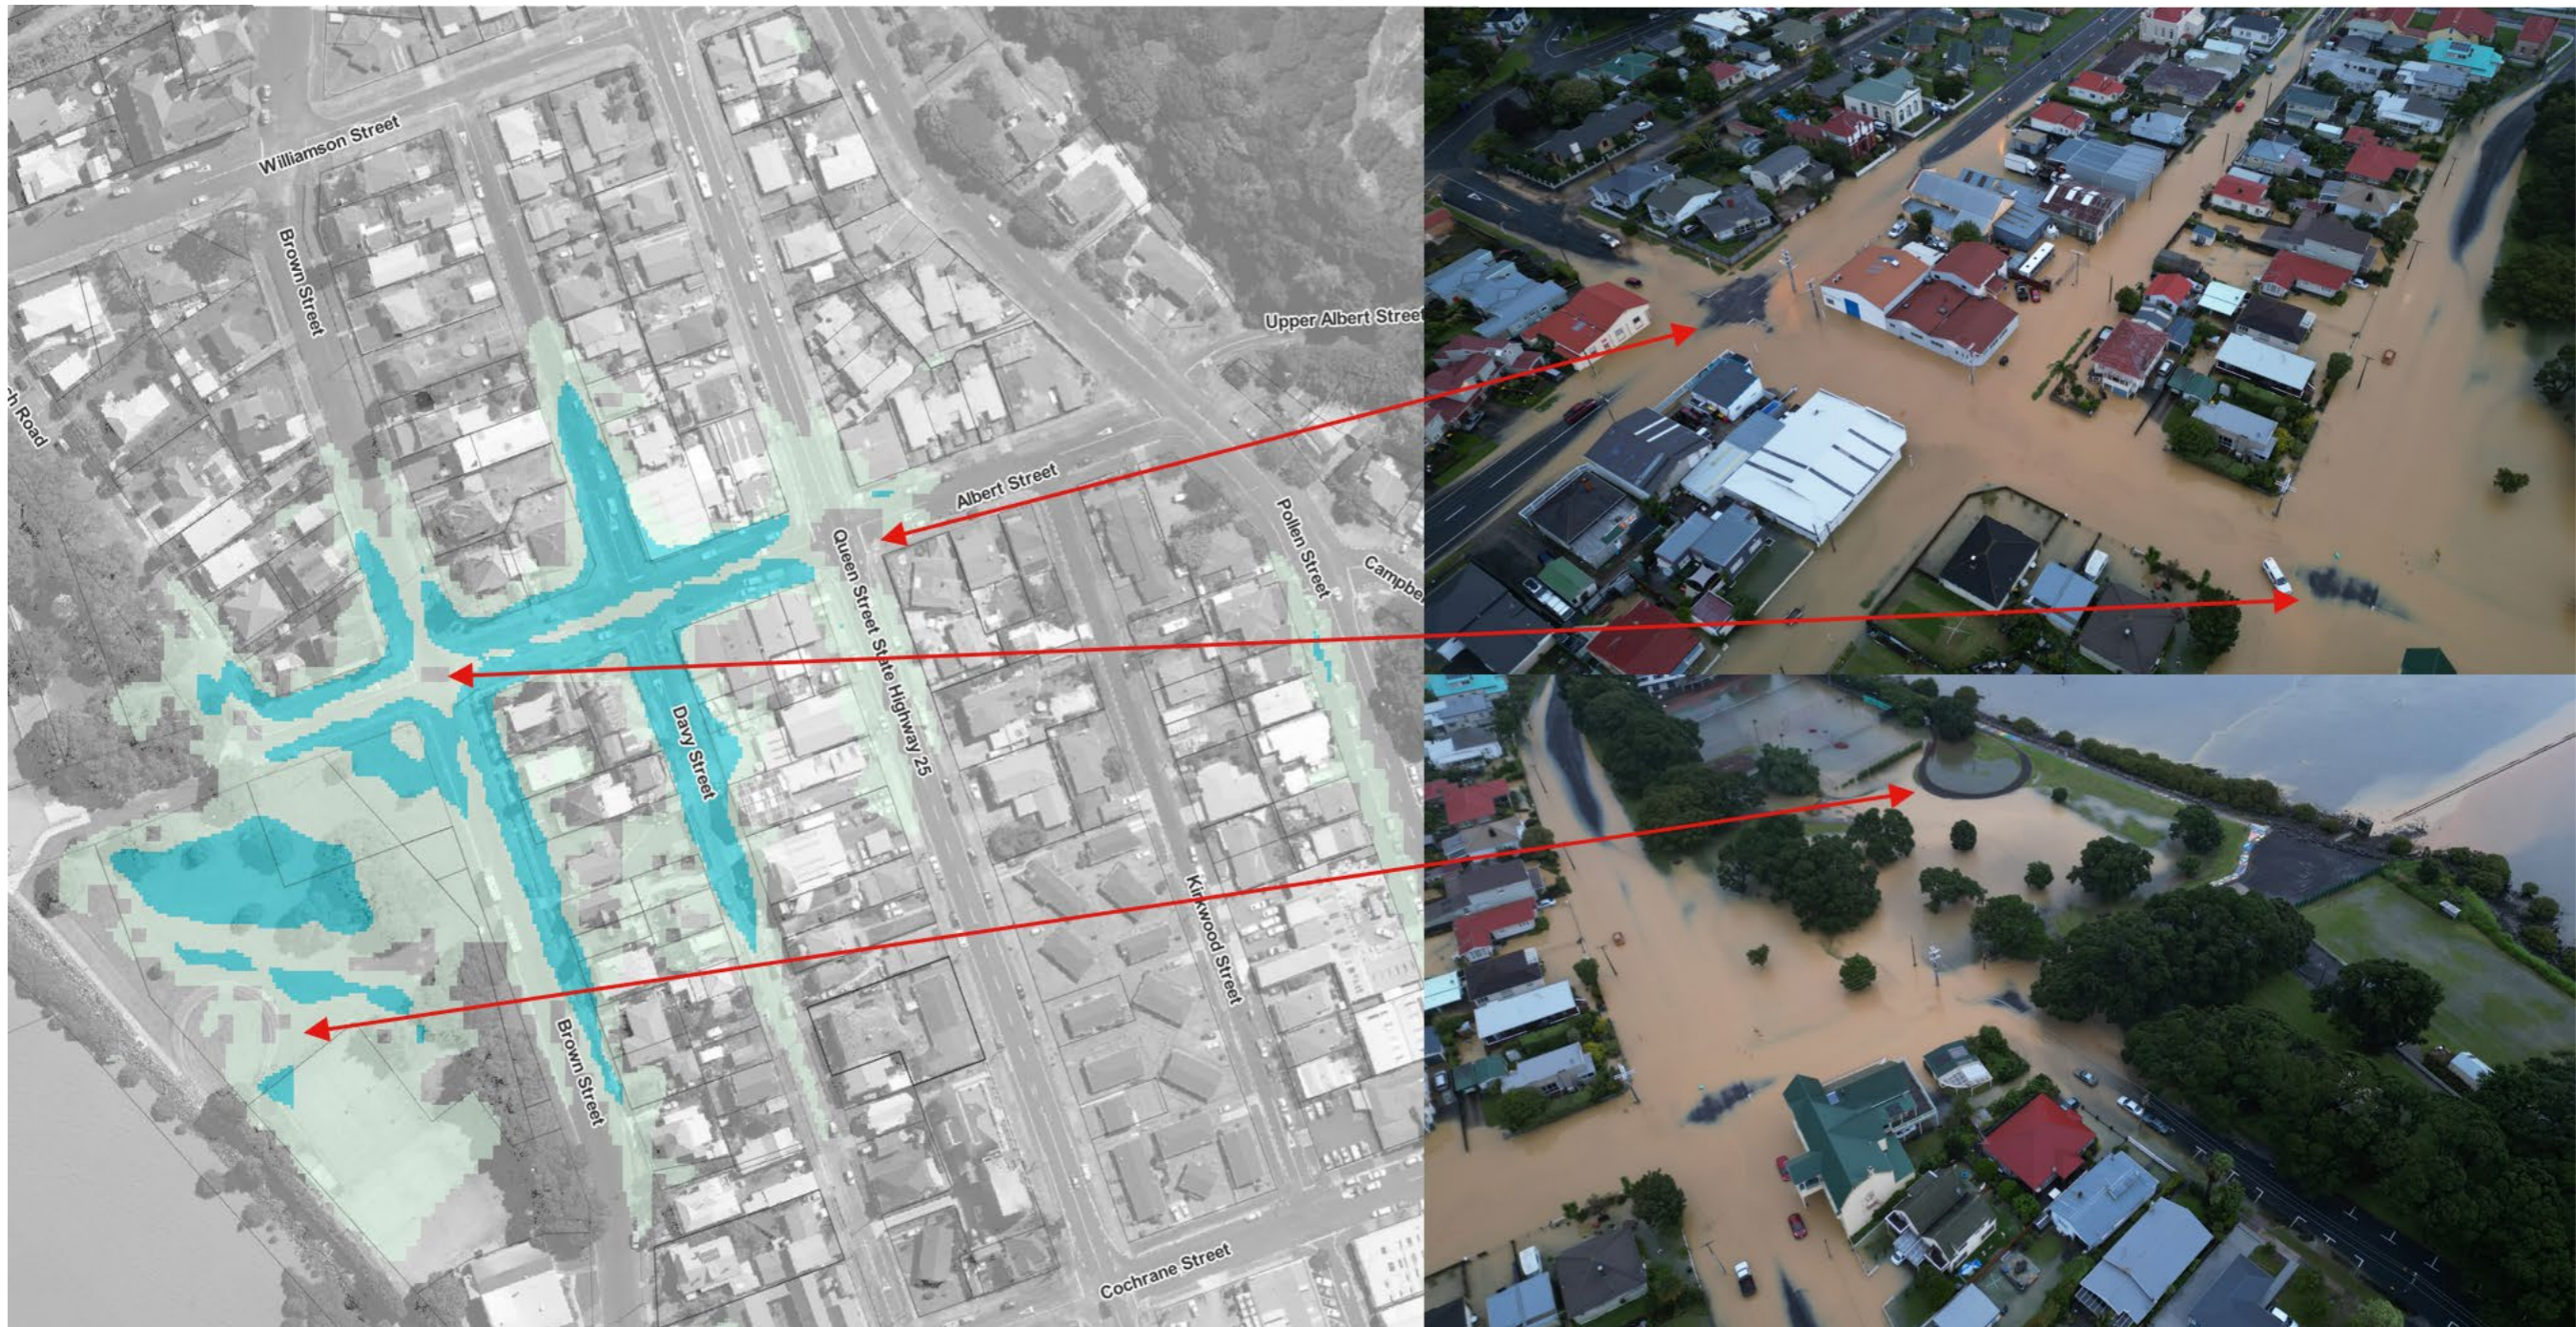
Figure 5-7: Comparison Drone Photography and Model Results – February 2023 Event at 07:00AM

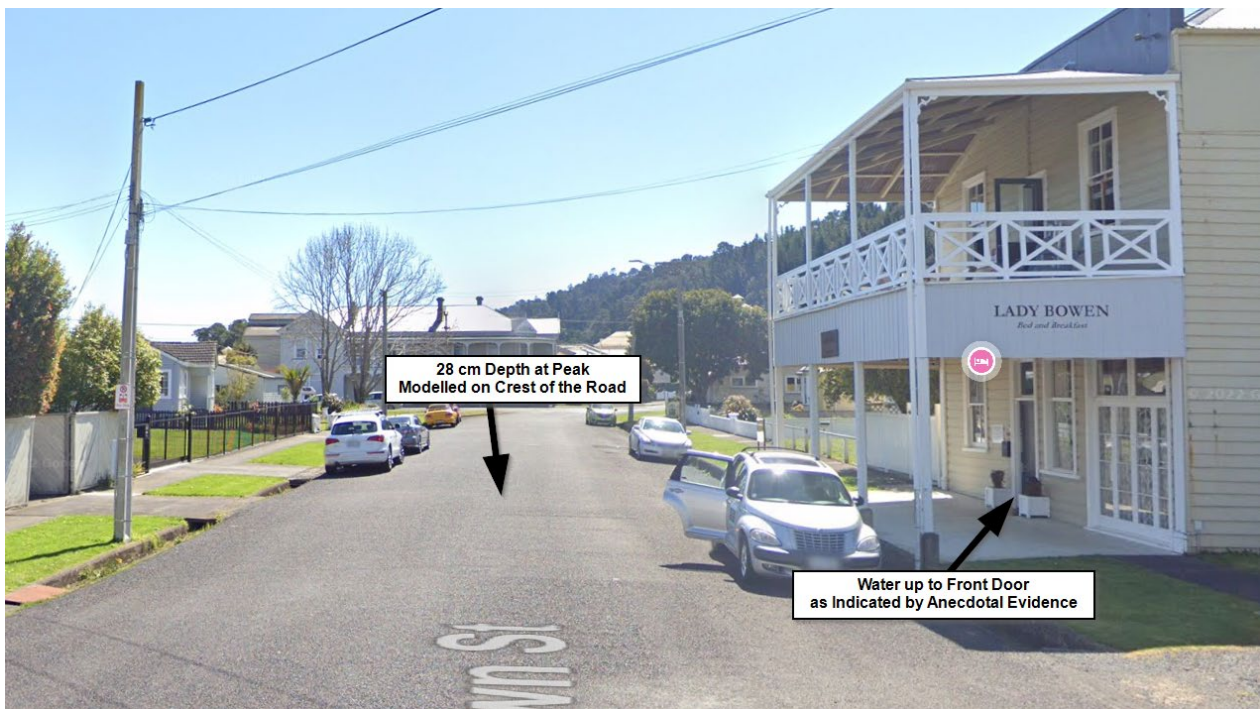
In the peak of the February 2023 event, 28 cm of depth was indicated by the model. Anecdotal evidence suggested that flood waters reached the front door of the Lady Bowen Air-bnb. **Figure 5-8** below shows the location of the peak depth on the crest of the road as well as the front door. It is difficult to determine the exact level of the front door in the image and the balcony at the front of the property does not allow for accurate levels of the footpath from LiDAR. However, cross sections of the road cut at adjacent locations show the footpath on the side of the Lady Bowen Air-bnb are level or slightly higher than the crest of the road. This would indicate that flood waters may have reached the front door with a depth of approximately 28 cm.

Figure 5-8: Comparison of Modelled Level and Observations at the Lady Bowen Airbnb – February 2023 Event (Courtesy of Google Streetview)

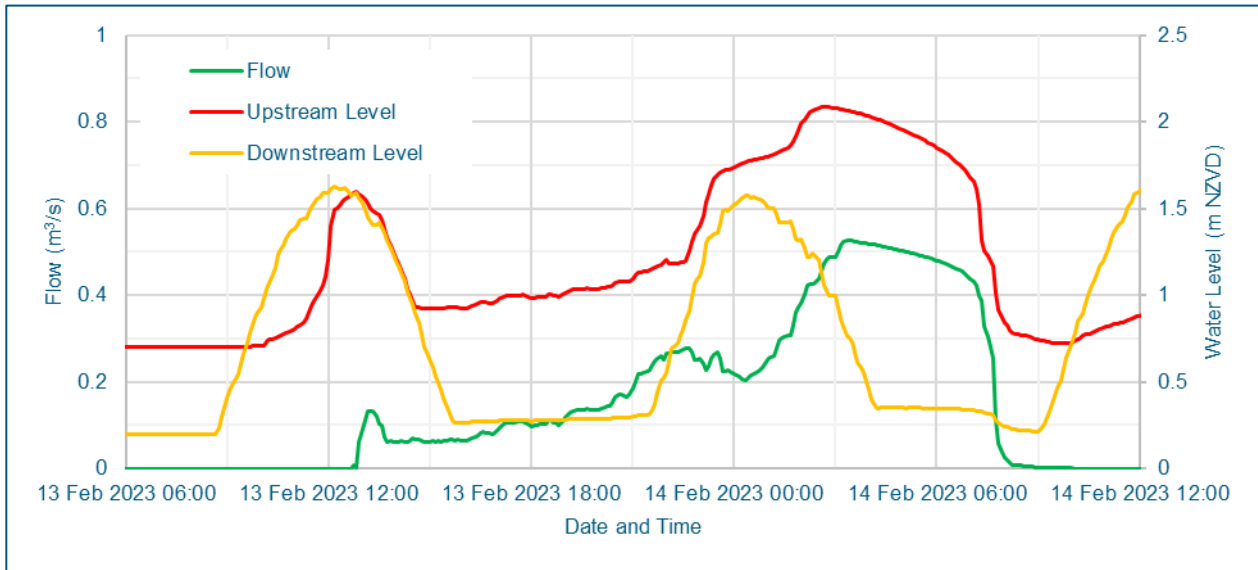
The ponding observed at the low point in Albert Street is in part due to the lack of head available to drain from the land side to the ocean side during periods of elevated ocean levels. **Figure 5-9** below shows the flow and upstream (land side) and downstream (ocean side) water levels for an existing piped ocean outlet on the western end of Albert Street. The figure shows that although the upstream level is elevated due to the ponding, the pipe cannot flow to its full capacity due to an elevated ocean level, due to there not being enough head.

Figure 5-9: Piped Ocean Outlet at Albert Street – February 2023 Event – showing elevated upstream levels and flow limitation due to elevated tailwater conditions

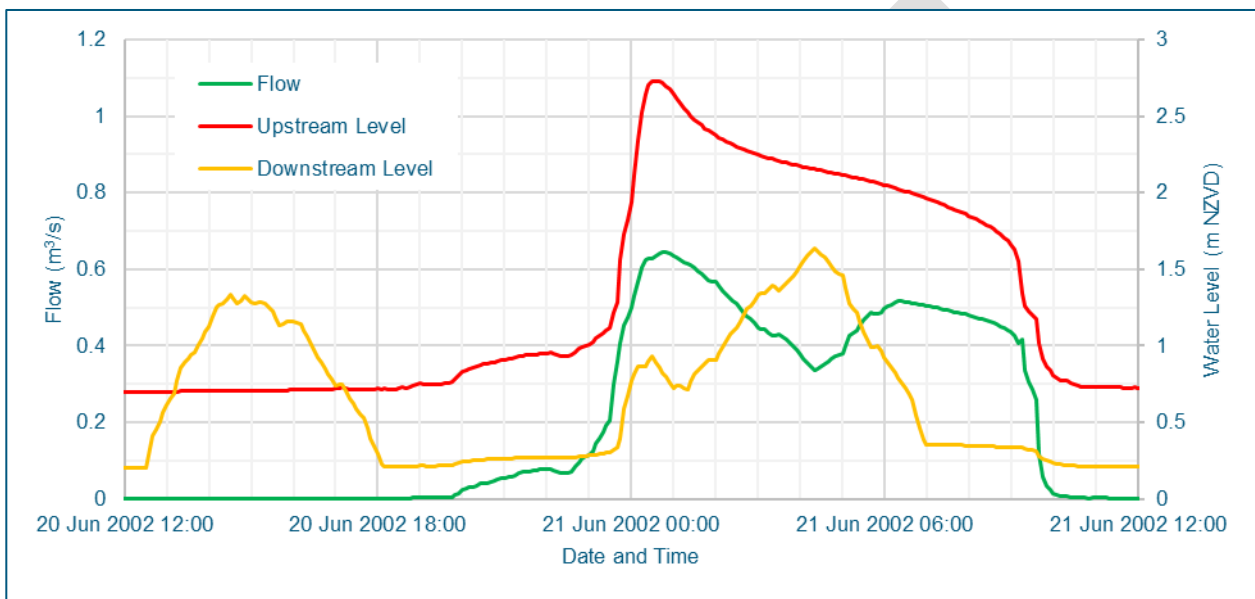
Figure 5-17: Piped Ocean Outlet at Albert Street – The Weather Bomb

Similar to the February 2023 Event, the ponding observed at the low point in Albert Street is in part due to the lack of head available to drain from the land side to the ocean side during periods of elevation ocean levels. However, during The Weather Bomb event, the model estimated a significant amount of water ponding at the Albert Street low point, and it is unlikely that lower ocean tailwater levels would lead to a significant difference in the peak ponding depth. **Figure 5-17** below shows the flow and upstream (land side) and downstream (ocean side) water levels for an existing piped ocean outlet on the western end of Albert Street. The figure shows that although there is a head difference between the upstream (land) and downstream (ocean) side of the pipe, it takes approximately 9 hours for the majority of the water to drain to the ocean, due to limited pipe capacity and large volume of ponded water.

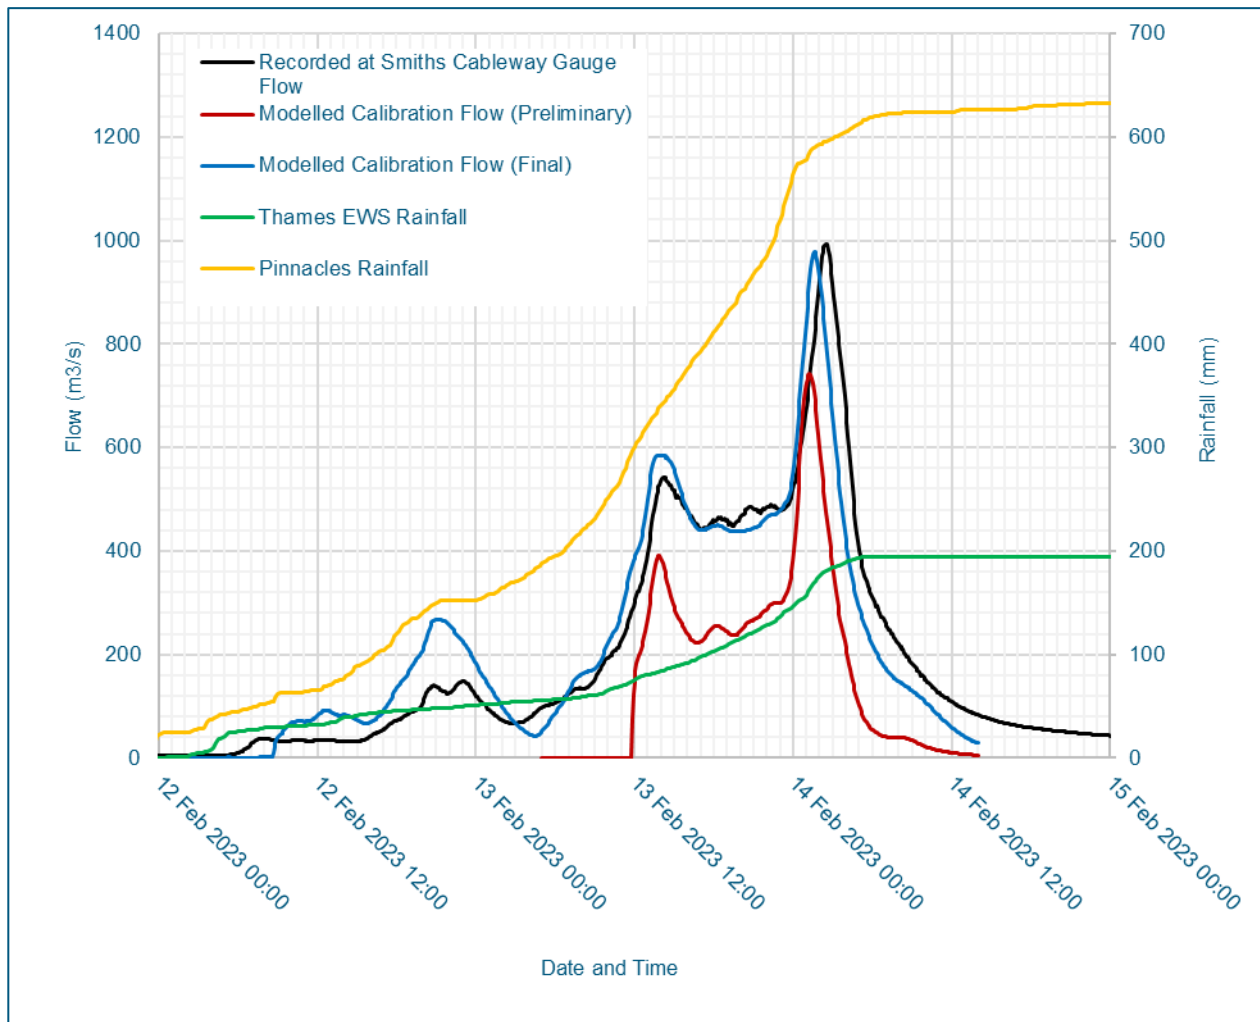
Figure 6-4: Recorded Rainfall and Recorded and Modelled Flow at Smiths Cableway – February 2023 Event

Figure 6-4 below shows that during the February 2023 event, approximately 200 mm of rainfall was recorded by the Thames EWS gauge and approximately 630 mm was recorded by the Pinnacles gauge. The figure also shows that a peak flow of 1000 m³/s was observed by the Smiths Cableway Gauge, peaking between 02:00 and 03:00 on 14 February 2023. **Figure 6-4** also shows the flow hydrograph at the Smiths Cableway from the simulation with parameters as described above – **Modelled Calibration Flow**

(Preliminary). The figure shows that the recorded hydrograph had significantly more volume than the modelled hydrograph. The figure also shows that the modelled hydrograph peaked almost 2 hours before the recorded hydrograph.

As a result of this initial calibration attempt, the rainfall losses were incrementally reduced from 4.5 mm/hr, however it was found that the peak flow at the Smiths Cableway gauge was not as sensitive to the loss rate as the distribution of the rainfall across the catchment.

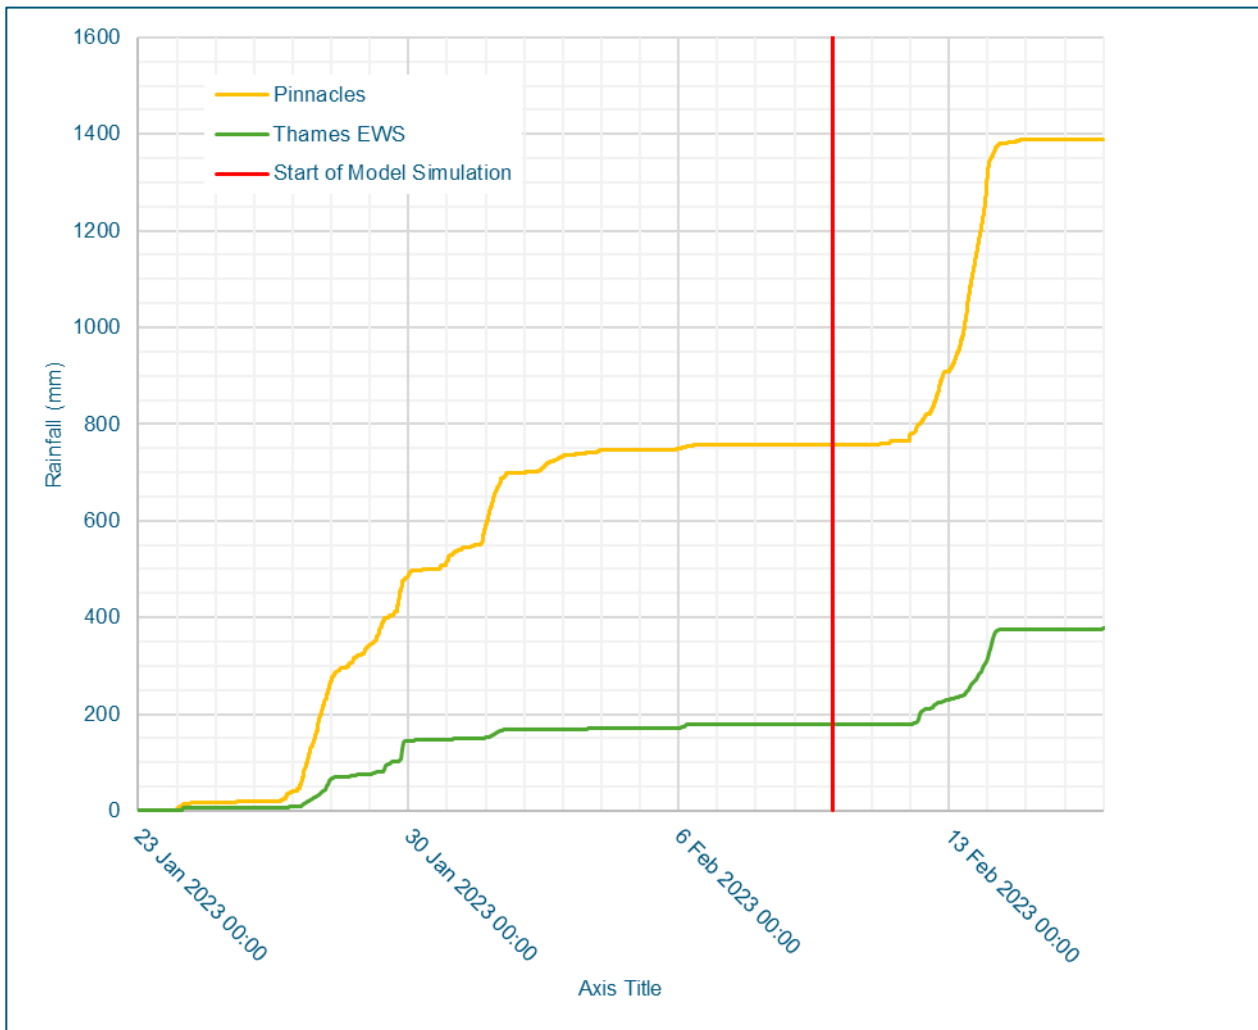
Figure 6-6: Rainfall Leading up to February 2023 Event

Figure 6-6 below shows the rainfall recorded by the Pinnacles and Thames EWS gauges leading up to the simulation of the February 2023 Event. The Pinnacles gauge recorded nearly 800 mm of rainfall in the two weeks before the start of the flood event, whereas the Thames EWS gauge recorded only 200 mm, in comparison. For this reason, the rainfall losses in the Kauaeranga River were adjusted to 1.3 mm/hr through the calibration process and the rainfall losses were kept at 4.5 mm/hr for the Thames stream catchments, since it was assumed that the rainfall falling on the Thames stream catchments in this event was more similar to the Thames EWS than the Pinnacles Gauge, due to the Thames streams being at a much lower elevation.

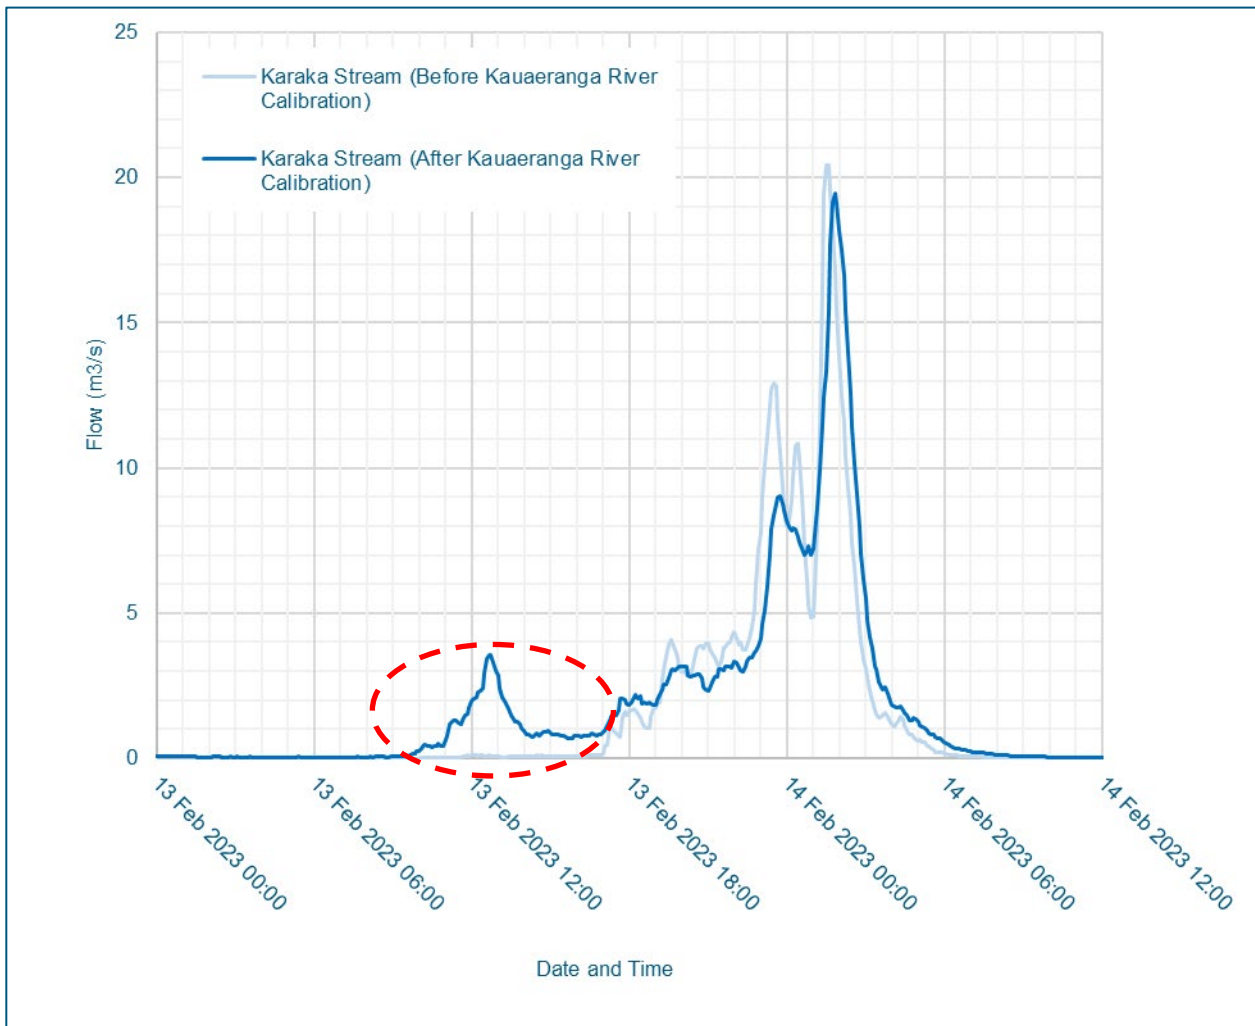
Figure 6-7: Flow in Karaka Stream Before and After Kauaeranga River Calibration – February 2023 Event

Figure 6-7 below shows the modelled flow in Karaka Stream for the February 2023 event before and after calibration of the model to the Kauaeranga River. The figure shows a slight reduction in peak flow (approximately $1 \text{ m}^3/\text{s}$) due to the increased roughness. Note that the additional flow in the simulation after calibration around 13 February is due to the model simulation starting earlier, whereas the previous run commenced after 13 February (difference shown with a dashed red circle in the Figure below).

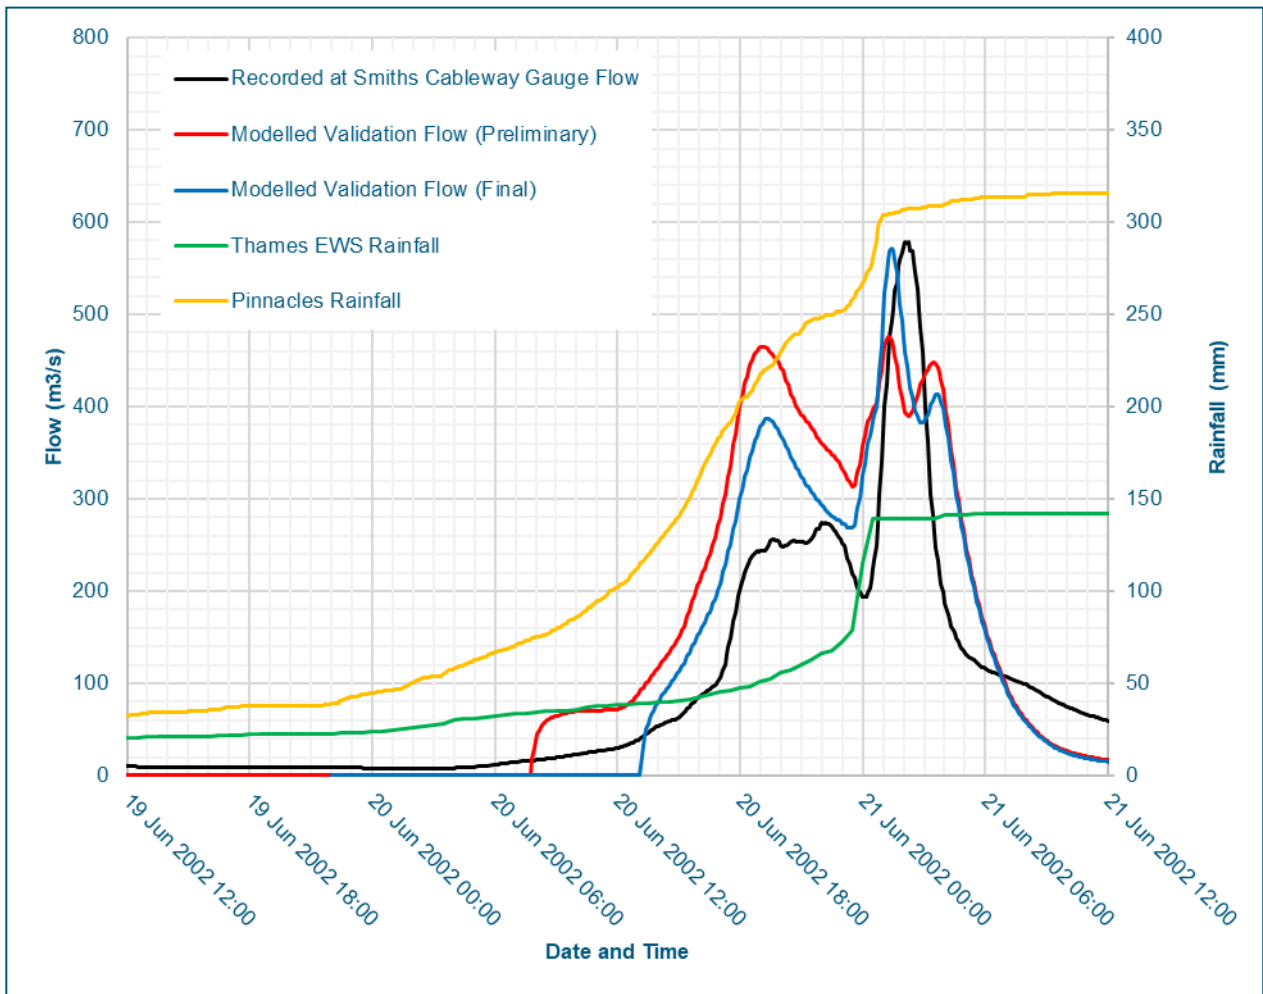
Figure 6-6 below shows the rainfall recorded by the Pinnacles and Thames EWS gauges leading up to the simulation of the 2002 Weather Bomb. Both gauges recorded between 50 to 100 mm of rainfall in the two weeks before the start of the simulation. For this reason, the rainfall losses in the Kauaeranga River and the stream catchments were both set at 1.5 mm/hr.
