Thames Coastal Protection Project - Feasibility Study

Fluvial Modelling Report Update

Client: Thames-Coromandel District Council

Reference: PA3520-101-101

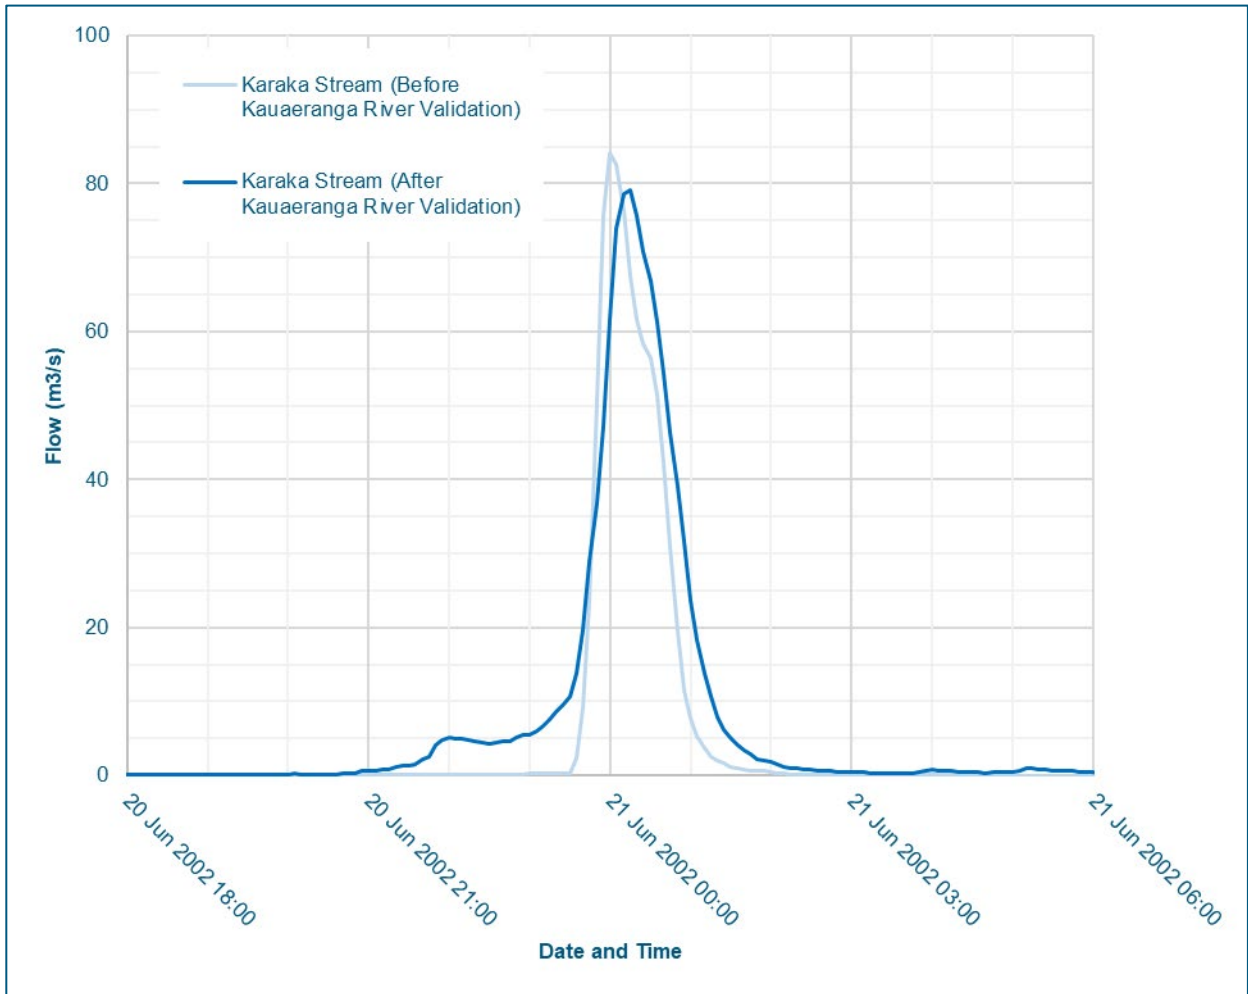
Figure 6-10: Flow in Karaka Stream Before and After Kauaeranga River Calibration – 2002 Weather Bomb

Figure 6-7 below shows the modelled flow in Karaka Stream in the 2002 Weather Bomb before and after calibration of the model to the Kauaeranga River. The figure shows a slight reduction in peak flow (approximately 5 m³/s) due to the increased roughness and reduction in continuing loss from 4.5 mm/hr to 1.5 mm /hr.

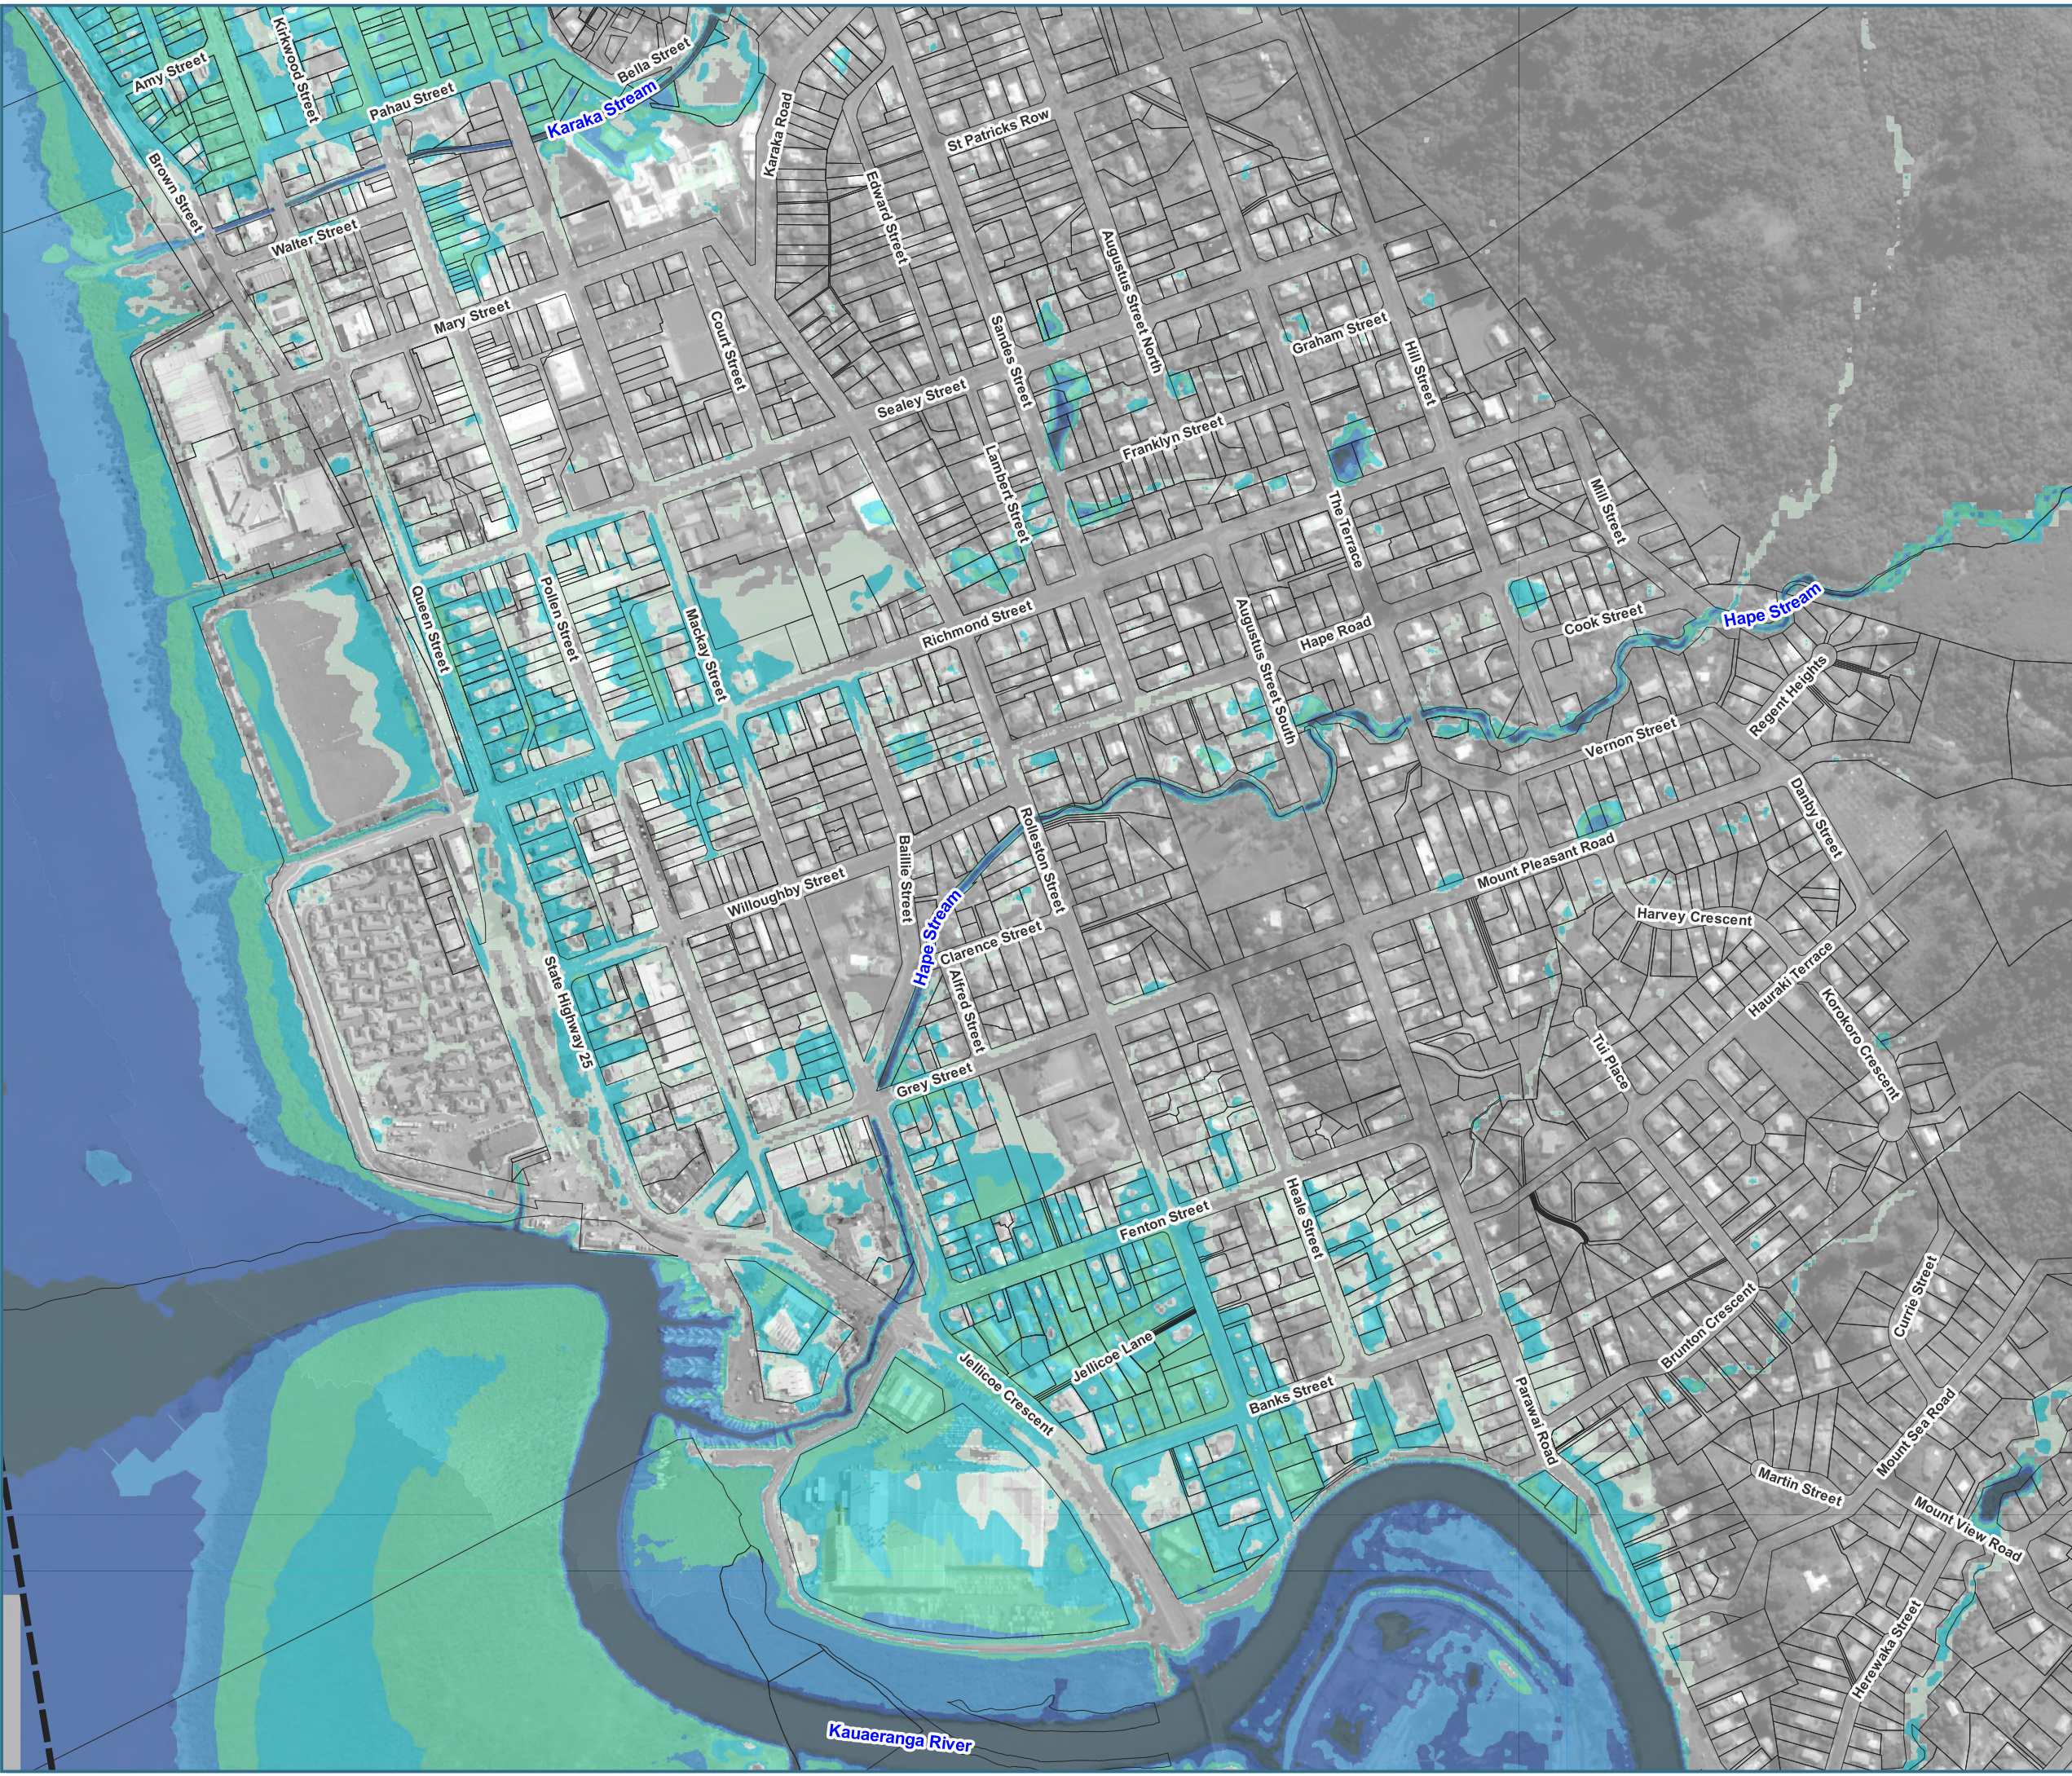
Figure 3 (Sheet 1)

In the 10 year ARI Event (shown in **Figure 3** in **Appendix B**), overtopping of Karaka Stream occurs first at the Bella Street Culvert. This results in between 0.5 and 1 m of ponding occurring near Albert Street as both the local catchment in the town as well as the overtopping flow from Karaka Stream ends up at this location. Overtopping of the seawall is observed from the land side in the model to the west of the croquet club (between Albert St and William St), thought a survey should be conducted in this location of the existing seawall level. The seawall is currently represented using LiDAR since the drone photography was unreliable due to the heavy vegetation in this area. The coincident event for the 10 year ARI, the HAT, does not result in overtopping of the existing coastal defences from the ocean side. Hape Stream breaks out immediately upstream of Augustus Street South and an overland flowpath can be seen heading towards Richmond Street with a peak flow of 2.3 m³/s. Hape Stream also overtops Grey Street at the Mackay Street Bridge.

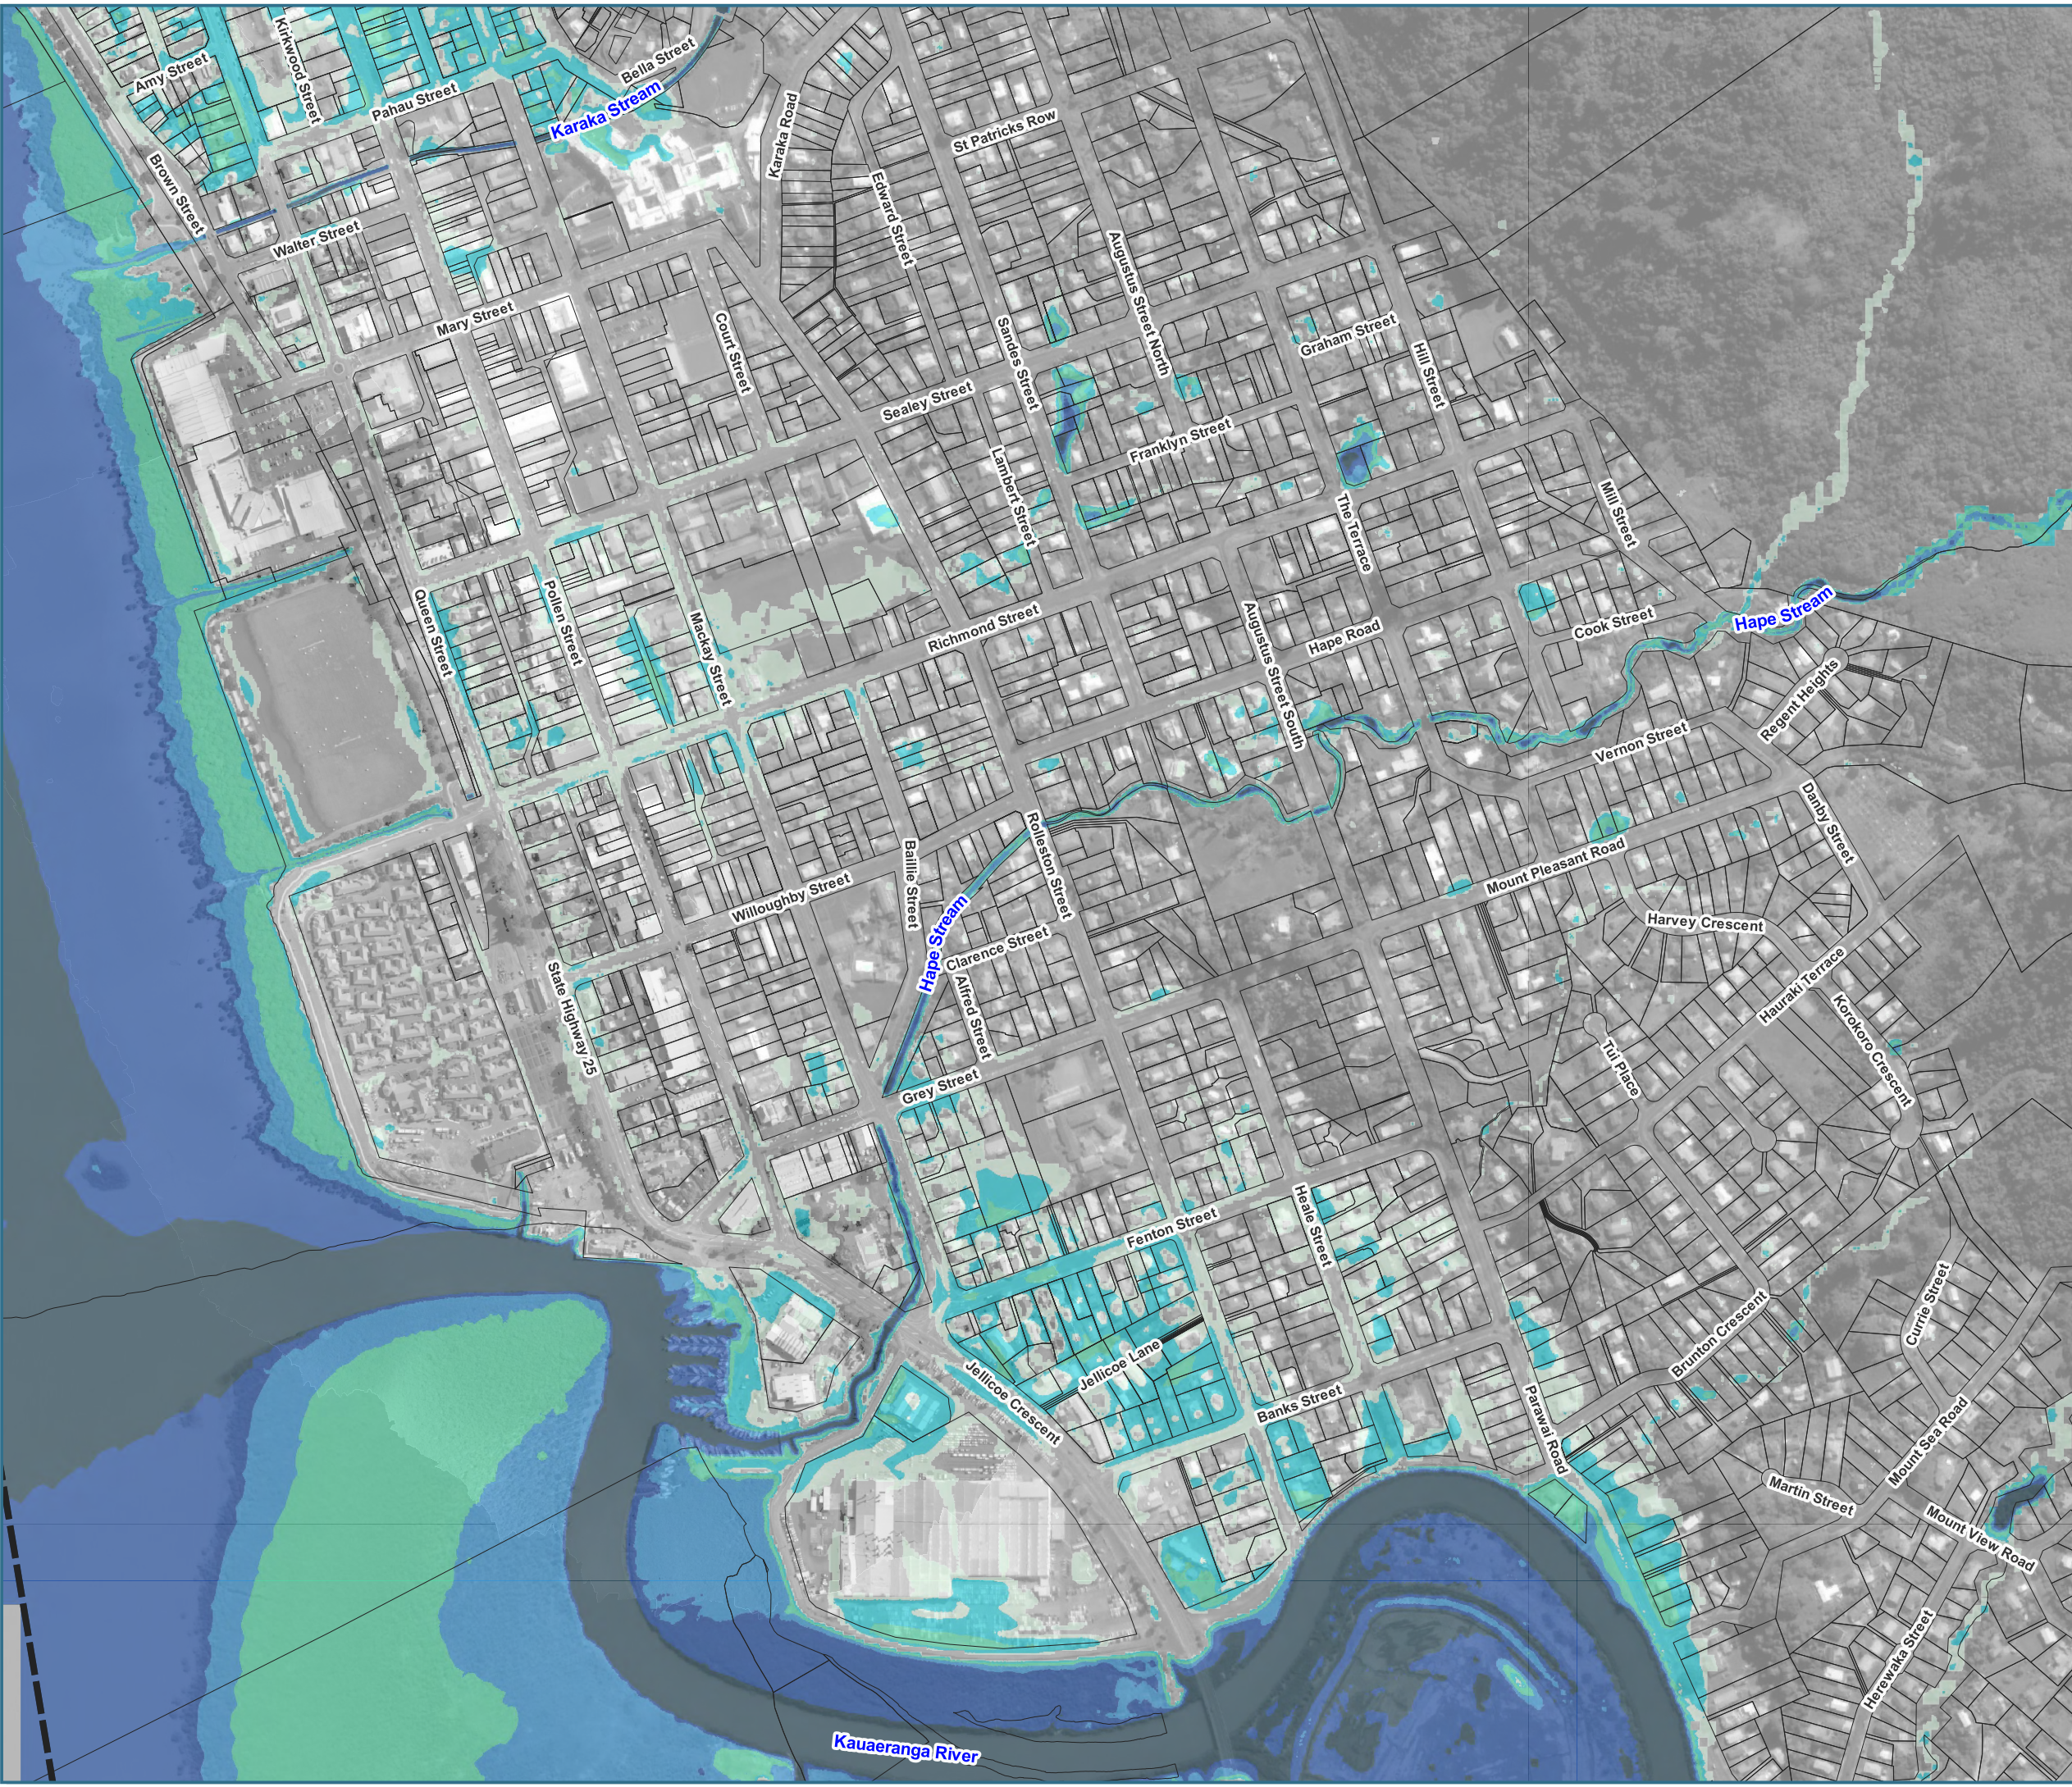
Figure 4 (Sheet 1)

In the 50 year ARI Event (shown in **Figure 4** in **Appendix B**), overtopping of Karaka Stream occurs at the Bella Street Footbridge and the Bella Street Culvert. This results in between 1 and 1.5 m of ponding occurring near Albert Street as both the local catchment in the town as well as a significant amount of overtopping flow from Karaka Stream ends up at this location. Overtopping of the seawall occurs in various locations between Karaka Stream and William Street from the land side, but the coincident ocean event for the 50 year ARI, i.e. the HAT, does not result in overtopping of the existing coastal defences from the ocean side. Hape Stream breaks out immediately upstream of Augustus Street South and an overland flowpath can be seen heading towards Richmond Street with a peak flow of 5 m³/s. Hape Stream also overtops Mackay and Grey Street at the Mackay Street Bridge.

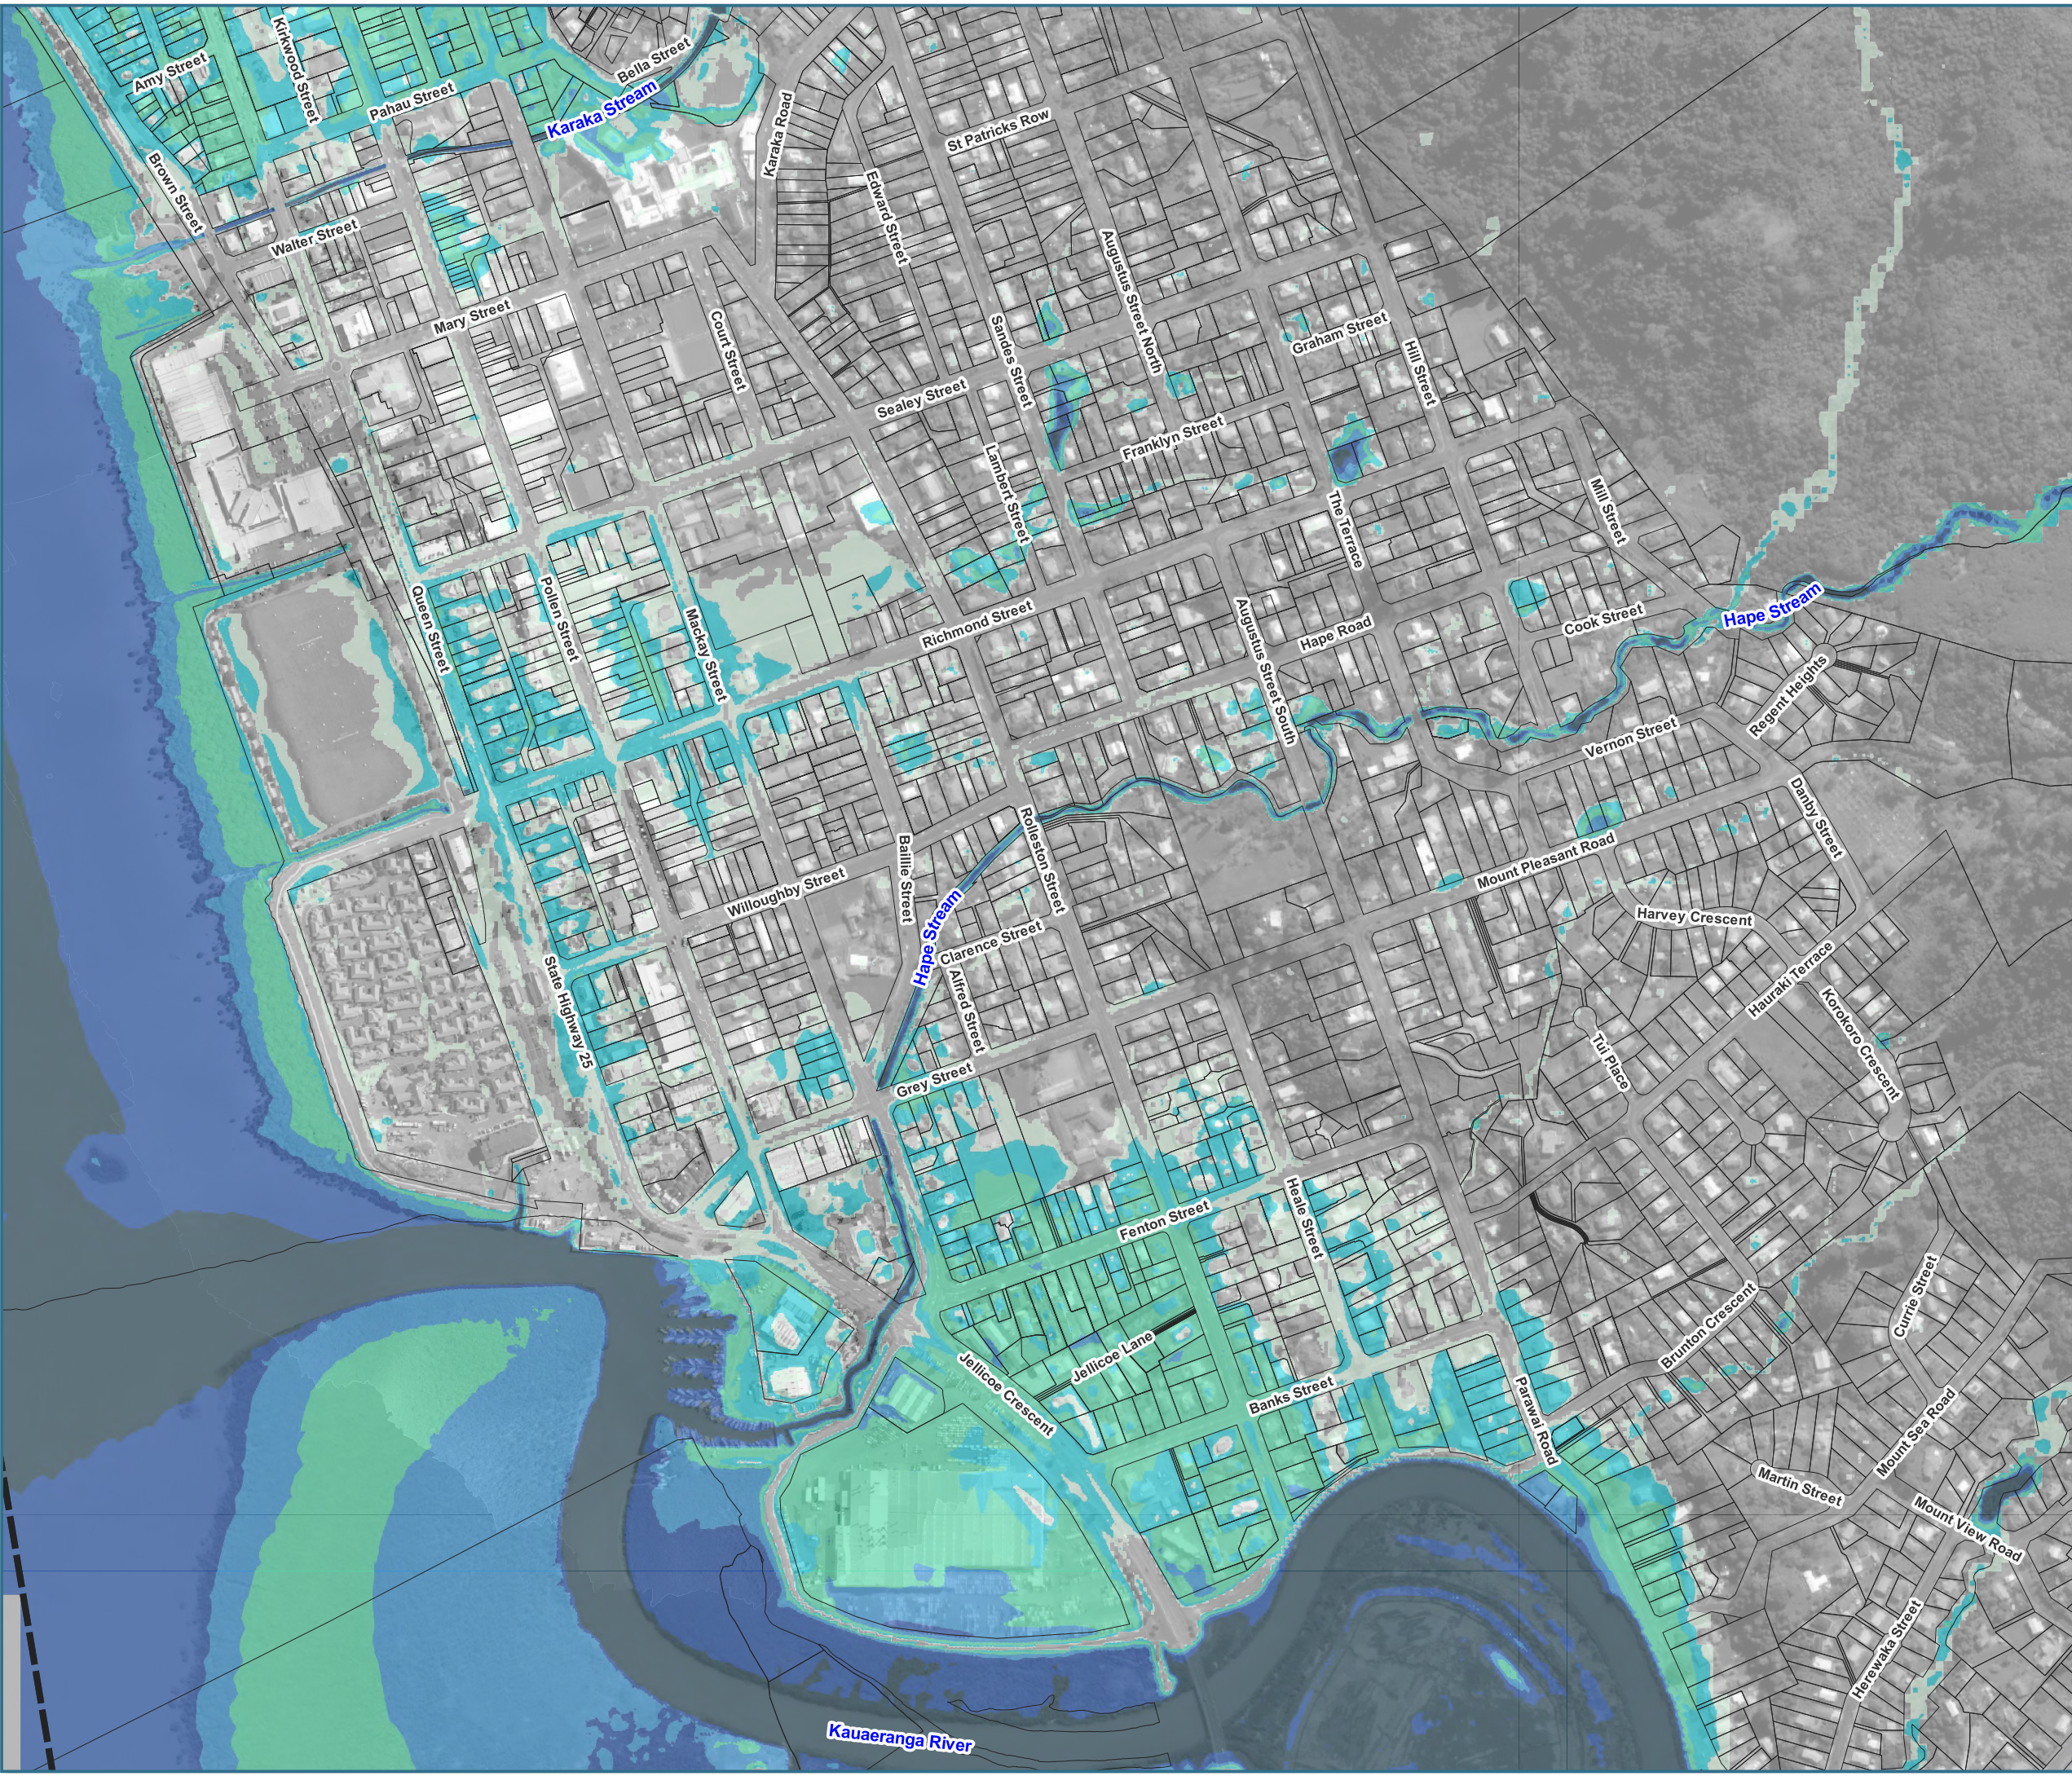
Figure 5 (Sheet 1)

In the 100 year ARI Event (shown in **Figure 5** in **Appendix B**), overtopping of Karaka Stream occurs at the Bella Street Culvert as well as the Bella Street Footbridge. This results in significant flooding in the majority

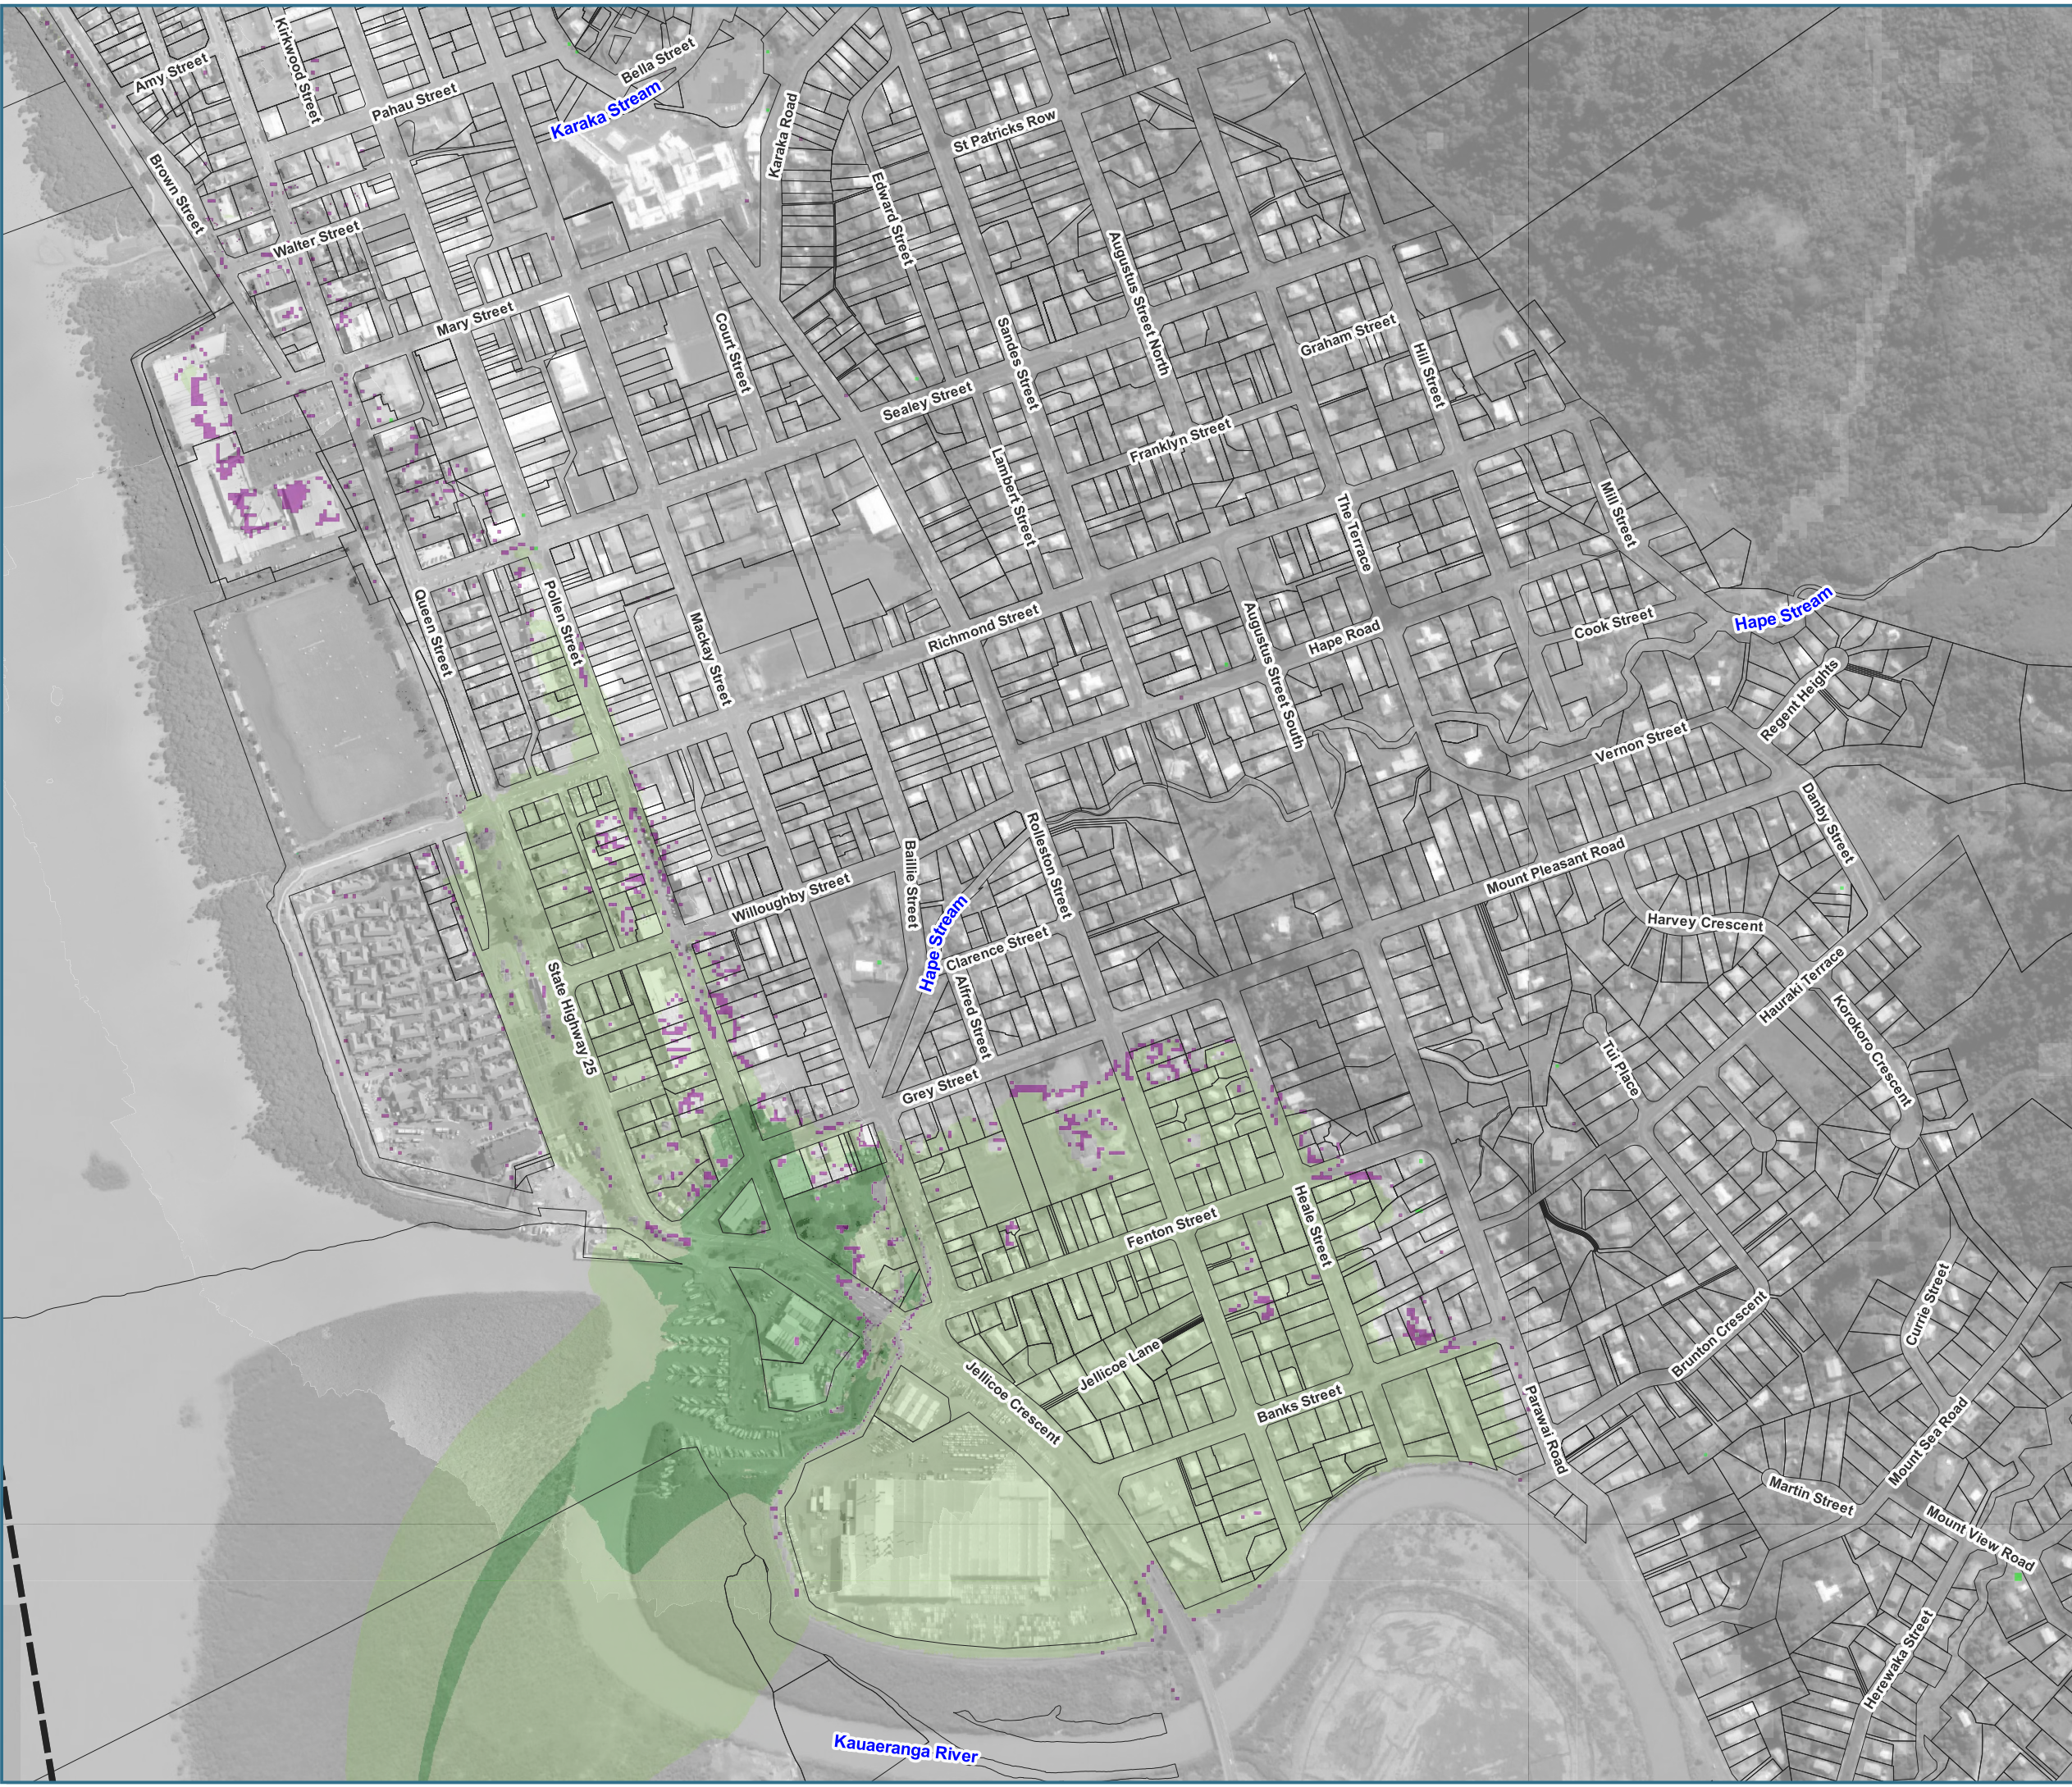
Figure 8 (Sheet 1)

Figure 8 in **Appendix B** shows that with climate change impacts in the medium term (year 2080) if no measures are made to further protect Thames, a significant increase (0.4 – 0.7 m) in depth may occur as a result of climate change in the 100 year ARI event. This is most severe near the ocean with sea level rise and vertical land movement as the main causes, but the increased rainfall extremes leads to more flooding in the Township as Karaka Stream and Hape Stream have increased flows (refer **Table 7-11** above) and the depth in the streams and the areas where the streams break out increases by between 0.1 and 0.4 m.

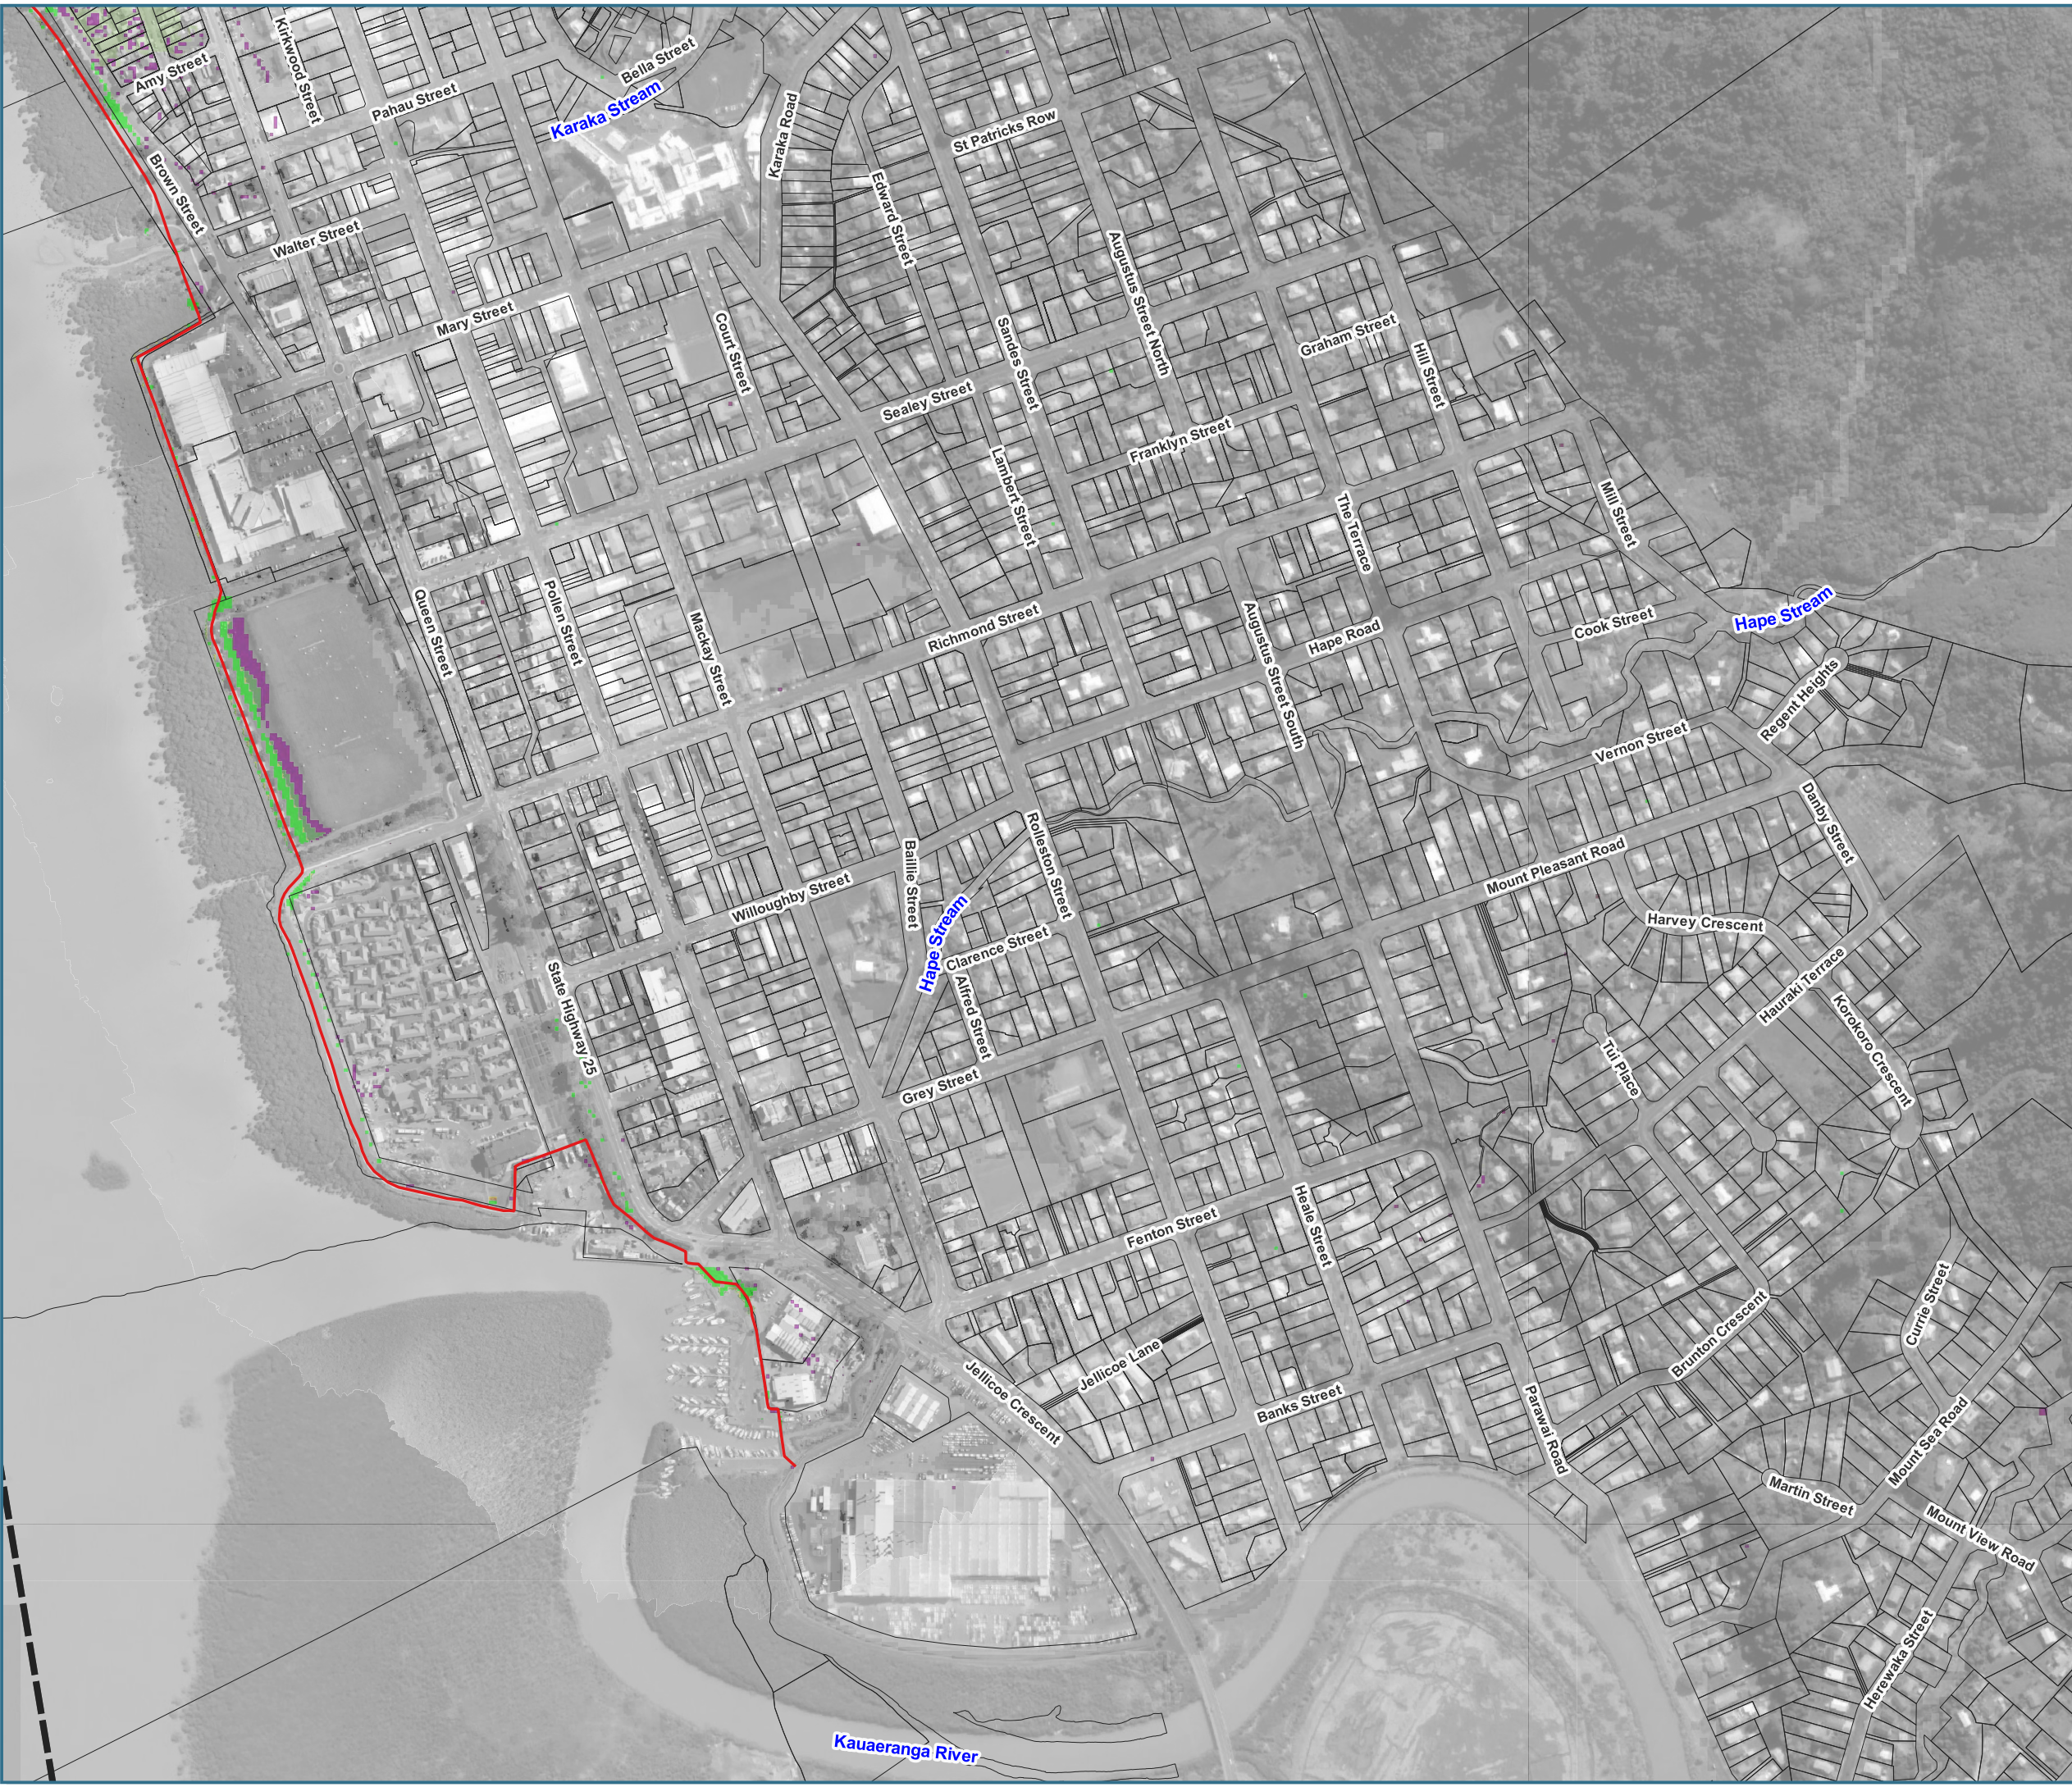
Figure 11 (Sheet 1)

Figure 10, Figure 11 and **Figure 12** in **Appendix B** show that with the Coastal Defence Concept Design in place with open gates, impacts on peak flood level are observed in the 10, 50 and 100 year ARI events, respectively. The impacts are in the vicinity of Albert Street due to the overtopping of the existing coastal defences in the baseline scenario and are between 0.05 – 0.1 m in the 10 year and more significant in the 50 and 100 year ARI events. The proposed Concept Design results in additional water ponding on the land-side since the height of the proposed sea wall does not allow overtopping, whereas in the baseline scenario, the seawall is observed to overtop from catchment flooding in events as frequent as the 10 year ARI. A detailed survey should be conducted on the existing seawall to accurately determine its current level and understand the potential impact on land-side flooding if the seawall is raised the fluvial floodwaters to escape due to overtopping, as they do in the existing case.
