Thames Coastal Protection Project - Feasibility Study

Fluvial Modelling Report Update

Client: Thames-Coromandel District Council

Reference: PA3520-101-101

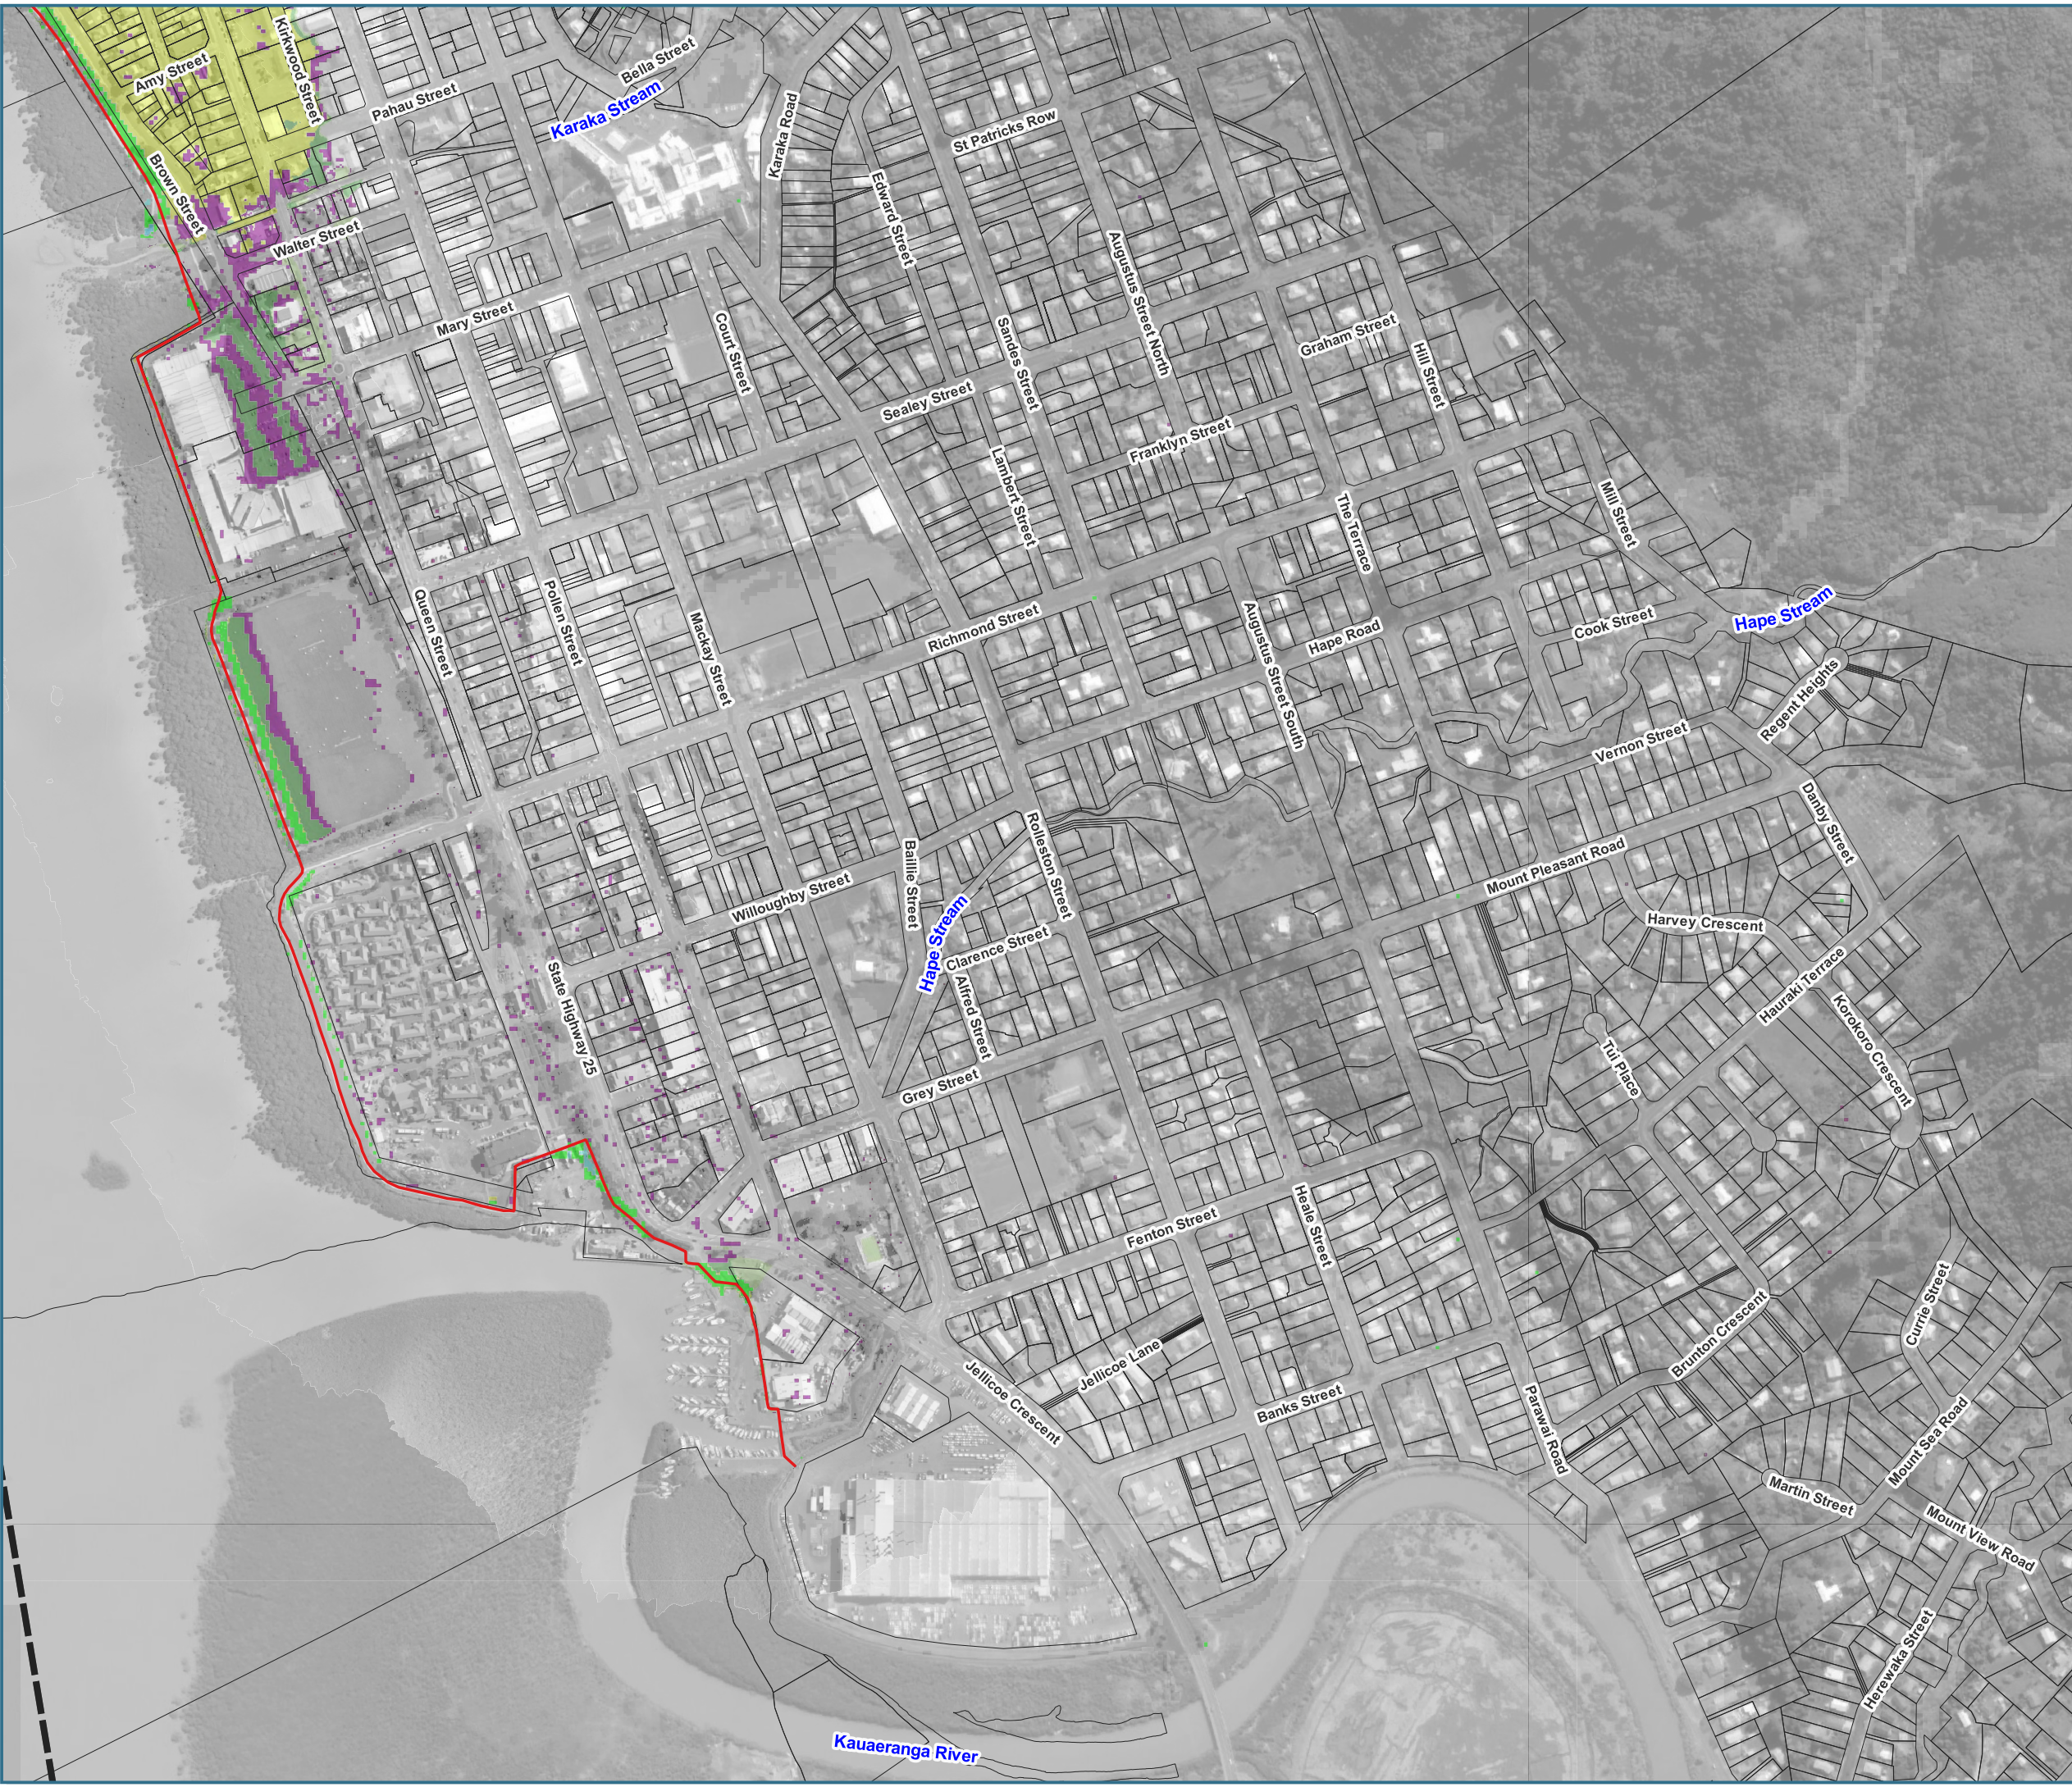
Figure 12 (Sheet 1)

Figure 10, Figure 11 and **Figure 12** in **Appendix B** show that with the Coastal Defence Concept Design in place with open gates, impacts on peak flood level are observed in the 10, 50 and 100 year ARI events, respectively. The impacts are in the vicinity of Albert Street due to the overtopping of the existing coastal defences in the baseline scenario and are between 0.05 – 0.1 m in the 10 year and more significant in the 50 and 100 year ARI events. The proposed Concept Design results in additional water ponding on the land-side since the height of the proposed sea wall does not allow overtopping, whereas in the baseline scenario, the seawall is observed to overtop from catchment flooding in events as frequent as the 10 year ARI. A detailed survey should be conducted on the existing seawall to accurately determine its current level and understand the potential impact on land-side flooding if the seawall is raised the fluvial floodwaters to escape due to overtopping, as they do in the existing case.
